ARTIFICIAL INTELLIGENCE-BASED EVALUATION OF PIPELINE STRUCTURES USING MULTI-SENSOR ROBOTS

ARTIFICIAL INTELLIGENCE-BASED
EVALUATION OF PIPELINE STRUCTURES
USING MULTI-SENSOR ROBOTS

THE UNIVERSITY OF TEXAS AT ARLINGTON

August 2023

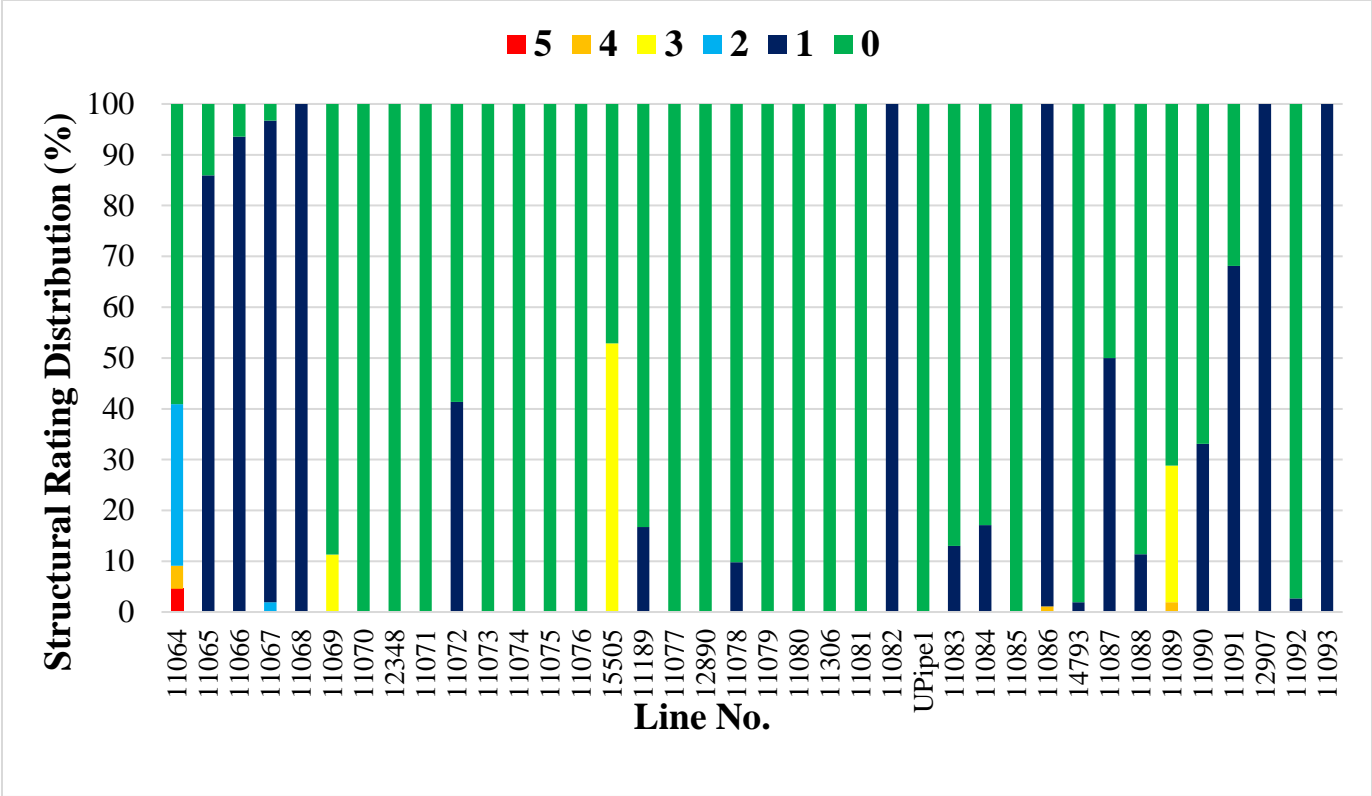
Figure 4-1 Structural rating for each line

SN	Distance from starting manhole (ft.)	Structural Rating	O&M Rating	Remarks
Line_11064				
1	45 to 50	5	-	Corroded Reinforcement found
2	55 to 60	4	-	Missing Aggregate
Line_11086				
1	275 to 280	4	-	Reinforcement Visible
Line_11089				
1	80 to 85	4	-	Reinforcement Visible

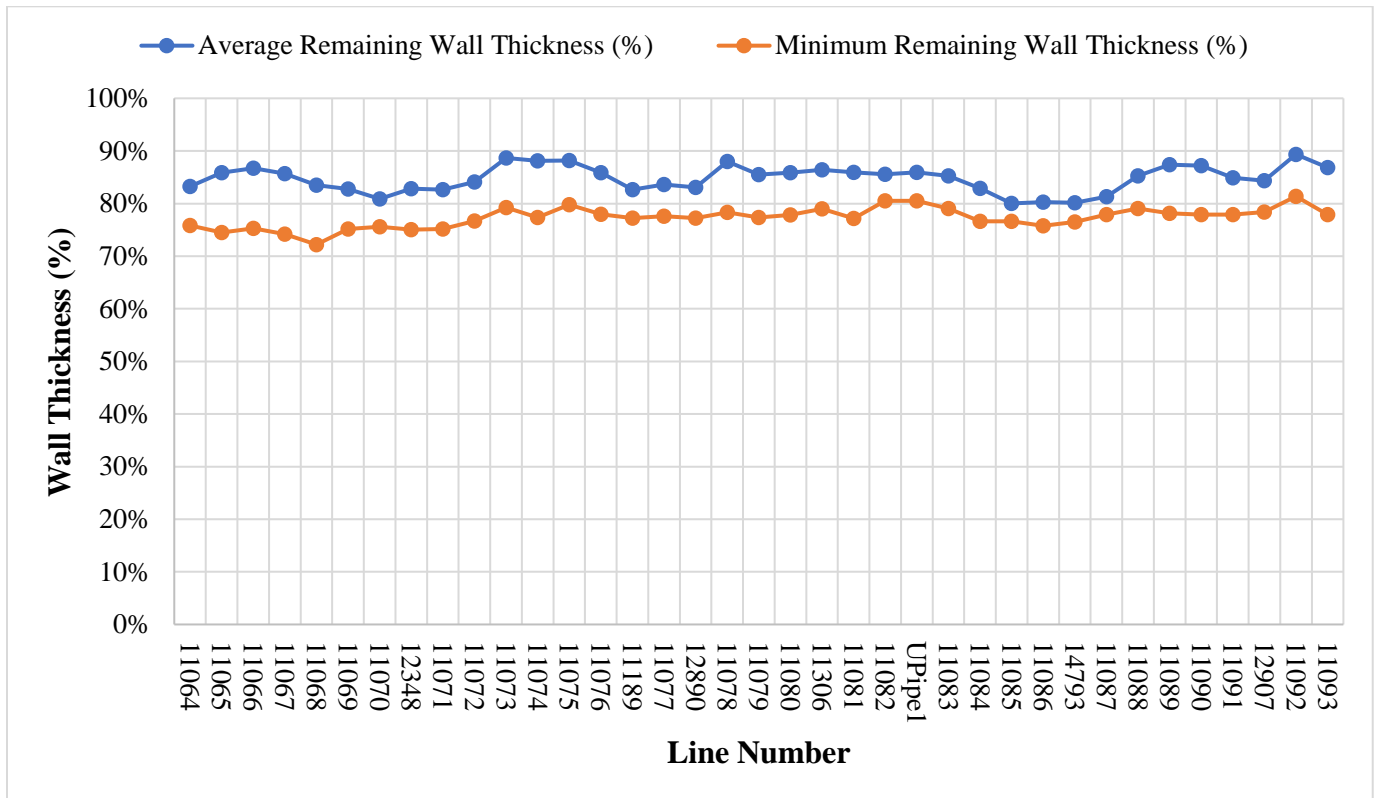
Figure 4-3 Average and minimum wall thickness of each line

A. 2D lidar revealed that although there was almost an inch of corrosion in some areas, which might expose the rebars in the future, none of the pipes were corroded to the extent that they need immediate attention. The CCTV, however, revealed projecting aggregates in some sections that need be addressed soon. The graph below shows the average and minimum wall thickness of each line.

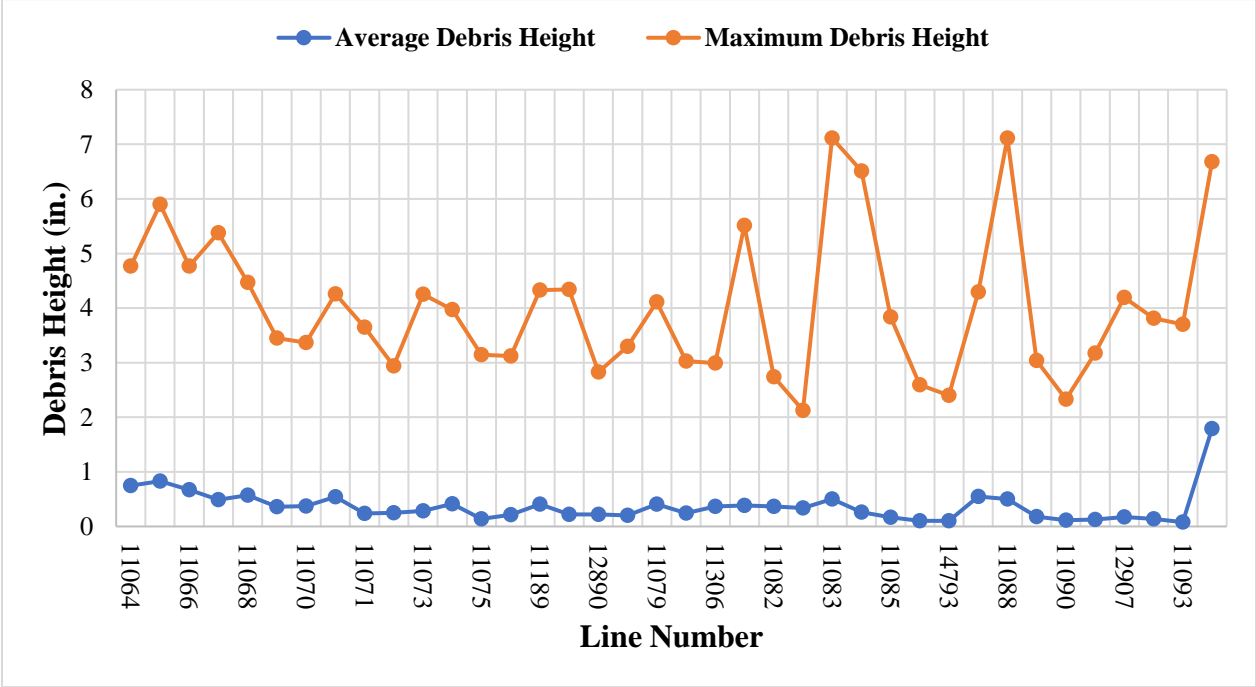
Figure 4-4 Debris Height Distribution for each line.

high-water levels, were found in line 15505, the only flexible pipe encountered. The debris height gradually increased from the upstream manhole and decreased after approximately 80 feet. The graph below shows the average and maximum debris height for each line.

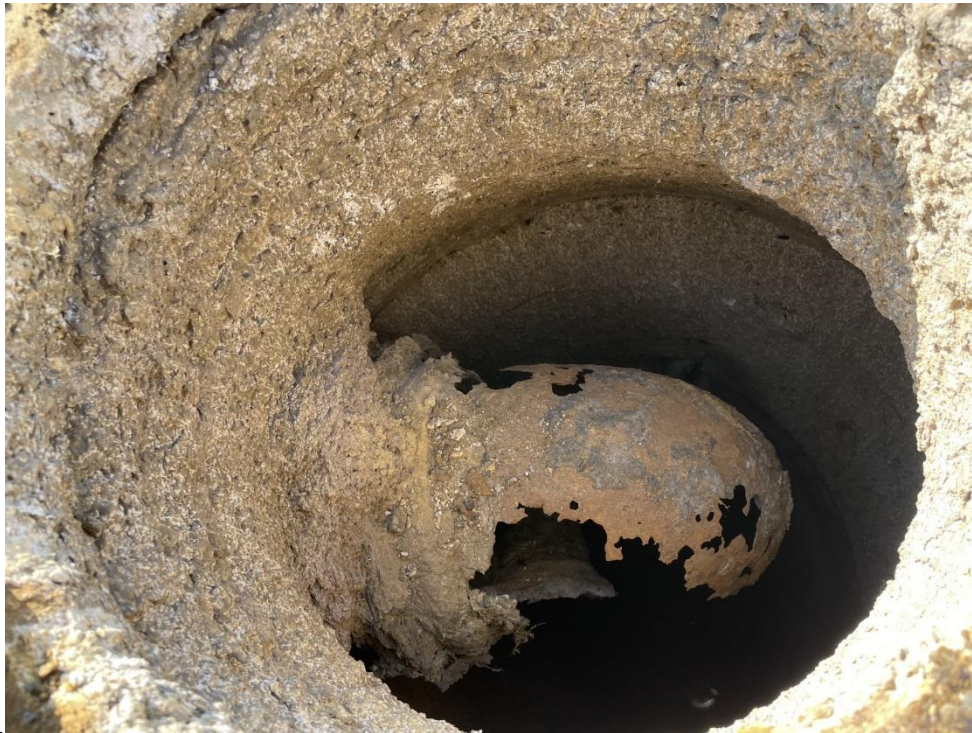
Figure 6-4 Example of an obstacle found in manholes
