2022 Fall Honors Capstone Projects

## TREE ROOT INFLUENCE ON BUILDING FOUNDATIONS IN EXPANSIVE CLAY SOILS IN NORTH TEXAS

HONORS BACHELOR OF SCIENCE IN ARCHITECTURAL ENGINEERING

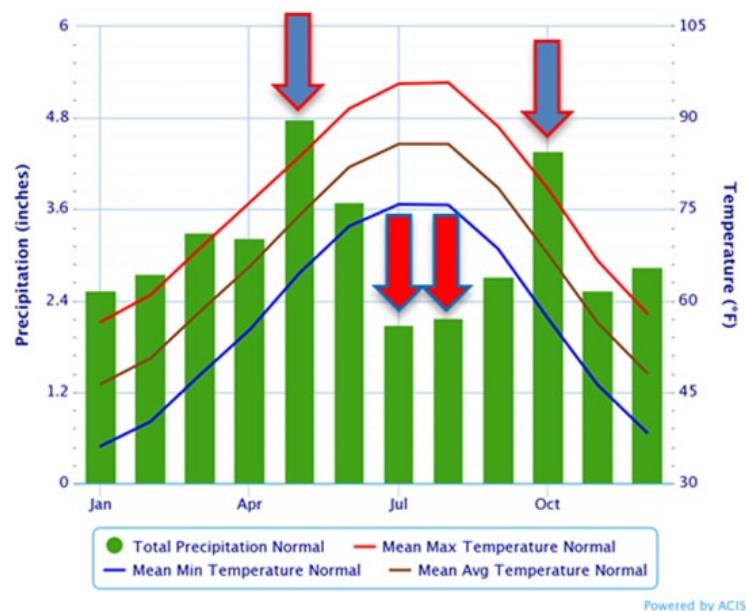
Figure 2.3: Dallas-Fort Worth Normals. Note: National Weather Service, Regional Climate Centers, National Centers for Environmental Information, & Applied Climate Information System. (2020). *Monthly Climate Normals (1991–2020) - Dallas-Fort Worth Area, TX* [Dataset]. National Weather Service.

rainfall of 2.08 and 2.18 inches and an average high of 95.6 °F and 95.8 °F, respectively. There are two rainy seasons throughout Texas in the spring and fall, with the most precipitation occurring in May and October for the DFW area at 4.78 and 4.37 inches, respectively. The coldest months are during winter in January and December, with an average low of 36.1 °F and 38.3 °F, respectively (National Weather Service et al., 2020). Considering the temperature throughout the seasons and varying precipitation levels, soil shrinkage and swelling are likely to occur around the aforementioned months, affecting residential foundations.

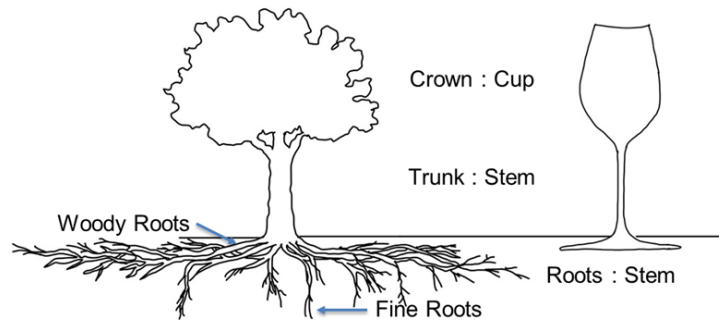
Figure 2.4: Tree Root System and Wine Glass Analogy.  
Note: VegaMartinez, R. (n.d.). [Sketch of root and glass analogy].

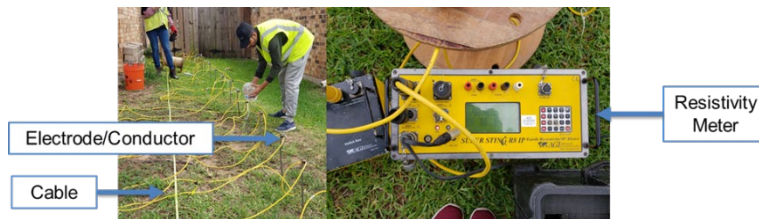
Figure 3.1: ERT Components and Set-Up. Note: VegaMartinez, R. (n.d.). [Photo of Electrical Resistivity Tomography equipment and layout].

For this research, electrical resistivity tomography will be used to determine the soil distribution and detect temporal changes in moisture and root volumes. Because the electrical resistivity of wood, soil, and water are different, a correlation between the dry and wet soil conditions in relation to root volumes is expected.

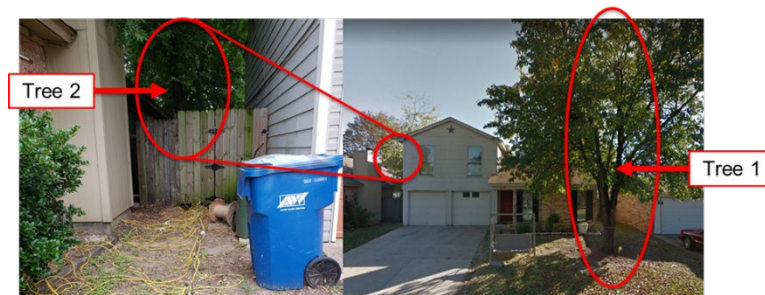
Figure 3.2: Case Study House, Site, Located in Arlington, TX. Note: VegaMartinez, R. (n.d.). [Photo of offending tree location and house].

This case study focuses on the North Texas area. The case study house is located in Arlington, Texas. It is a two-story residential home that is experiencing foundation

cracking. This research focuses on two trees, as noted in Figure 3.2. There were two imaging sessions conducted, one in May and another in August. These time periods were chosen based on the Climatic Normals data. The soil would be wetter and have an increased volume in May, while in the dryer summer months, like August, the soil would be dryer and decrease in volume. From these ERT imaging sessions, the results gathered should show a discrepancy in moisture causing the trees to react. Presumably, this comparison in data will exhibit a change in root mass gravitating toward the wetter soil beneath the house foundation, drawing water. Over time this pattern of wet and dry will cause cracking and settlement to occur under the house.

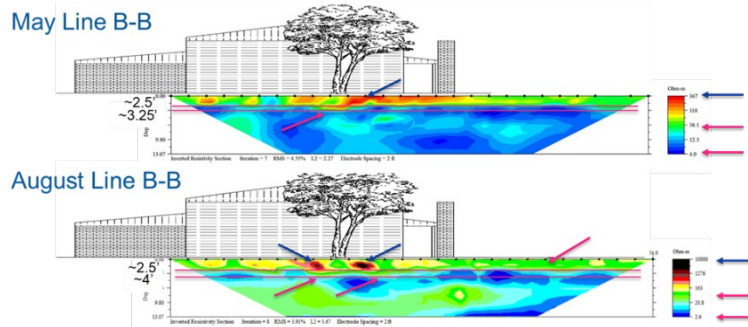
Figure 4.2: Results for Tree 2 Line B-B. Note: VegaMartinez, R. (n.d.). [Data from imaging sessions for Tree 2].

The results from Line B-B for both sessions are shown in Figure 4.2 above. From the May session, the initial soil conditions and relationship to the tree are shown. The blue designates the moist soil at varying saturation levels, where the water table can be implied to be at about 2.5 feet. Above the water table, varying levels of moisture exist at the topsoil. Focusing on the area beneath Tree 2, there is a dip shown in green. Green delineates a drier soil content that declines slightly below the water table. This describes the initial position of Tree 2's roots, already seeking moisture below.

Comparing the results of May to August for Tree 2 Line B-B, there is general drying of the soil. This is to be expected due to the change in temperature and precipitation. Looking at the initial position of the water table at 2.5 feet, there is a change in moisture. The soil is slightly drier as indicated by the lighter blue shade. Looking beneath Tree 2, there are now two indentions located at approximately 4 feet in depth and about 6 feet apart. The position of the tree roots has extended themselves about 3 feet laterally and 9 inches in depth. The black colorization indicates a resistivity of 1000 ohmmeters, which is extremely dry and slightly mirror the dry areas shown in May's session. Furthermore, when

compared to the area of the soil undisturbed by tree root interaction, there is slight drying noticed due to climate but overall, the topsoil remains undisturbed.

Tree 2 Line B-B provided clearer results with demonstrative conclusions. The difference in images exhibit a change in root mass gravitating toward the wetter soil beneath the slab. The roots grew laterally 3 feet and 9 inches in depth in search of water during this drought. The extreme resistivity results shown in black in Figure 4.2 are an anomaly and most likely depicts the concrete slab. From the first imaging in May for Line B-B, the same area is dry but indistinguishable from surrounding composition. Now from the August imaging, the area is made clearer.

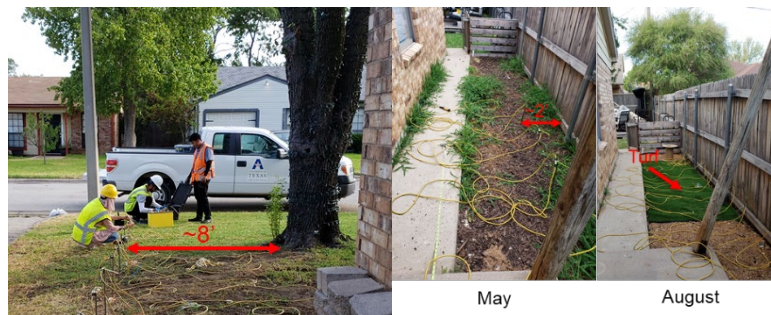
Figure 5.1: Tree 1 Line A-A Problems. Note: VegaMartinez, R. (n.d.). [Photo of Tree 1 proximity and changes to site].

Unfortunately, the results from Tree 1 Line A-A were inconclusive. All that can be definitively stated is that there has been a change in moisture content within the soil profile. Somethings to note about the results, because of the proximity of the line to the tree being farther than ideal, an accurate relationship between the soil and the roots could not be depicted. This is due to the extended slab, to remedy this, I would consider drilling holes into the slab to better capture the tree. And perhaps imaging horizontally across the house rather than vertically. Also, there were changes to the site upon the August visit. The right side of the house had undergone some home improvements with the grassy area replaced with turf and a French irrigation system. This led to a change in the resistivity line by two feet, skewing the results of the imaging.
