TESTING AND EVALUATION OF POLYMERIC SPRAY APPLIED PIPE LINING IN PRESSURE PIPE APPLICATIONS

DISSERTATION

The University of Texas at Arlington

August 2023

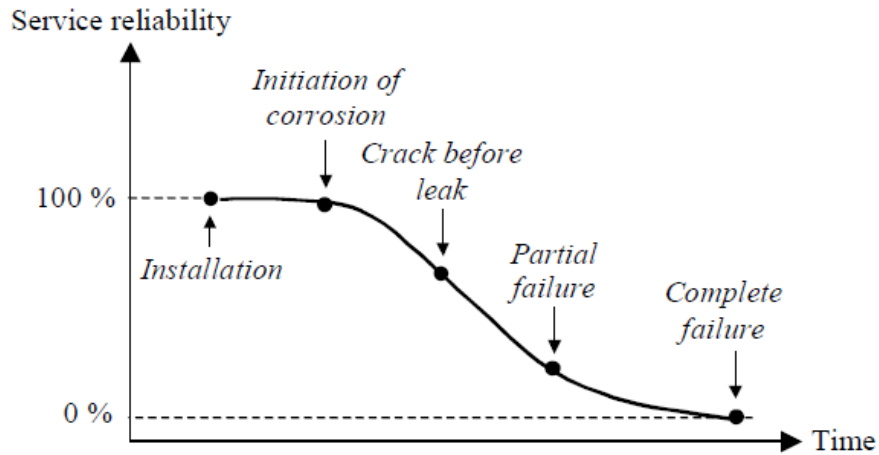
Figure 1.2. Pipe Failure Development (Adapted from Misiunas, 2005)

As illustrated in Figure 1.2, each step's service reliability depends upon the pipe's service life. The pipe deterioration is a gradual process with a decreasing efficiency and structural capability. Thus, a gradual declining curve of pipe service reliability is shown in Figure 1.2.

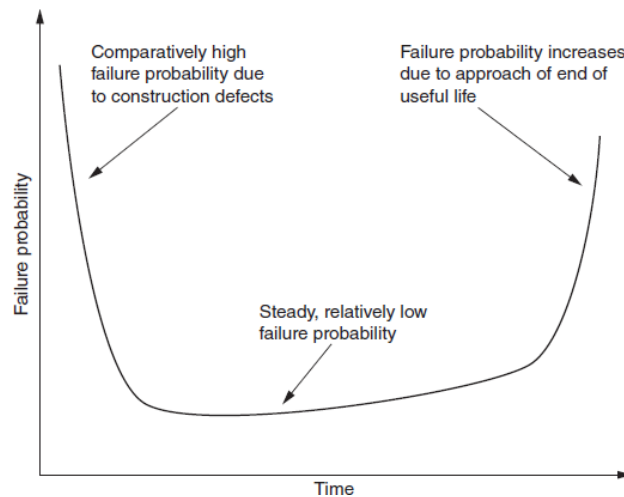
Figure 1.3. Bathtub Curve of Pipe Performance (Najafi & Gokhale, 2022)

Other studies by Najafi and Gokhale (2022) & Singh and Adachi (2011) represented pipe failure in the shape of the “bathtub curve.” The bathtub curve was derived from the pipe failure rate versus time, as shown in Figure 1.3. The first stage is the “Early stage,” which shows a steep downward curve. This downward curve indicates that a greater number of pipe failures were recorded just after the installation due to defective installation procedures and/or faulty pipe material.

The second stage is the “Useful life” period, which shows a lower failure rate. Failure in this stage generally happens due to some incidents, such as heavy traffic loading, ground movement, or interference by a third party. The third stage is the “Wear-out” stage which again shows a higher number of pipe failures. This higher rate could be due to the end of the design life; during this time, the pipe entirely deteriorates.

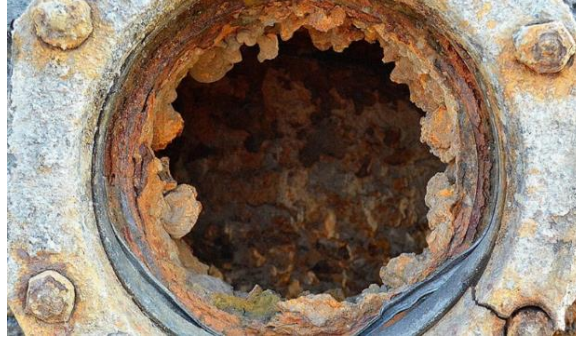
Figure 1.5. Pipe with Corrosion Deposit Affected Hydraulic Flow Capacity
(Source: APP Manufacturing)

The second most common type of pipe failure is hydraulic failure. A hydraulic pipe failure occurs when the pipelines fail to supply the fluid at the required pressure (Zhou, 2018). The hydraulic failure can be due to irregularities on the internal pipe surface, and deposits created due to corrosion. These irregularities and deposits reduce the internal diameter and subsequently, affect the flow capacity of the pipe. In addition, these corrosion-deposited irregularities also affect the pipes' internal smoothness, which increases the friction factor and decreases the flow capacity.

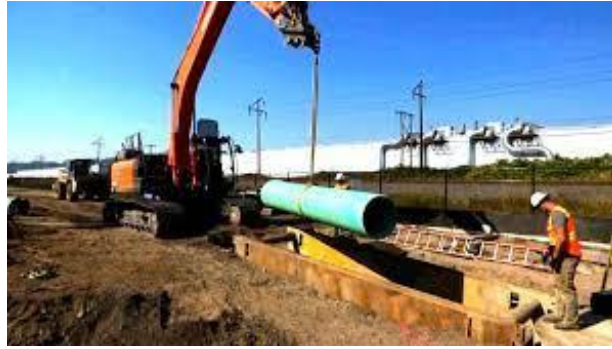
Figure 1.6 Open Cut Method

Najafi and Gokhale (2022) explained that the open cut renewal method is more expensive and time-consuming than the trenchless techniques; about 70 percent of the extra cost is due to site restoration. Figure 1.6 shows the open cut method of replacing the pipe. In contrast, Figure 1.7 shows the trenchless method of rehabilitating the larger diameter pipe (left side) and smaller diameter pipe (right side).

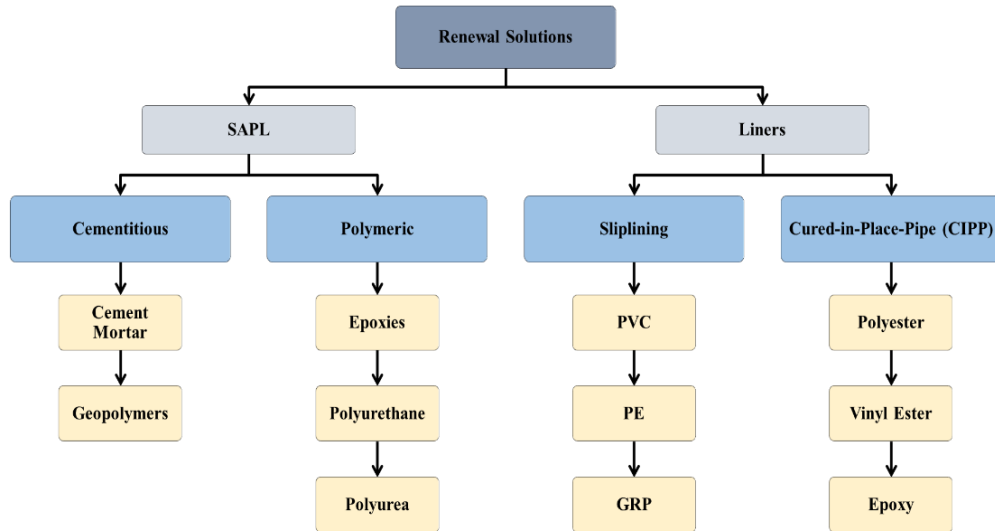
Figure 1.8 Renewal Solutions in Trenchless Technology
(Adapted from Najafi & Gokhale, 2022)

project specific conditions and constraints, availability of trenchless technology contractors and providers, and plans for future pipe applications (Najafi, 2010). Figure 1.8 shows the different renewal solutions based on renewal methods and the material used.

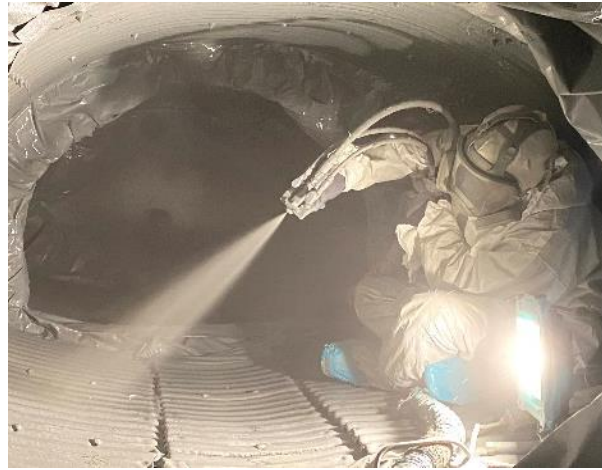
Figure 1.9 SAPL Manual Application

Polymeric SAPL is a new renewal application that can be used to structurally renew deteriorated gravity and pressure pipelines. It can be applied to a varied range of concrete, masonry, corrugated metal, and steel pipelines. Furthermore, the polymeric lining is approved for water mains by the National Sanitation Foundation (NSF) (Najafi & Gokhale, 2022). The polymeric SAPL can be applied manually or with a robotic application, depending on the pipe diameter and space constraints. Figure 1.9 below shows a manual application of the polymeric SAPL liner and Figure 1.10 shows a robotic application. Polymeric SAPL has material

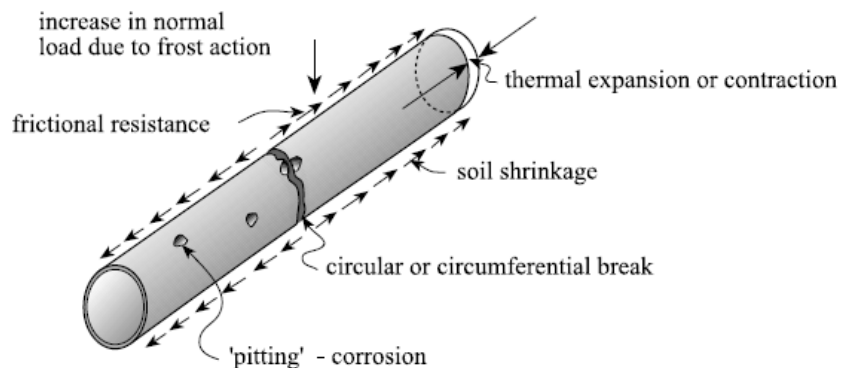
Figure 2.1 Failure Mode of Underground Pipe Due to Direct Tension
(Adapted from Rajani & Kleiner, 2001)

Figure 2.1 represents the graphical representation of pipe defects and failure mode of an underground pipe due to direct tension. Figure 2.2 illustrates the pipe failure mode due to bending and Flexure. Figure 2.3 exemplifies the pipe failure due to hoop stress.

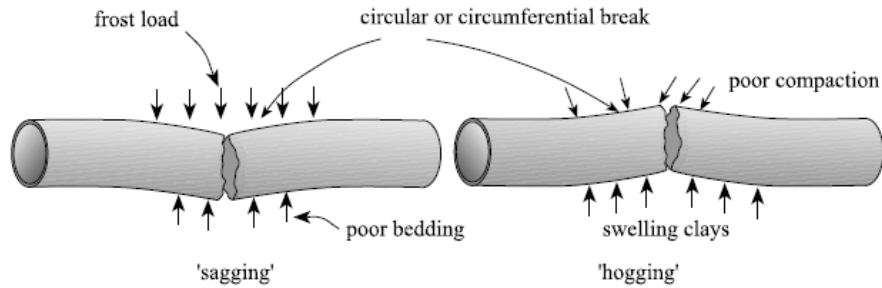
Figure 2.2 Failure Mode of Underground Pipe Due to Bending and Flexure (Adapted from Rajani & Kleiner, 2001)

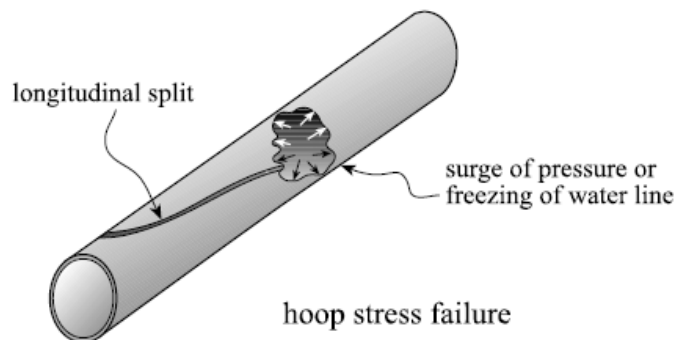
Figure 2.3 Failure Modes of Underground Pipes Due to Hoop Stress (Adapted from Rajani & Kleiner, 2001)

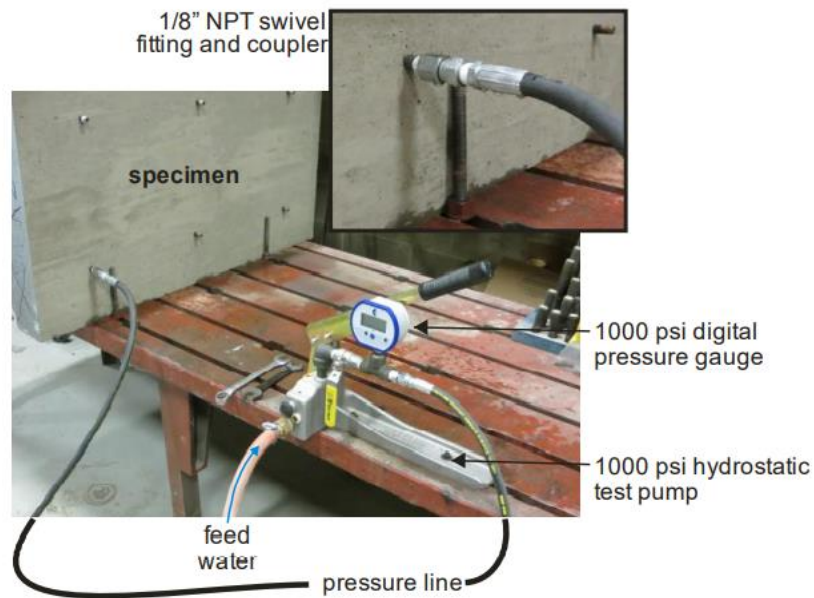
Figure 2.4 Hydrostatic Test Apparatus (Harries and Sweriduk, 2013)

Harries and Sweriduk (2013) performed the hydrostatic pressure tests on Spray-Applied Epoxy Lining System. The experimental setup was designed to evaluate the ability of spray-applied epoxy liner to resist internal hydrostatic pressure, as shown in Figure 2.4. The experimental program replicated the ‘blow out’ of any enclosed structure under hydrostatic pressure. Defects ranging from 0.5 to 6 inches were created in the concrete structure, and then, these defects were lined with an epoxy liner. Hydrostatic pressure was applied to the test setup and the pressure values resisted by the liner were determined.

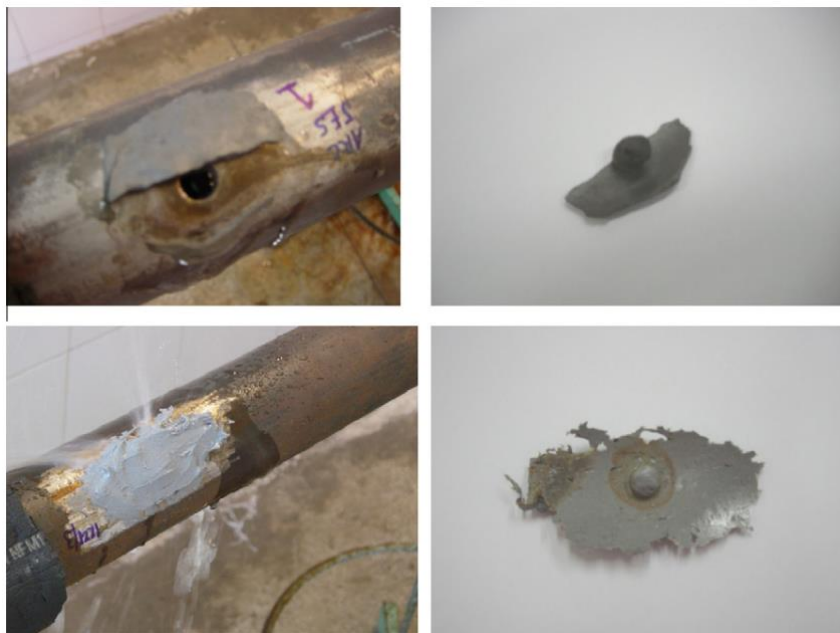
Figure 2.5 Corrosion Damaged Pipes Repaired with Epoxy
(Costa Mattos et al., 2012)

Costa Mattos et al. (2012) also performed research on hydrostatic burst test on water pipelines similar to the research work done by Harries and Sweriduk (2013), but this study also included the long-term hydrostatic test. The study evaluated the strength of epoxy lining for repairing the corrosion damaged water pipelines (approx. 3.5 in. diameter) that were used in offshore oil and gas platforms. Burst tests and long-term hydrostatic tests were performed at constant pressure levels and at temperature between 175 °F and 195 °F. In these tests, the structural integrity of the epoxy lined pipelines was assessed. An average burst pressure of 3600 psi was applied to the test setup, whereas 1500 psi constant internal pressure was applied in a long-term test at 175 °F. A system failure was observed at a peak pressure of 2,490 psi after 6 days. Figure 2.5 shows the corrosion damaged pipes repaired with epoxy.

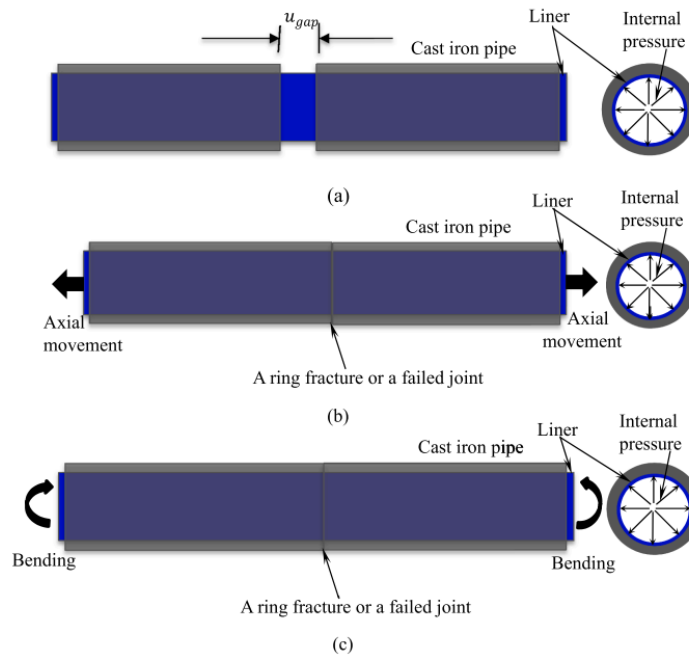
Figure 2.6 Pressurized Cast Iron Pipes Lined with Polymeric Liners
(Adapted from Fu et al. 2022)

regression. Different pipe properties, liner properties, loading conditions, and interface properties were considered while developing the equations. This study was based on numerical analysis, in which the available models and results from the literature were used. The study did not perform the experimental data for validating the developed models.

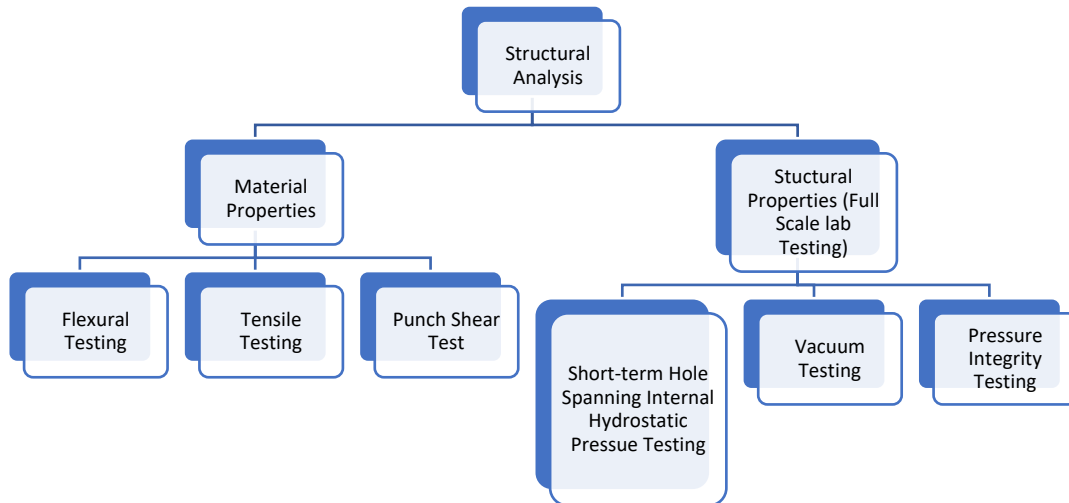
Figure 3.1 Structural Evaluation of SAPL

As presented in Figure 3.1, for the material testing, three material tests were performed to determine the flexural, tensile and punch shear strength. These material properties were important to determine mechanical behavior of the material, and these properties were used in designing the liner thickness for the full-scale laboratory testing developed for determining the structural properties of the liner material. The test designed for the structural properties are short-term hole spanning internal hydrostatic pressure testing, which is evaluating the structural properties of the material as semi-structural and determining the hole-spanning capacity of the polymeric SAPL lined pipe with corrosion holes.

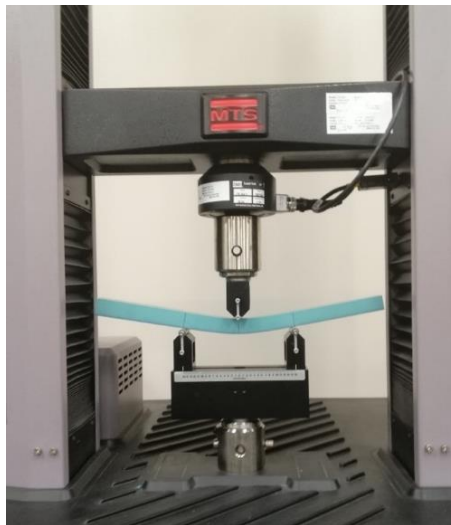
Figure 3.2 Three-Point Flexural Bending Test

The three-point bending flexural test is conducted to investigate the flexural (bending) properties of the Polymeric SAPL according to the ASTM D790. Method A is used to perform the

testing. Figure 3.2 shows the MTS machine used to conduct the three-point bending test along with one of the specimens.

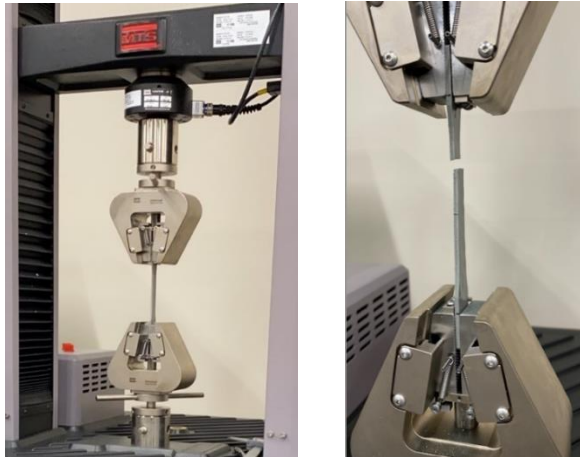
Figure 3.3 Tensile Test (left) and Specimen Rupture (Right)

material can experience under tension divided by the cross-sectional area. Figure 3.3 (right) represents the broken specimen due to tensile failure. The test were performed at different temperatures of 73° F, 120° F, 150° F, and 32° F.

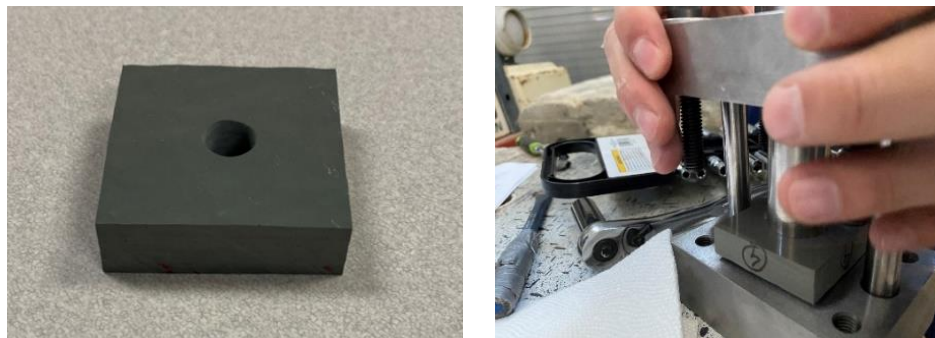
Figure 3.4 Specimen before Testing (left)
Specimen Installed in Punch Shear Fixture (right)

Shear strength testing is used to determine the load at which a plastic will yield when sheared between two metal edges. This test method covered the procedure for determining the shear strength of polymeric material according to the ASTM D732-17. Six plastic specimens were tested for shear strength. All specimens were 2-inch squared plates and 0.50 in. thick, as shown in Figure 3.4 (left). Specimens were installed in the punch shear fixture as shown in Figure 3.4 (right).

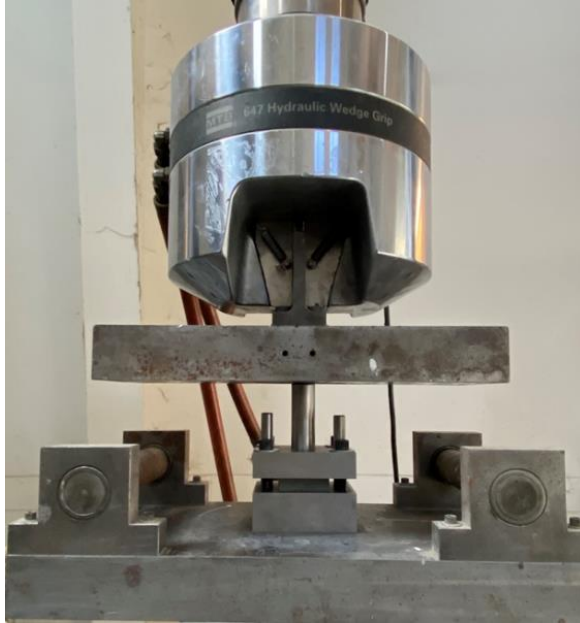
Figure 3.5 Punch Shear Test

Figure 3.5 shows the MTS testing machine and the punch shear fixture that are used to conduct the Shear strength test as per the ASTM D732-17. The specimens were subjected to a test speed of 0.050 in./min. During the Shear strength test, the male punch is forced through the hole in the metal fixture causing shear along the edge of the hole. An MTS testing machine equipped with Data Acquisition (DAQ) system is used to provide the vertical load on the punch shear fixture

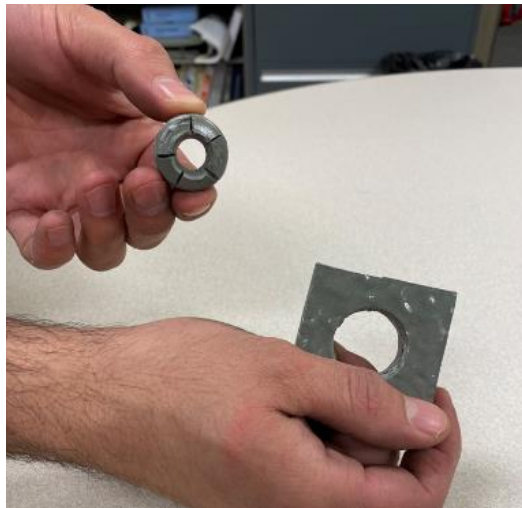
Figure 3.6. Specimen after Shear Failure

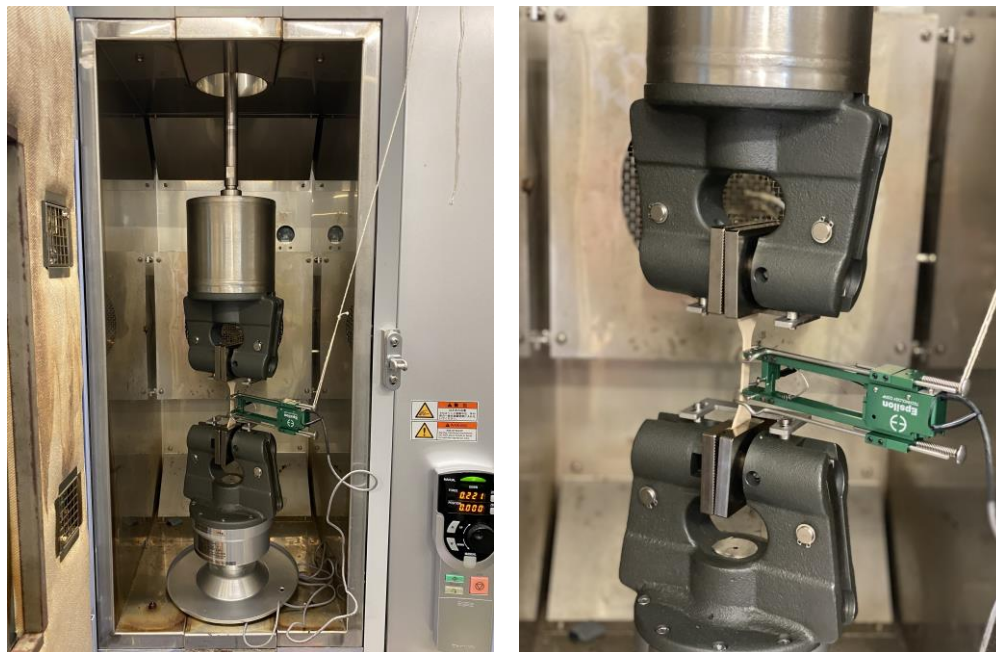
Figure 3.7 Tensile Test Pure Polyurea Material

A similar procedure as described in section 3.3.1.2 was applied to test the tensile strength of the pure polyurea material. This material was elastomeric in nature and was more flexible. Five dog bone specimens were tested for tensile strength. The specimen thickness and width were 0.071 in. (1.790 mm) and 0.242 in. (6.134 mm) respectively as per ASTM D638 Class IV. The specimen was placed and tightened in the grips of the testing machine. The specimens were subjected to a test speed of 0.197 in./min (5.0 mm /min), and were pulled against opposite end at this speed. DAQ recorded the load vs displacement data at a periodic interval of 0.10 seconds.

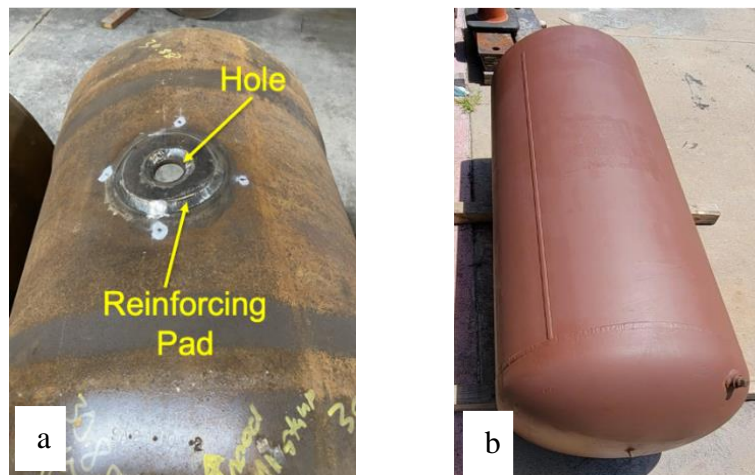
Figure 3.8 (a) Pipe Sample with Hole Spanning and (b) Spigot Ends with Dish Heads

In this experimental setup, three carbon steel pipe samples of 30 in. diameter with a thickness of 0.375 in. and 3 ft long were tested. To simulate actual field conditions of corrosion holes, circular holes of ½, 1-, and 2-inch diameters were created, respectively, in three pipe samples at the center of the pipes using drilling or torching techniques. The pipe hole is as shown in Figure 3.8 (a), and each hole was grinded for smoothness. The 3-foot pipe samples (as shown in Figure 3.8 (a)) were connected to 6 ft long spigot end (as shown in Figure 3.8 (b)) on both sides and fabricating an overall length of the test setup as 15 ft long. The pipe samples and spigot ends were in conformance with all applicable American Water Works Association (AWWA) standards. The pipe material used to fabricate these pipes was AWWA C200 Grade 42 or higher. The thickness of the pipes was designed to resist 500 psi pressure. For welding the spigot ends to the dish heads, a high-quality weld with a pressure rating of up to 500 psi was used.

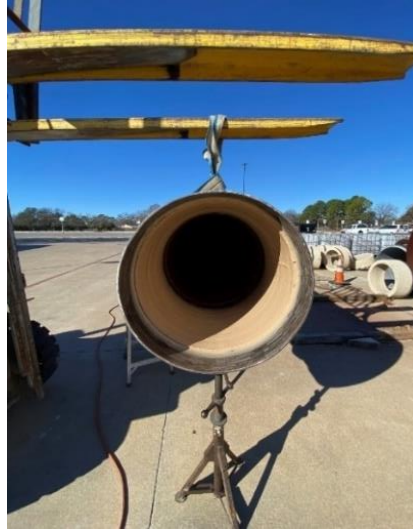
Figure 3.9 Inside View of Test Section with Pure Polyurea Liner

The 3-ft test section with hole was solely lined with SAPL and connected to the spigot ends. The inside view of the test section with pure polyurea polymeric liner is shown in Figure 3.9.

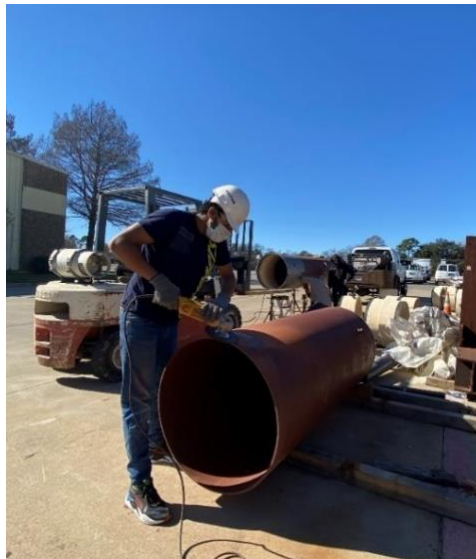
Figure 3.10 Spigot End Grinding before Welding

The test section with different sized holes was changed in the 3 consecutive tests, and the two spigot ends were reused for each test. The certified high-quality arc welding was used to avoid any leakage and weld failure due to high pressure expected during the testing. Prior to welding, grinding was performed on both the spigot ends and the middle section to achieve a smooth surface. The grinding process for the spigot end is depicted in Figure 3.10.

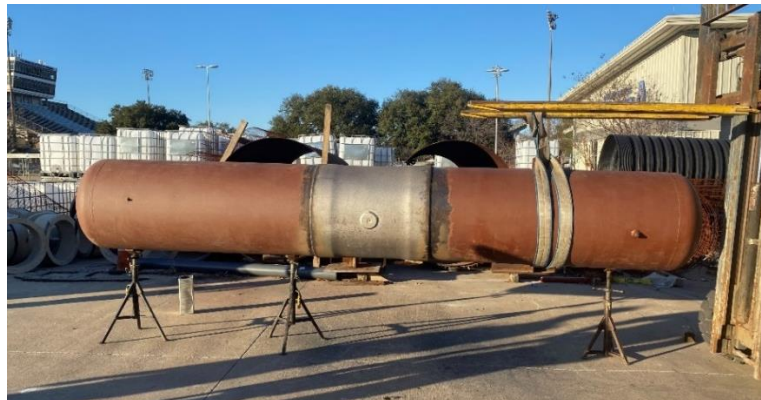
Figure 3.12 Spigot Ends Welded on Both Ends of the Test Section

Figure 3.12 below shows the complete test setup of 15 ft long when both the spigot ends were successfully welded to the test section.

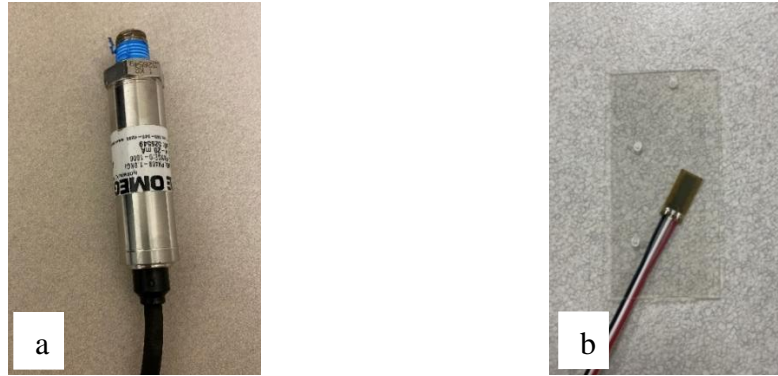
Figure 3.13 (a) Pressure Transducer (b) Strain Gauge

As shown in Figure 3.13 (a), the Omega Engineering, model PX409-1.0KGI transducer was installed on the spigot end to accurately measure and monitor the pressure. The accuracy of the transducer is $\pm 0.08\%$, and the pressure range was from 0 to 600 psi. Its output is in the range of 4-20 mA and was connected to the Micro Measurement system 8000, a data acquisition (DAQ) system, for real-time monitoring and recording of pressure data in psi throughout the test.

Due to space constraints for installation on the 0.5-inch, the strain gauge was only installed on the liner exposed through the 1-inch and 2-inch diameter holes. The purpose of the strain gauges was to monitor the strain experienced by the liner material (exposed through hole) when subjected to internal hydraulic pressure. The strain gauge is represented in Figure 3.13 (b).

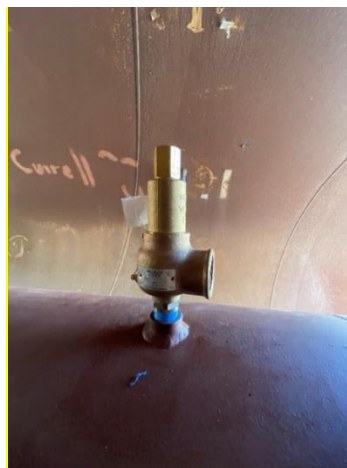
Figure 3.14 Air Release Valve

Figure 3.14 shows a 1-inch air release valve installed at the top of the spigot end to release any entrapped air before pressurizing the test section. The air release valve could handle the pressure of test setup up to 600 psi.

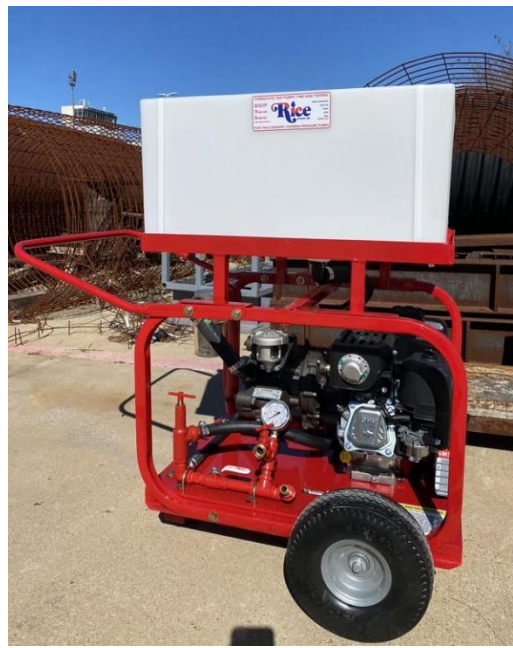
Figure 3.15 Hydrostatic Pressure Pump

A Rice Hydro Inc hydrostatic pump, shown in Figure 3.15, was used to pressurize the test setup to a maximum pressure of 500 psi. The pump model was DPV-3B, a diesel-operated pump, and powered by the Briggs and Stratton Vanguard 200 engine. The DP-3 was a triple diaphragm pump. The pump outlet hose had a 0.5-inch quick connect coupling to provide an easy and quick connection to the test setup. The pressure regulator on the pump enabled adjustment of the pressure, with an operating range of up to 550 psi. A pressure dial gauge mounted on the pump continuously monitored the pressure output of the pump. The pump was connected to the test setup, incrementally pressurizing it in 50 psi increments until reaching a maximum pressure of 600 psi.

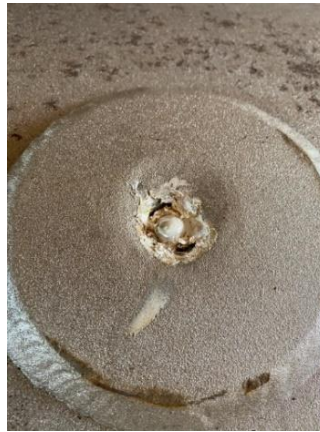
Figure 3.16 Pipe Sample with 0.5 in. Hole Spanning

The first pipe sample tested was with a 0.5-inch hole spanning. The liner thickness for the pipe sample was designed as per AWWA Class II, and the liner thickness calculated for the 0.5-inch hole spanning was 0.25-inch. The liner exposed through a 0.5-inch hole spanning is shown in Figure 3.16. Prior to the application of the liner, the pipe sample was abrasive blasted and primed with "Metal Prime" at a thickness of 4-5 mils. A pure polyurea liner was then sprayed onto the surface, achieving a thickness of 0.25 inches.

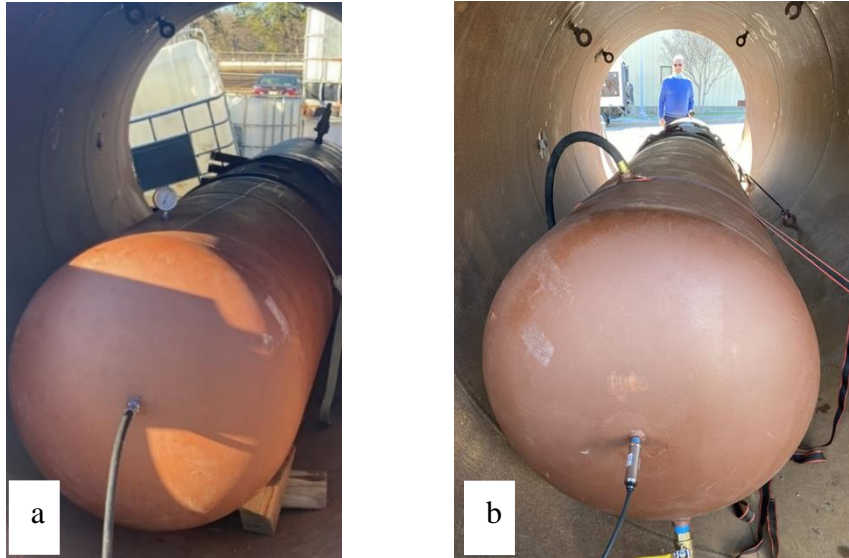
Figure 3.17 (a) Pump Hose Connection to Test Setup (b) Transducer Connected to Test Setup

The polymeric lined pipe sample was welded to the spigot at both ends, creating a test setup with a total length of 15 feet, as described in the test methodology section. This 15-foot test setup was then placed inside a 72-inch diameter carbon steel pipe and securely fastened to steel hooks available within the pipe. Figures 3.17 (a) and 3.17 (b) illustrate this setup. The purpose of the strapping was to provide an added safety measure in case of liner failure and to prevent any movement of the test setup during the application of high pressure, up to 500 psi. The test setup was connected to the pump at the water inlet connection provided at the spigot end, as shown in Figure 3.18.

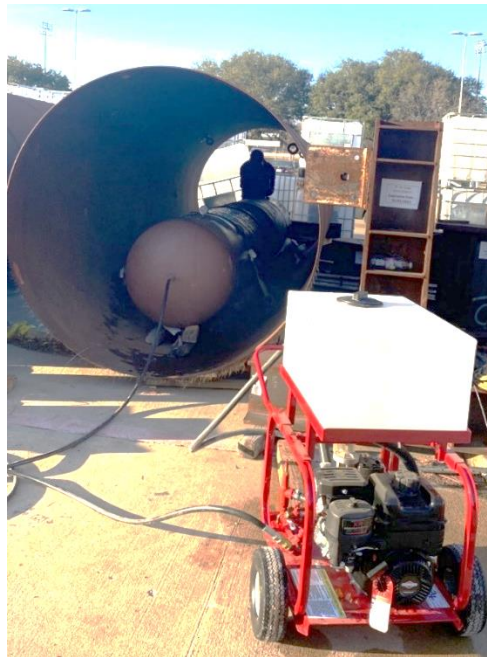
Figure 3.18 Complete Test Setup

Figure 3.18 shows the complete assembly of the test setup. During the test procedure, four test runs were performed. The weather and environmental conditions were recorded on the test day, as shown in Table 3.2.

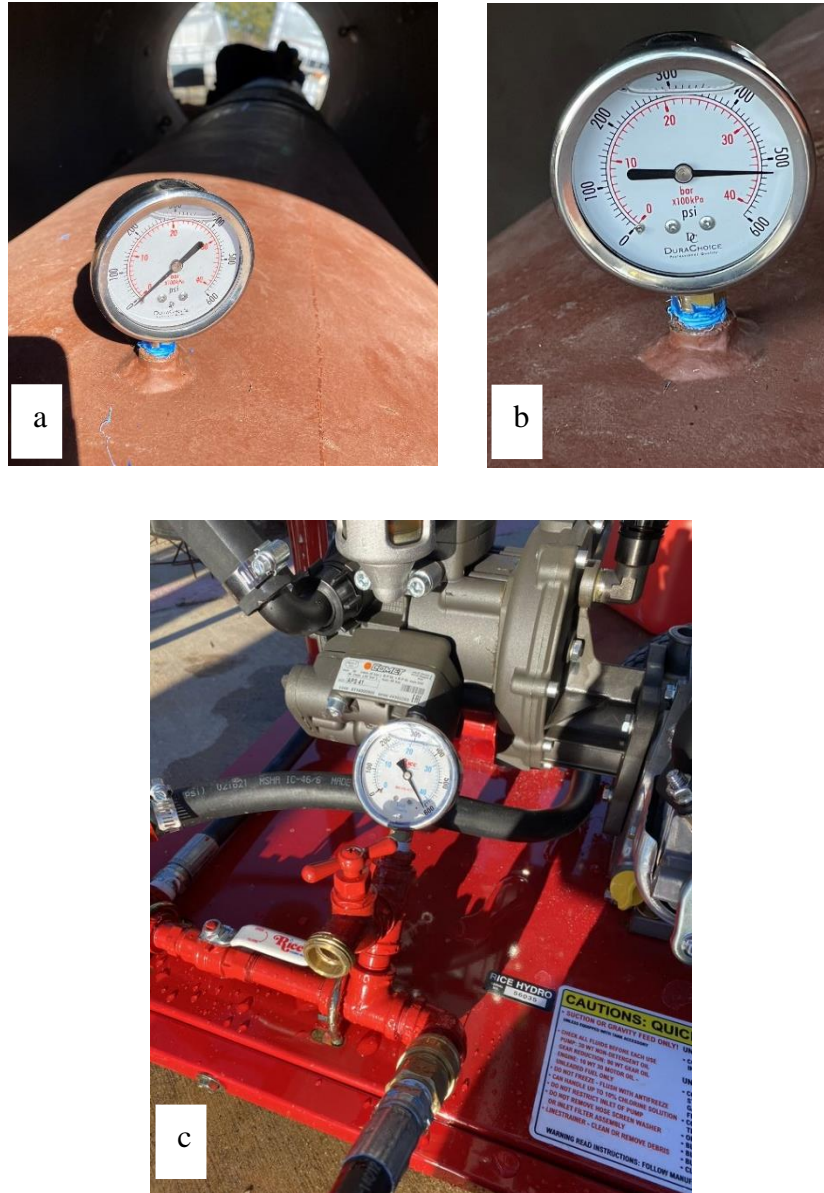
Figure 3.19 (a) Pressure Dial Gauge Initial Reading (b) Pressure Dial Gauge Reading at the End of the Test (c) Pressure Dial Gauge Reading of the Pump

Table 3.2 shows that the temperature recorded on the test day was 47° F, and the wind speed was six mph. The water temperature during the test was noted at 42° F. Prior to pressurizing the test setup at a desired pressure of 500 psi, the setup was tested for any leak detection. The test setup was pressurized to 100 psi and held for 15 minutes to check any water leakage from weld joints or the coupling joints of the instrumentation provided. In addition, the proper functioning of the instrumentation was checked during this leak detection test.

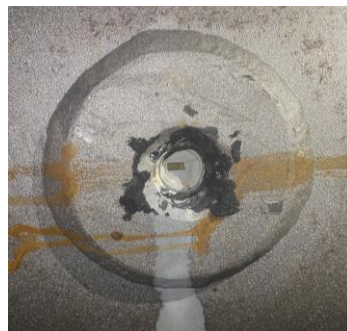
Figure 3.22 1-inch Hole Spanning Pipe Sample

The first pipe sample tested was with a 1-inch hole spanning. The liner thickness for the pipe sample was designed as per AWWA Class II, and the liner thickness calculated for the 1-inch hole spanning was 0.5-inch. The liner exposed through a 1-inch hole spanning is shown in Figure 3.22. Similar to 0.5-inch hole spanning liner installation, prior to the application of the liner, the pipe sample was abrasive blasted and primed with "Metal Prime" at a thickness of 4-5 mils. A pure polyurea liner was then sprayed onto the surface, achieving a thickness of 0.5 inches. The installation procedure of the liner was entirely similar to first pipe sample.

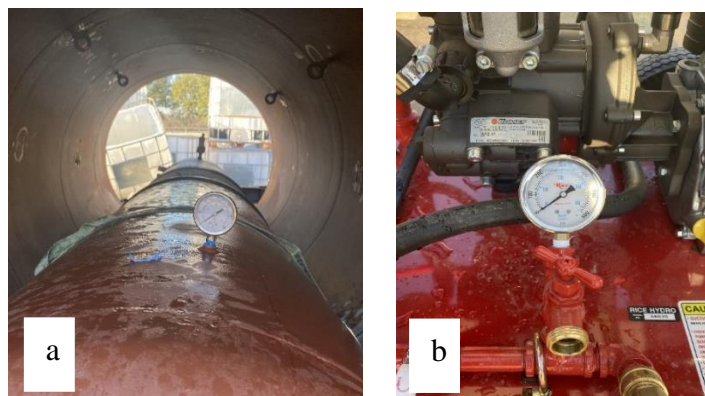
Figure 3.23 (a) Pressure Dial Gauge Initial Reading at the Start of the Test
 (b) Pressure Dial Gauge (on pump) During the Start of Test

Table 3.3 shows that the temperature recorded on the test day was 76 °F, and the wind speed was 8 mph. The water temperature during the test was noted at 60 °F. Prior to pressurizing the test setup at a desired pressure of 500 psi, the setup was tested for any leak detection. Then the test setup was pressurized to 100 psi and held for 15 minutes to check any water leakage from welding joints or the coupling joints of the instrumentation provided, and to check for the proper functioning of the instrumentation.

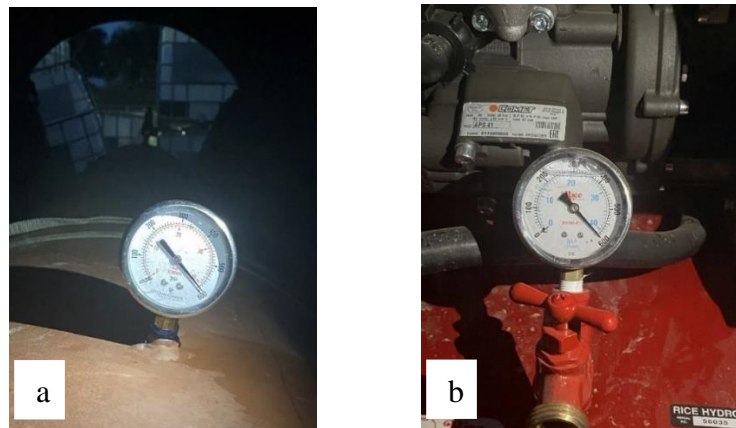
Figure 3.24 (a) Pressure Dial Gauge Reading at the End of the Test
(b) Pump Pressure Dial Gauge Reading at the End of the Test

Similar pressure requirement of 500 psi was applied to second pipe sample. The test setup was successfully pressured to more than 500 psi pressure and held for 10 to 15 minutes. Figures 3.24 (a) and (b) show the test setup achieved the maximum pressure more than 500 psi.

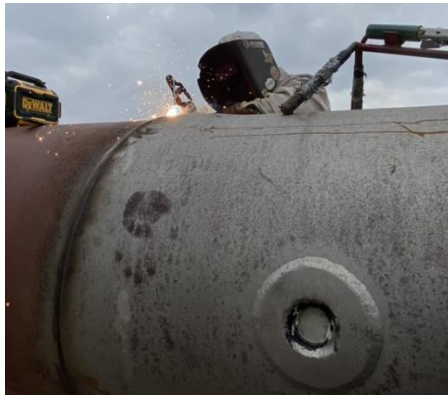
Figure 3.25 Pipe Sample 2 in. Hole Spanning

The liner exposed through 2 in. hole spanning is shown in Figure 3.25. Similar to first and second pipe samples, the third pipe sample was also abrasive blasted and primed with the Metal Prime at 4-5 mils. A pure polyurea liner was then sprayed onto the surface, achieving a thickness of 1 in. The installation procedure of the liner was entirely similar to first and second pipe samples.

The third sample tested was with a 2-inch hole spanning. The spigot ends cut from the 1-inch hole spanning test were reused for the 2-inch hole spanning pipe sample. The liner thickness for 2 in hole spanning sample was also designed as per AWWA Class II, and the calculated thickness is 0.75-inch.

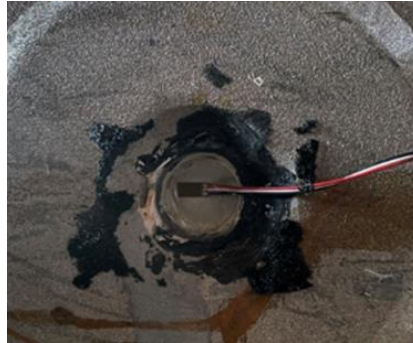
Figure 3.26 Strain Gauge Installed on 2 in. Hole Spanning

The test setup assembly and testing procedure were similar to 0.5 and 1 in. hole spanning testing. The strain gauge installed on the 2 in. hole spanning is shown in Figure 3.26. The strain

at the liner exposed through a 2 in. hole was measured continuously during the testing using the data acquisition system.

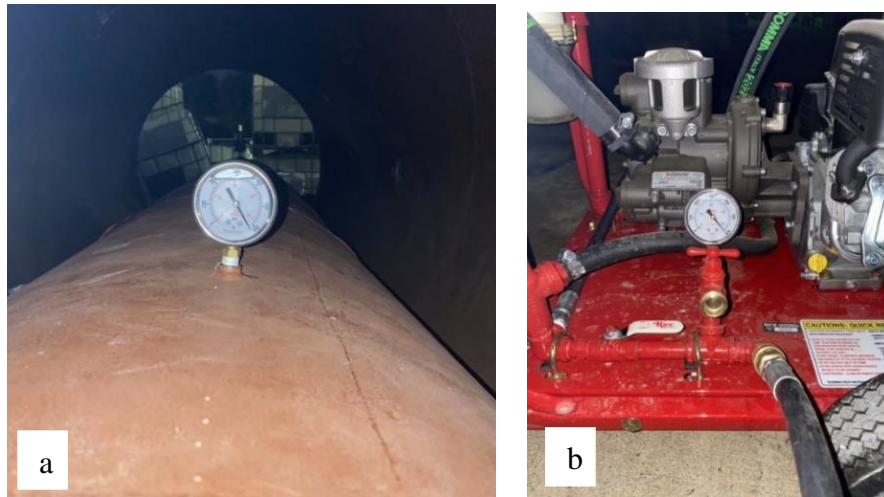
Figure 3.27 (a) Pressure Dial Gauge Reading on Test Setup (b) Pressure Dial Gauge Reading on Pump

Similar to previous testing of 0.5 and 1 in. hole spanning pipe samples, the water leak test was performed to detect any water leaks from the welding joints, and coupling connections of the instrumentations. The proper functioning of the instrumentations was performed before pressurizing the test setup to a desired pressure. The test setup was successfully pressured to more than 500 psi pressure and held for more than 10 days.

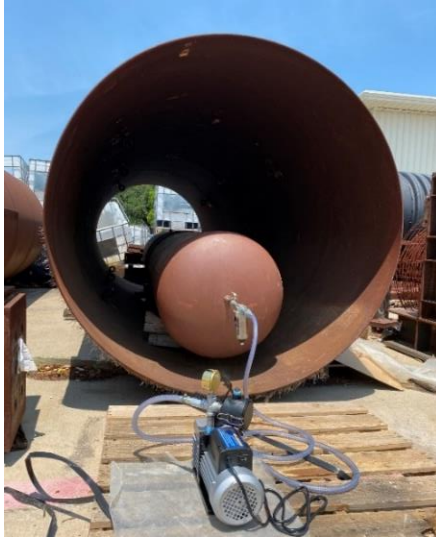
Figure 3.28 Vacuum Pressure Test Setup for 2 in. Hole Spanning Pipe Sample

The vacuum pressure test was conducted using a rotary vane oil lubricated vacuum pump with a power rating of 0.75 hp. A vacuum water separator was used in between the test assembly and the vacuum pump. This vacuum water separator collected any moisture entrapped in the test setup before it reached to the vacuum pump during the generation of vacuum pressure in the test setup. The vacuum water separator had a vacuum pressure capability ranging from -100 kPa to 1000 kPa. Figure 3.28 shows the vacuum pump connected to the test setup of 2-in. hole spanning test setup.

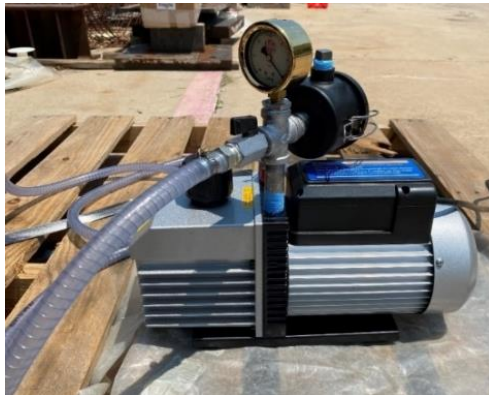
Figure 3.29 Vacuum Pressure Dial Gauge Reading
(Pressure Achieved Zero in. of Hg in Test Assembly)

The vacuum pump connected to the test setup first evacuated the air entrapped, and a zero atmospheric pressure was reached in the closed chamber, as represented in Figure 3.29.

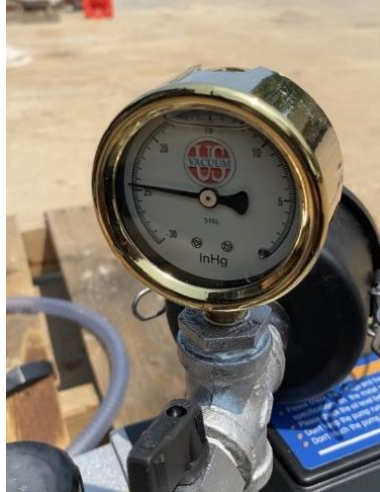
Figure 3.30 Vacuum Pressure Dial Gauge Reading
(Pressure achieved 24.6-in. of Hg in Test Assembly)

After achieving zero atmospheric pressure, the test setup was subjected to further vacuum pressure, as shown in Figure 3.30.

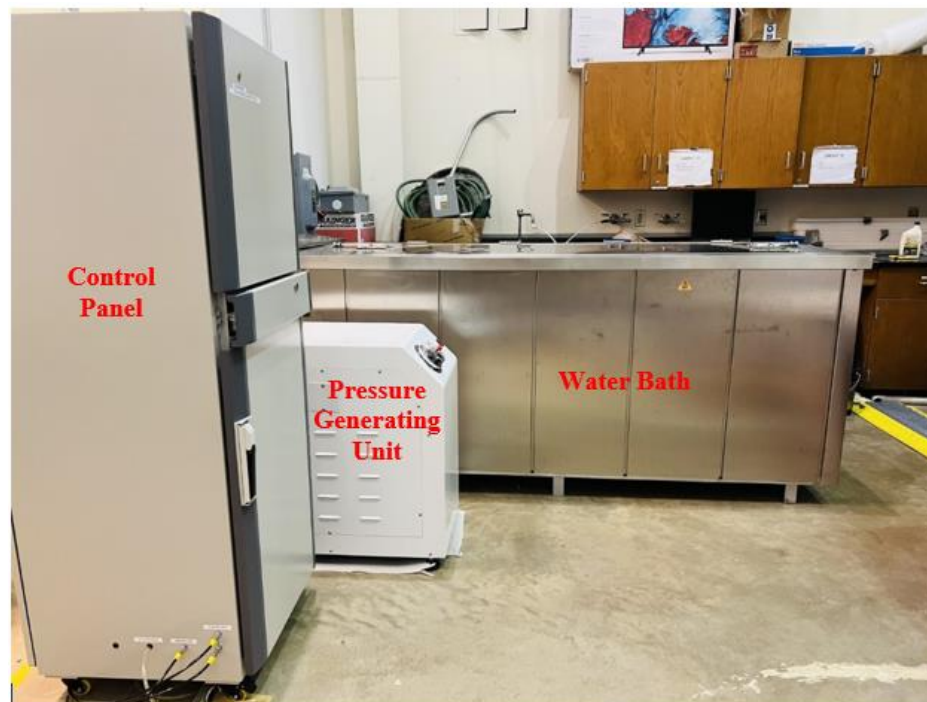
Figure 3.31 Test Setup

A hydrostatic pressure testing equipment, specifically designed as per ASTM D1599, was used to perform the test. The equipment was designed to apply constant pressure to the pipe samples at a required temperature. Throughout the test, the pressure and temperature were continuously monitored and recorded. Figure 3.31 shows the pressure integrity test setup, which included the water bath/thermal tank, pressure generating unit, and control panel. Figure 3.32 shows the chiller unit attached to the water bath.

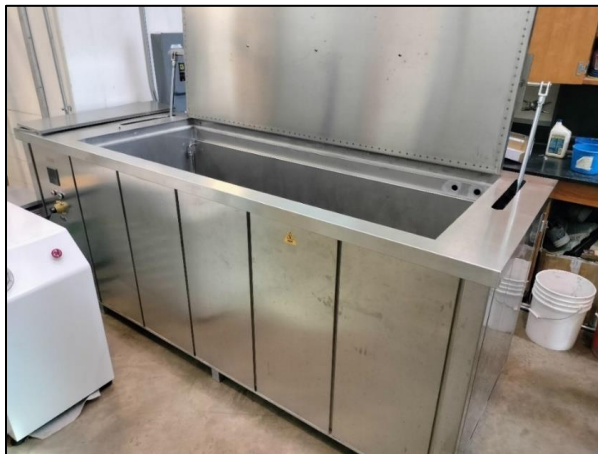
Figure 3.33 Water Bath

The water bath was made of high-quality stainless steel with internal dimensions of 74.80 in x 27.56 in. x 31.50 in. (1900 mm x 700 mm x 800 mm), as shown in Figure 3.33. The tank has an inbuilt heating system with a power of 13.5 kW, which was used to heat the water to achieve the required temperature for the test. A continuous water loop was running in the water bath tank to circulate the heated water to maintain temperature uniformity throughout the water bath tank. The water temperature can be heated from room temperature to 203° F with a temperature control accuracy of $\pm 0.9^\circ$ F.

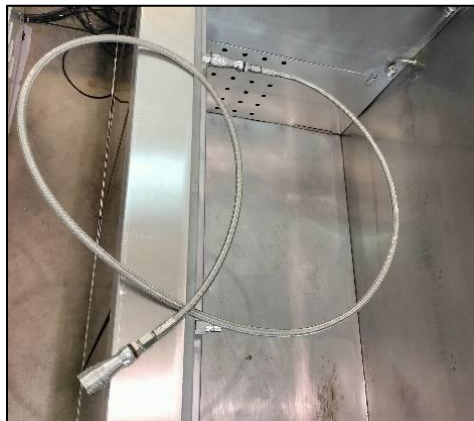
Figure 3.34 Pressure Hose in Water Bath

The water bath tank had an excellent thermal insulation system to maintain the required water temperature. When the water was fully heated, the insulation kept the outer surface of the bath tank at room temperature. Thus, the insulation system provided an optimal energy-saving and safety feature to the water tank. In addition, the tank had an automatic water filling floating valve. The lid of the water bath tank was operated with a hydraulic system. As shown in Figure 3.34, the water bath was provided with a quick connect pressure valve to supply the pressure to the pipe sample.

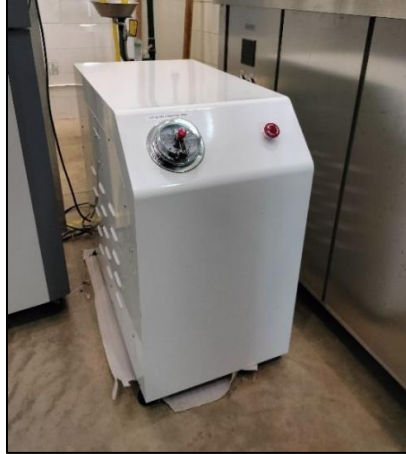
Figure 3.35 Pressure Generating Unit

One end of the pressure generating unit was connected to the control panel from where the pressure was controlled. The other end was connected internally to the quick connect pressure valve in the water bath to pressurize the pipe sample. A continuous water supply was provided to the pressure-generating unit for generating and supplying the pressure to the pipe sample. The pressure range of the unit was from 0 to 1450 psi. The unit had an emergency stop as a safety feature. Pressure generating unit is shown in Figure 3.35.

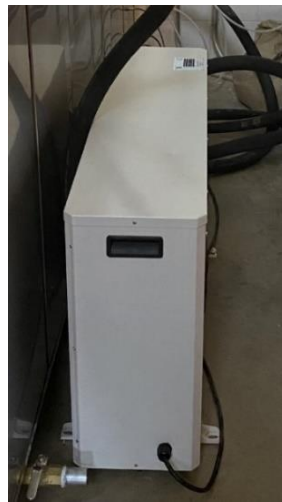
Figure 3.36 Chiller Unit

Chiller was used when the test water temperature needed to be below room temperature.

The Chiller unit is shown in Figure 3.36.

During this operation, the water connection to the heater was closed through the gate valve, whereas the water connection between the chiller unit and the water bath tank was opened. Thus, the water was continuously circulated through a loop connection between the chiller and the tank. In this way, the water was cool down to the required temperature. The lowest temperature achieved

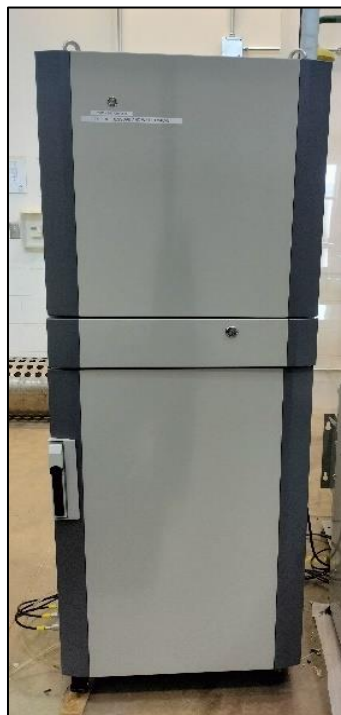
Figure 3.37 Control Panel Unit

The pressure and temperature control unit had an inbuilt software to input the test parameters such as pipe diameter, thickness, length, and pipe material. The control panel was controlling and monitoring the pressure and water temperature. The target pressure was entered into the control unit, and the unit then communicated to the pressure generating unit to pressurize the pipe sample at this pressure uniformly within 72 seconds. During the test, if the pipe sample failed before the target pressure, the unit automatically stopped and recorded the burst pressure and time-to-failure. The time vs. pressure graph was recorded for each pipe sample. The Control unit panel is shown in Figure 3.37.

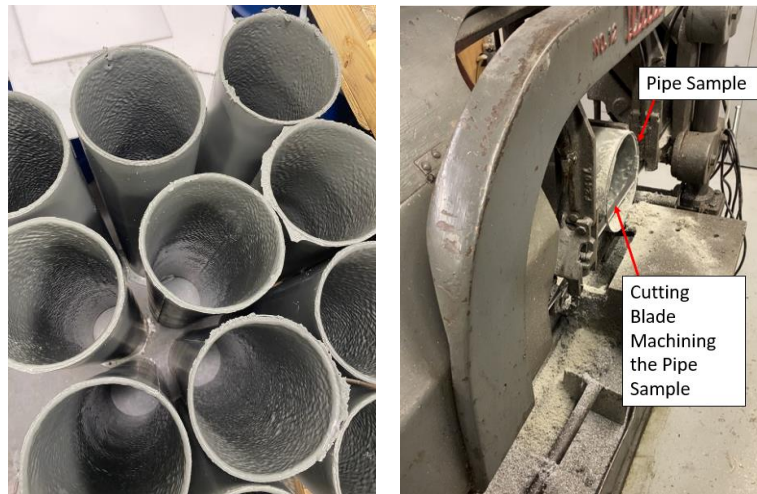
Figure 3.38 Pipe Cutting at Lathe Machine

The pipe samples were machined to cut the pipe's improper, uneven, or rough ends. Figure 3.38 shows that the pipe sample was cut on the lathe machine with the automatic saw cutter blade to remove the uneven ends. The pipe samples were cut at 90 degrees for the proper bedding of the end caps on the pipe sample. Removing the uneven ends was as minimum as possible so that the overall length of the pipe samples was not reduced.

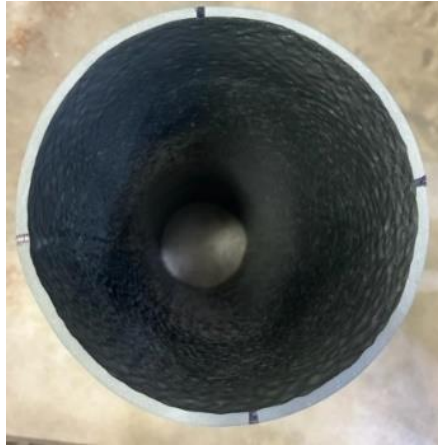
Figure 3.40 Marked Pipe Sample

1. All the pipe samples were marked at four points circumferentially (as shown in Figure 3.40) on both ends of the pipe, such as 1,2,3,4 on top end and 1',2',3',4' on bottom end.

2. Vernier caliper was used to measure the thickness at these four marked points on both ends of the pipe, and the average thickness was calculated.
3. The outer diameter (OD) was measured between the pair of each odd numbered points (1 and 3) and even numbered points (2 and 4) at one end and similarly on the other end of pipe using vernier caliper. The average OD of pipe sample was calculated.
4. The pipe length was measured at these four marked points, and the average length was calculated.
5. Samples were marked with sample number, orientation (used for end caps installation) and temperature. The example of the marking system is represented in Figure 3.41 below.
