TESTING AND EVALUATION OF POLYMERIC SPRAY APPLIED PIPE LINING IN PRESSURE PIPE APPLICATIONS

DISSERTATION

The University of Texas at Arlington

August 2023

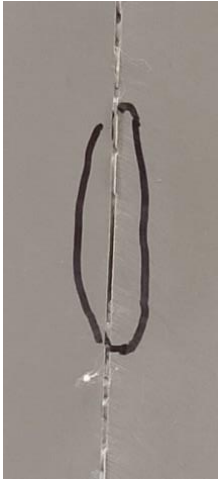
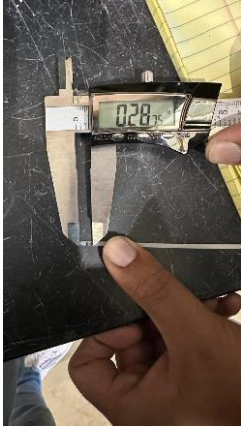
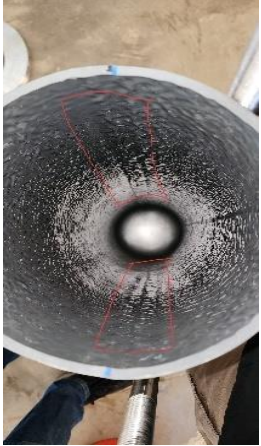
Figure 3.42 Visual Inspection of Pipe Samples

1. Seam line joints formed due to jigs molding was a main concern and thus, it was thoroughly inspected for any irregularities or narrow gaps. Some of the samples showed gap intrusion which were minor or negligible, whereas some of them were major, but not throughout the pipe thickness. Major gap intrusions were reducing the effective pipe thickness. Some examples of gap intrusion are shown in Figure 3.42. These samples were able to be tested, but the defects were recorded for each sample.

2. The pipe interior and exterior were checked for any cracks, air pockets, bubbles, or bulging over the surface. Some of the samples had bulging on the inside of the pipe, which were captured during the inspection, as represented in Figure 3.42.

Seam line defects	Gap intrusion of 0.2875 in.	Interior Pipe Bulging along Seam line

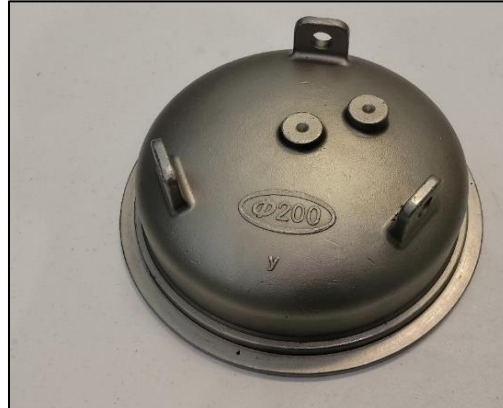
Figure 3.44 Bottom End Cap

End caps of 8 in. diameter were designed with anti-corrosive material. The material of the end caps could withstand the maximum pressure required for the test without failure. Figure 3.43 shows the top-end cap with pressure inlet valve and bleed valve. Figure 3.44 shows the bottom end cap.

These end caps were specifically designed for polymeric material to be tested at different temperatures. The polymeric material exhibits greater elasticity at higher temperatures, which can present challenges when installing end caps to achieve leak-proof joints. In addition, the end caps were designed to fit the pipe samples with different thicknesses with constant outer diameter. To

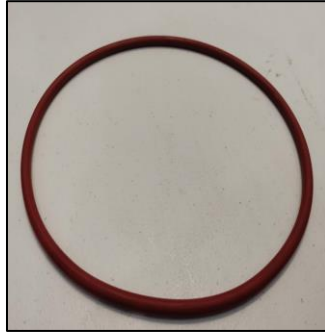
Figure 3.45 O-ring/Rubber Gasket

prevent leakage, a leak-proof rubber gasket or O-ring was employed to seal any gaps between the pipe sample and the end cap. The O-ring/rubber gasket is shown in Figure 3.45.

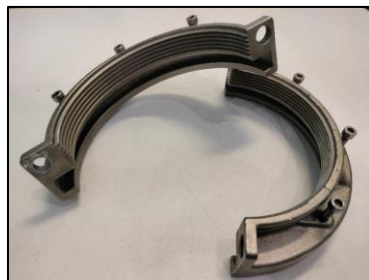
Figure 3.47 Clamping System

The clamping system as shown in Figure 3.47, was used to hold the end caps.

The clamping system was designed with the intention of avoiding excessive stress on the pipe ends. However, to ensure that the end caps remained in place during the high-temperature test, they were restrained using rods and holding plates (as illustrated in Figure 3.48). The rods were of the same length as the pipe and were bolted together with the holding plates, effectively securing the end caps in a fixed position.

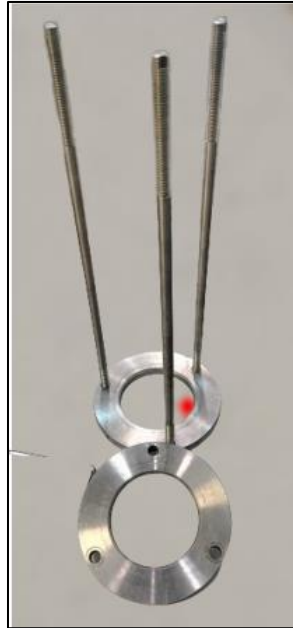
Figure 3.48 Rods and Holding Plates

Restrained end caps were necessary at elevated temperatures due to the elastic nature of the material, which prevented the end caps from slipping off. However, at room temperature and lower temperatures, restraining the end caps was not required. Nonetheless, in order to ensure comparable results across different temperatures, the rods were used during testing for all temperature conditions. The following steps were followed to install the end caps on the pipe samples.

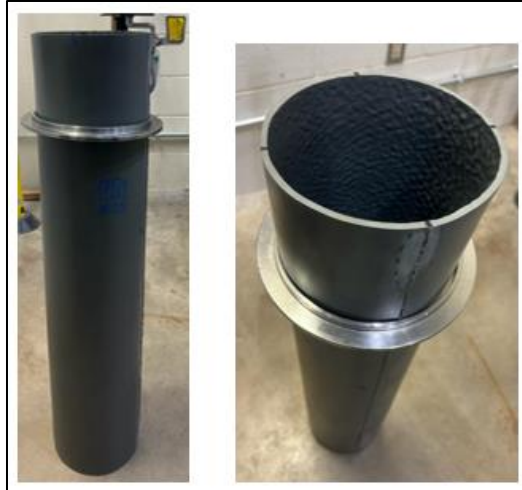
Figure 3.49 Pipe Sample with Snap Ring

Step 1: The sample was placed vertically, and the snap ring slid through the top end with its raised ridge facing up, as shown in Figure 3.49.

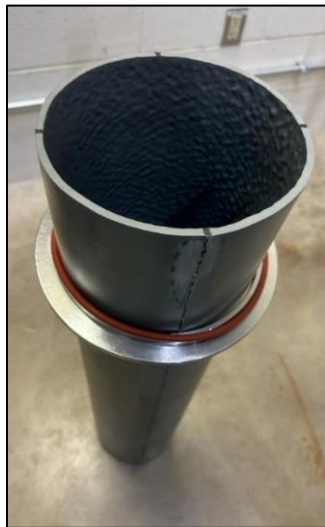
Figure 3.50 Pipe Pipe Sample with Snap Ring and O-ring

Step 2: The rubber O-ring was cleaned with oil lubricant and placed above the snap ring, as represented in Figure 3.50.

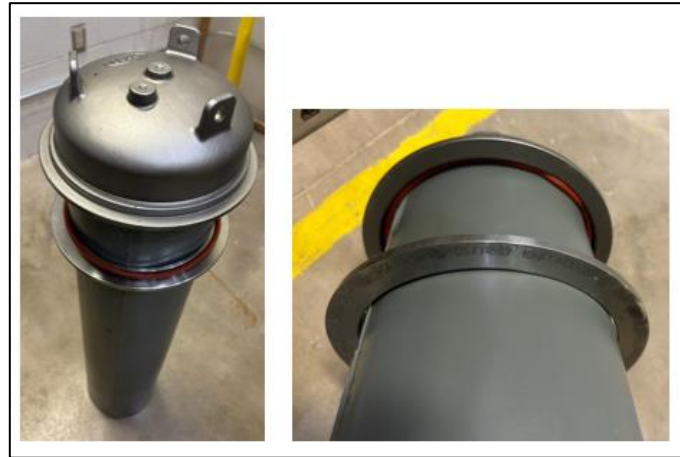
Figure 3.51 Bottom End Cap Installation in Process

Step 3: The bottom end cap was placed over the pipe and tapped gently with the rubber mallet to place it uniformly on the pipe sample. The O-ring was pushed inside the groove between the end cap and the pipe sample (as shown in Figure 3.51). Once the O-ring was perfectly pushed inside the groove, the snap ring was pulled upward towards the end cap to further push the O-ring

inside the end cap. The O-ring sealed any gap between the outer diameter of the pipe and the end cap to prevent any leaks.

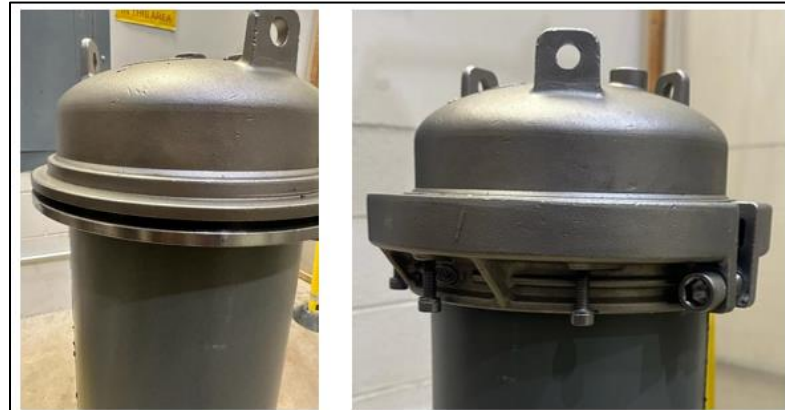
Figure 3.52 Pipe Sample with Top End Cap Installed

Step 4: The ridges of the end cap and the snap ring were fitted into the groove of the clamping system, which held the assembly together.

Then the clamps were tightened with two horizontal bolts on its two ends and eight vertical screws circumferentially (as shown in Figure 3.52). *(Note: Two horizontal bolts were tightened first but simultaneously to each other, and later tightened the eight vertical screws circumferentially).*

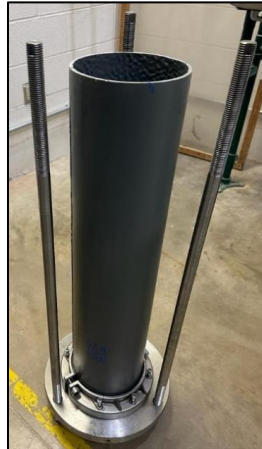
Figure 3.53 Pipe Sample with Restrained End

Step 5: The sample was flipped upside down and placed it on the restrained enclosure system specifically designed for these end caps (as shown in Figure 3.53). The pipe sample was filled with water with bottom end cap installed. *(Note: The water used to fill the sample was of the same temperature that was intended for the testing)*

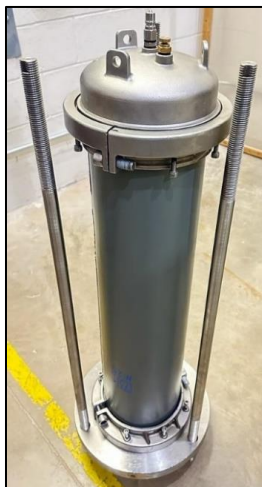
Figure 3.54 Top End Cap Installed on Pipe Sample

Step 6: The other end cap was installed following a similar procedure as described in steps 1 through step 4. Both end caps installed on the pipe sample are shown in Figure 3.54.

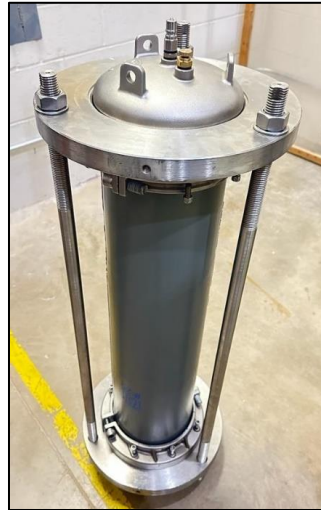
Figure 3.55 Pipe Sample with Both End Caps

Step 7: After the end caps were installed, the vertical rods with holding plates were tightened with the bolts simultaneously on both sides. The nuts were fastened but without putting

any pressure on the end caps. The rods were only holding the end caps; they did not push the end caps toward the inner side. The complete assembly of restrained end caps installed on the pipe sample is shown in Figure 3.55.

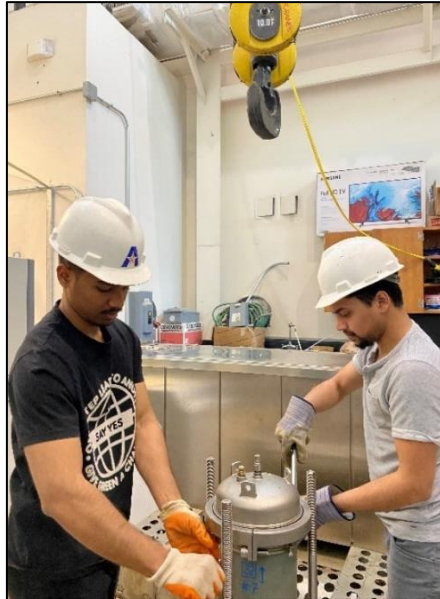
Figure 3.56 End Caps Installation in Progress

water bath was utilized to fill the pipe sample at a required testing temperature. Figure 3.56 shows the installation of end caps.

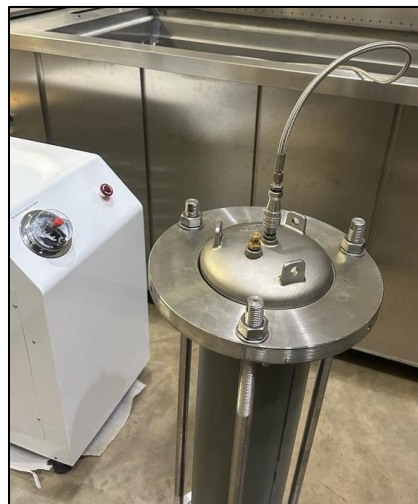
Figure 3.57 Pipe Sample Connected with Pressure Hose

After installing both end caps, the pressure hose in the water bath tank, which was internally connected to the pressure generating unit as illustrated in Figure 3.57, was connected to the pressure inlet valve on the top end cap. This pressure hose allowed water to be introduced into the pipe sample, filling any empty space.

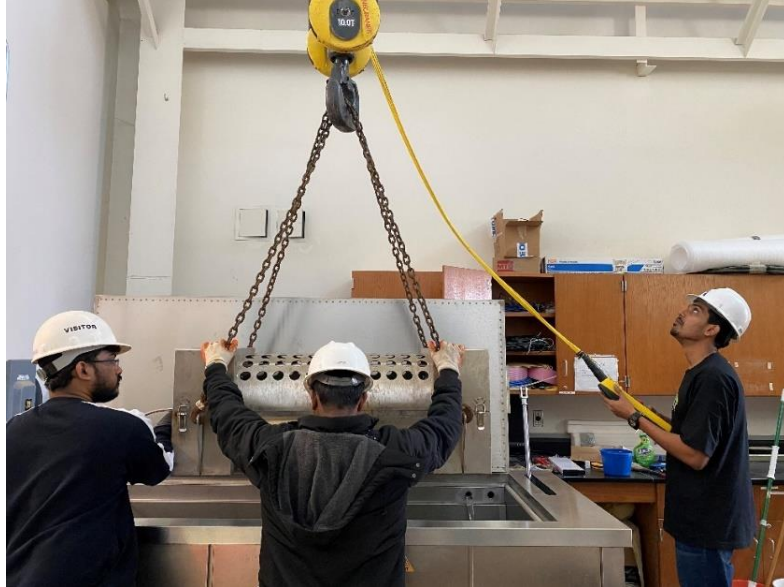
Figure 3.60 Pipe Sample Lifting with Crane

The pipe sample with the safety cage was lifted with the help of chains and a crane as in Figure 3.60.

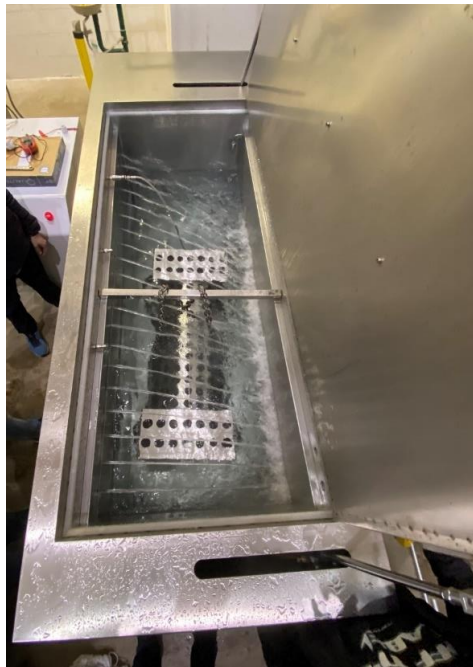
Figure 3.61 Pipe Sample Placed in Water Bath

The pipe sample with the cage placed in the water bath is shown in Figure 3.61.

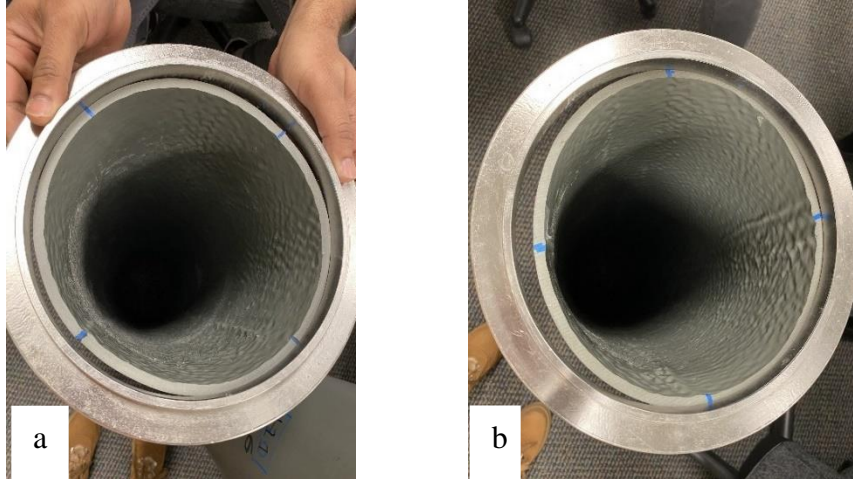
Figure 3.62 (a) Sample #6 Oval in Shape (b) Sample #9 Oval in Shape

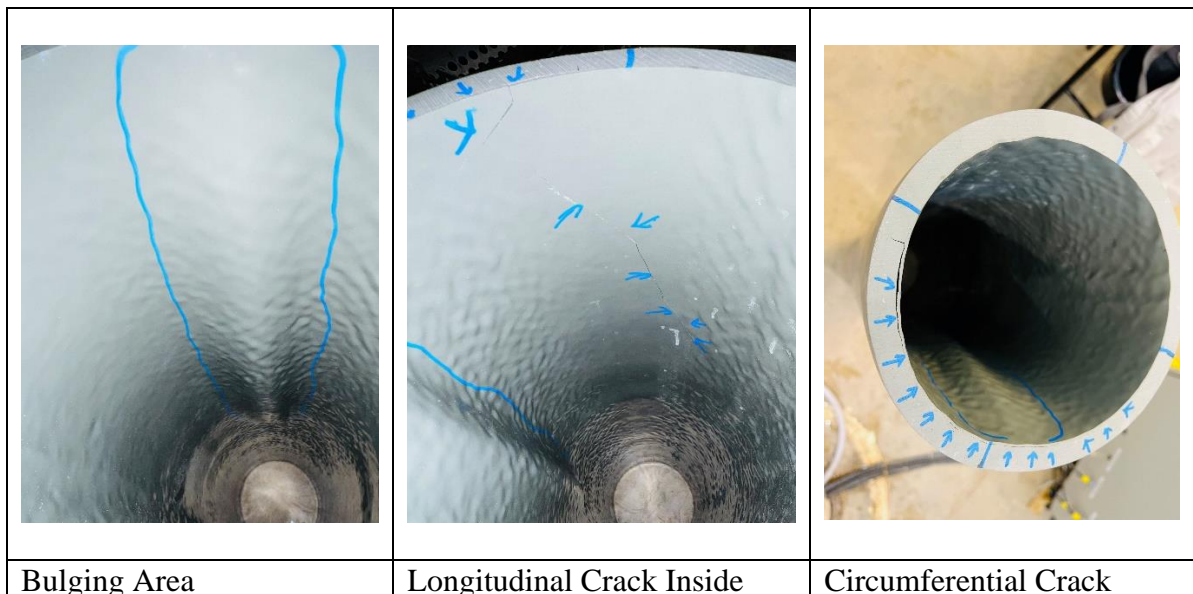
Figure 3.63 Sample #42 Visual Cracks and Bulging Areas

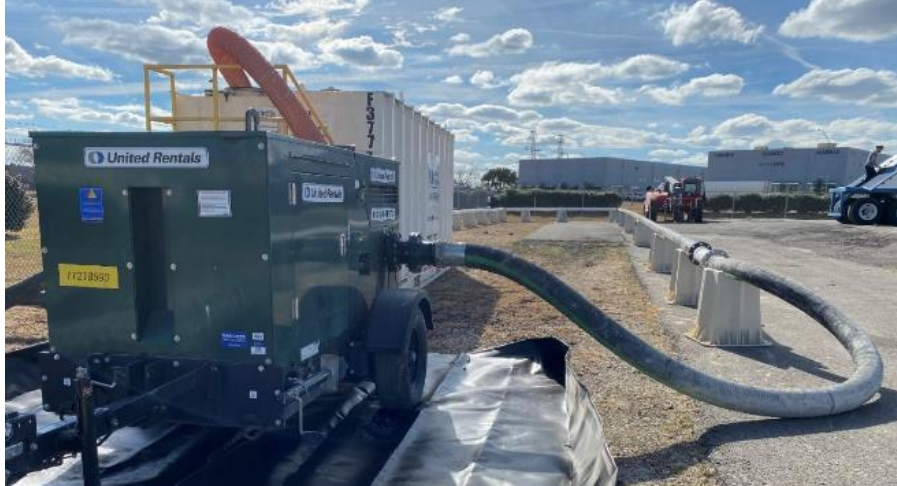
Figure 4.2 Centrifugal Variable Flow Rate Pump

The test setup consisted of a centrifugal diesel pump with variable flow rate. The maximum flow capacity was 2,680 GPM with a maximum shutoff head of 164 ft (71 psi) at an operating speed of 1,800 rpm. The minimum flow capacity was 450 GPM with a minimum shutoff head of 74 ft (32 psi). The minimum and maximum speed of the pump was 1,200 rpm and 1,950 rpm. The pump was driven by 75 horsepower Duetz diesel engine. The pump was a single-stage single suction pump with suction and discharge sizes of 6-in. diameters.

The flow rate for the pump was controlled by varying the engine speed. The maximum and minimum flow rates selected were 1,800 and 800 GPM respectively, which allowed the pump to run at the best operating efficiency between 72% to 81%. The pump was equipped with a vacuum-assisted priming system that automatically drew out the air until the water filled in the pumping system. Figure 4.2 below shows the diesel operated centrifugal variable flow rate pump.

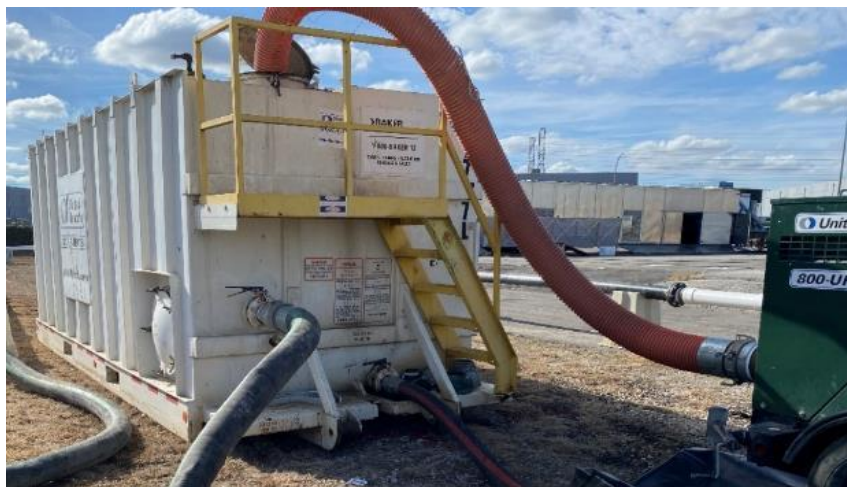
Figure 4.3 Water Tank

A carbon steel mini frac tank of 8,400 gallons was used for water storage and supply to the test setup. The model of water tank was “MINIFRACL”, and the make was “Wichita Tanks.”

Figure 4.3 shows the water tank used in this project.

The interior of the tank was smooth and lined with chemical resistance “Phenoline 380” for easy cleaning and maintenance. The exterior of the tank was coated with high gloss polyurethane. The tank's length, width, and height were 23 ft- 6 in., 8 ft- 6 in., and 8 ft- 6 in.,

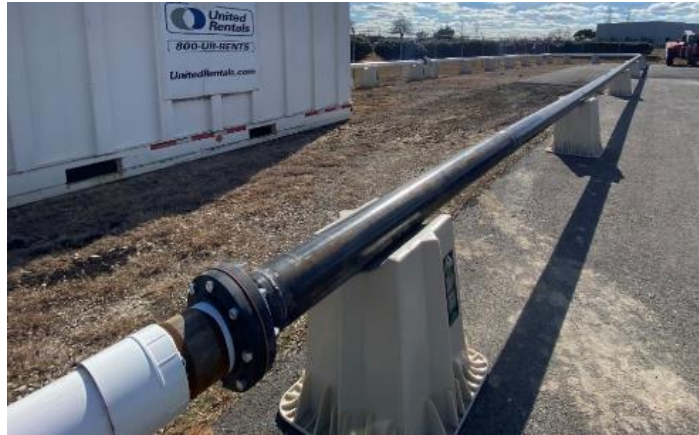
Figure 4.6 Carbon Steel Pipe Test section

The pipe sample consists of new 6 in. carbon steel pipes, schedule 40, of an overall length of 100 ft. The internal diameter (ID) of the pipe was 6.065 in. Carbon steel pipes of 20-ft sections

were welded together to fabricate a 100-ft straightened test section, as represented in Figure 4.6. The cribbing was used throughout the test setup to elevate the pipe at same level, as shown in Figure 4.6.

The entrance section of the PVC pipe was connected to the carbon steel pipe section with a 40 PVC coupling schedule. An epoxy adhesive was used at the coupling connection to ensure tightness. A steel socket bolt flange with thickness of 3/4 in. was installed at the start and end of the carbon steel pipe test section for easy installation and removal of the test section. Rubber gaskets were placed between opposing flanges to ensure a tight and leak-proof joint.

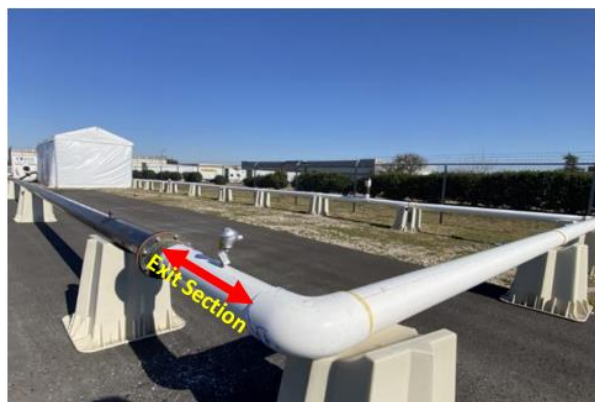
Figure 4.8 Thermocouple Installed at Exit Section

The exit section comprises a 6-inch PVC pipe with a length of 3 ft, connected to the carbon steel pipe section via a bolted flange connection, as illustrated in Figure 4.8. To monitor and record the water temperature and assessed any heat gain during water flow in the 100-ft carbon steel test section, a second thermocouple was installed on the PVC line at a distance of 1 ft 5 in. from the flange connection of the carbon steel pipe.

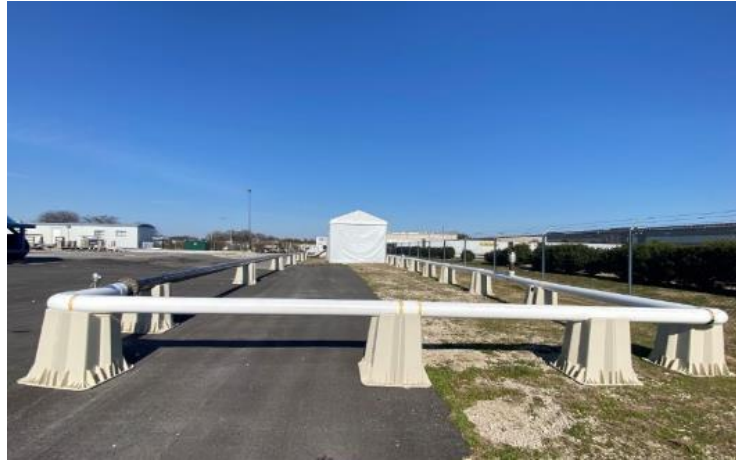
Figure 4.9 PVC Pipe Return Loop

The PVC pipe return section was fabricated to create the closed loop of the test section. At the downstream of the exit section, a 90° PVC elbow was connected to turn the PVC line at 90°, as shown in Figure 4.9. The returning PVC section perpendicular to the carbon steel pipe was 20 ft in length.

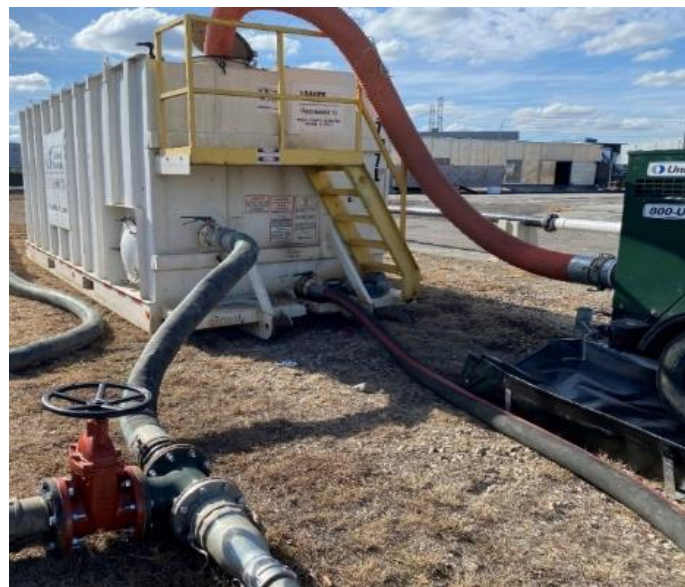
Figure 4.11 Test Setup End Loop Connection to Water Tank

A rubber pipe hose of 6 in. diameter, 30 ft was connected at the end of the PVC pipe to close the test loop. One end of the hosepipe was connected to the PVC return section, and another end was connected to the 6 in. gate valve, as shown in Figure 4.11. The gate value was connected to shut off the water supply from the test setup to the water tank.

As shown in Figure 4.11, the gate valve had a two-way connection to the water tank to decrease water flow velocity while returning to the tank. One hose pipe 6 in. of 9 ft length connected the gate valve and water tank. Another hose pipe 4 in. of 20 ft length connected the gate

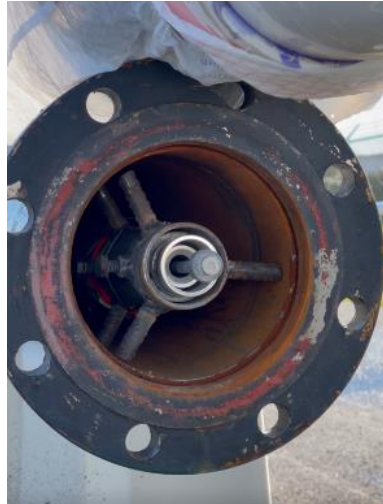
Figure 4.12 Inside View of Carbon Steel Pipe before Sand Blasting

Sand blasting was the first step for preparing a carbon steel pipe for the liner application. Sand blasting was also known as abrasive blasting, and it was a surface finishing process that involves the use of an air compressor and a sand blasting machine. Sand blasting machine sprays the sand particles with high pressure against the surface of the carbon steel pipe to smoothen it by removing rust and other contaminants on the surface of the pipe. Figure 4.12 shows the inside view of carbon steel pipe before sand blasting process. The primary purpose of the sand blasting was to create a clean and profiled surface so that the polymeric resin liner adhered to the 6 in. steel pipe.

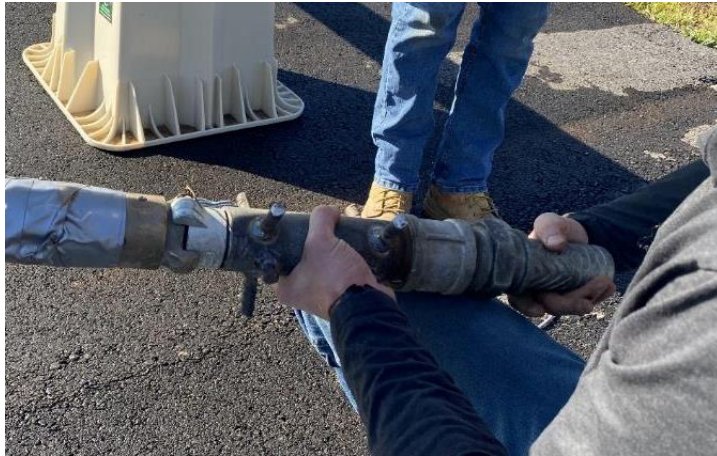
Figure 4.13 Sand Blasting Machine

This process of cleaning the pipe using the sand blasting technique was carried out for two complete passes to ensure that the surface was free of irregularities and any contaminations. The total time taken for sand blasting was approximately 2 hours 30 minutes. Sand blasting was also performed to achieve 2 to 3 mils of anchor profile, which was required for a good bonding of the liner application to the host pipe. The sand blasting machine is shown in Figure 4.13.

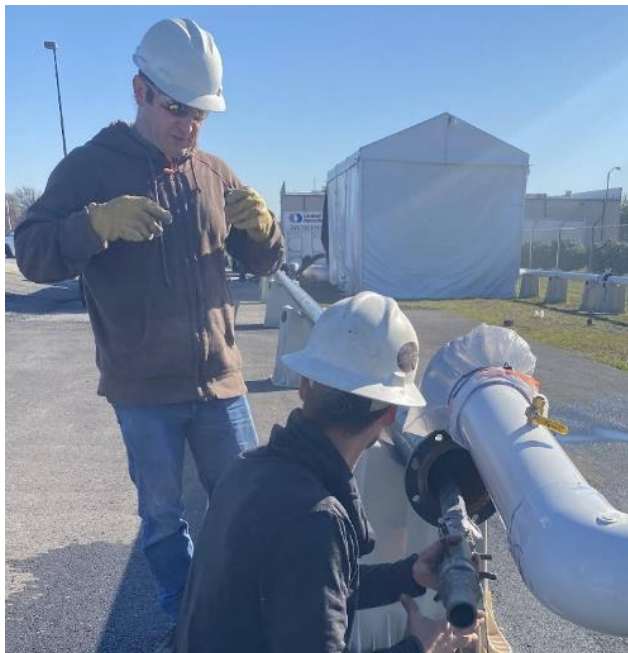
Figure 4.14 Sand Blasting Before Liner Application

Figure 4.14 shows the sand blasting machine being sanding inside the pipe from one end.

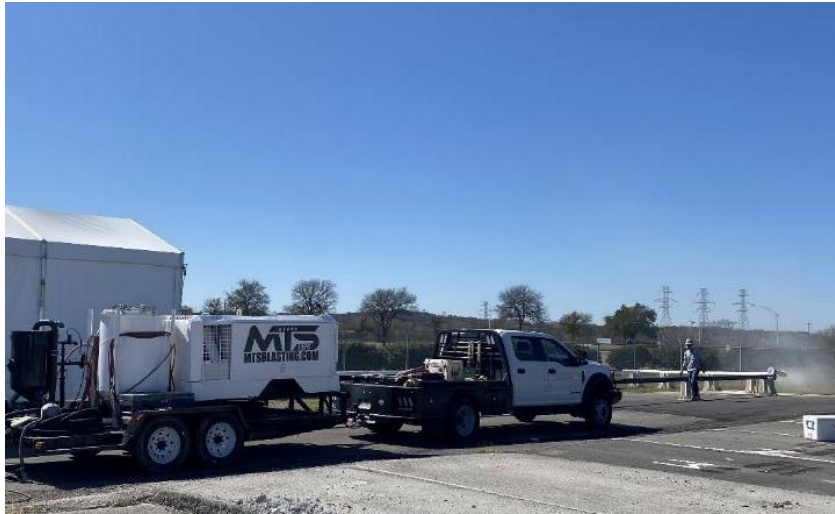
Figure 4.15 Sand Blasting in Progress

The sand blasting machine was connected to the sand blasting medium and air compressor on the truck. Figures 4.15 show the sand blasting of pipe in progress.

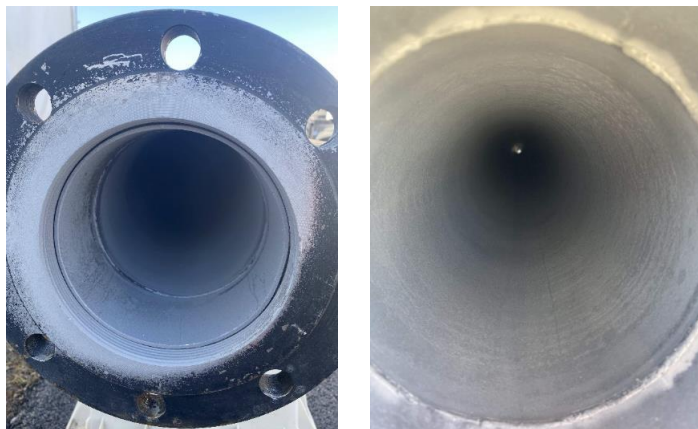
Figure 4.16 Inside View of Pipe After Sand Blasting

Figure 4.16 represented the inside view of the pipe after the sand blasting was completed. Sand blasting achieved the SP5 white blast with 2 to 3 mils of anchor profile.

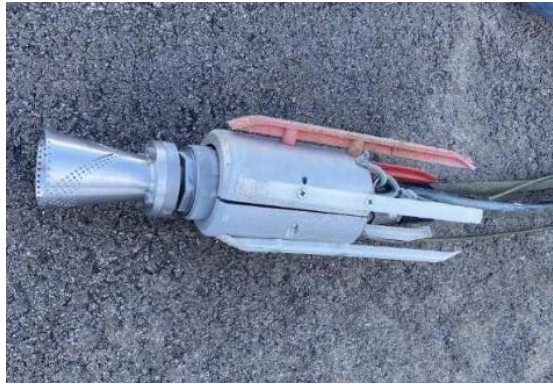
Figure 4.17 Spin Cast for Liner Application

The liner application started the day after the blasting was completed. One coat of 4-5 mils thickness of primer was applied inside the carbon steel pipe prior to the liner installation. Using a

spin-cast machine, the primer was sprayed uniformly on the inside circumference of the pipe. Figure 4.17 shows the spin-cast used both for the primer and liner installation.

The spray head was positioned at the entrance of the pipe and begins its operation from one end of the pipe section at a speed of 24 ft/min with the spray head rotating until it travels to the other end of the pipe section. The speed of the spin cast machine was operated from a control station. The spin cast cone spins at approximately 10,000 rpm when it was dry, but it slows down to 8,500-9,000 rpm when polyurea material starts spraying. Figure 4.18 shows the spin cast applying the primer to the bare pipe.

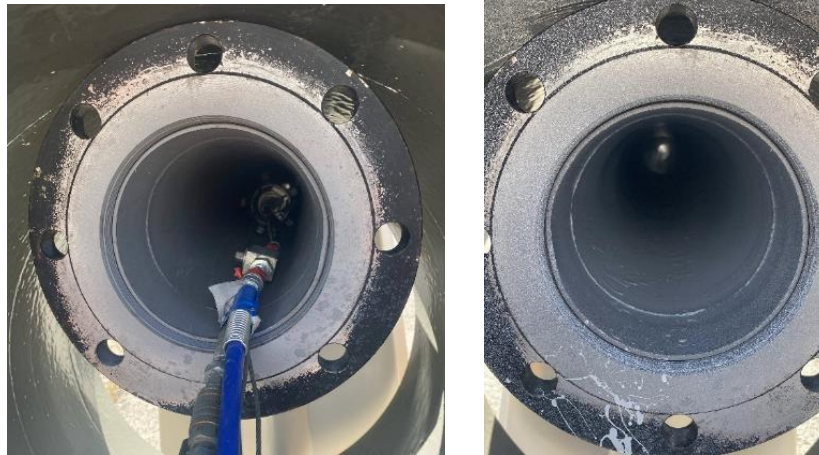
Figure 4.19 Inside View of Pipe After Primer Application

Primer was touch dry in 3 to 4 hours. Figure 4.19 shows the inside view of the pipe with primer application.

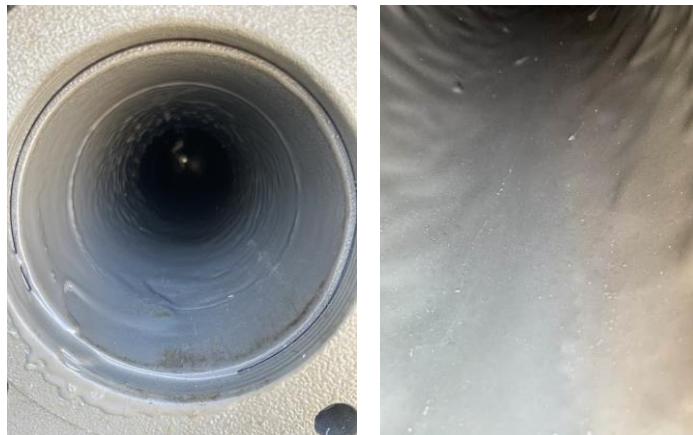
Figure 4.20 Inside View of Pipe After Liner Application

After the primer was completely dry, the liner was sprayed inside the carbon steel pipe using a spin cast machine which sprays the resin material uniformly along the circumference of the pipe.

The spray head was positioned at the entrance of the pipe and began its operation from one end of the pipe section at a speed of 24 ft/min. The spin cast cone spined at approximately 10,000 rpm when it was dry, but it slowed down to 8,500-9,000 rpm when polyurea material started

spraying. The frequency of the spin cast machine was operated from a control station. The liner thickness of approximately 85 to 90 mils was achieved in one pass. After applying the polymeric resin to the surface of the pipe, it was allowed to dry out completely for 24 hours to ensure optimal bonding between the liner and the pipe's surface. The curing process was done at ambient temperature. Figure 4.20 shows the liner application on the pipe sample.

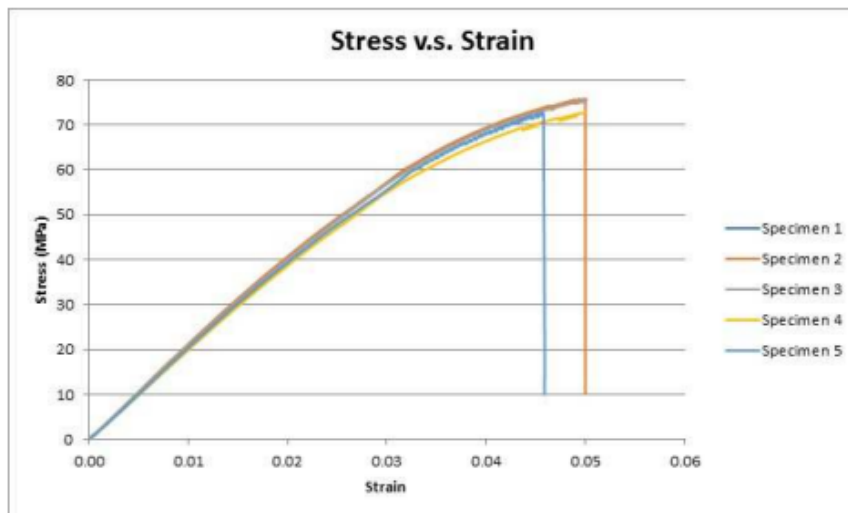
Figure 5.1 Flexural Stress vs. Strain

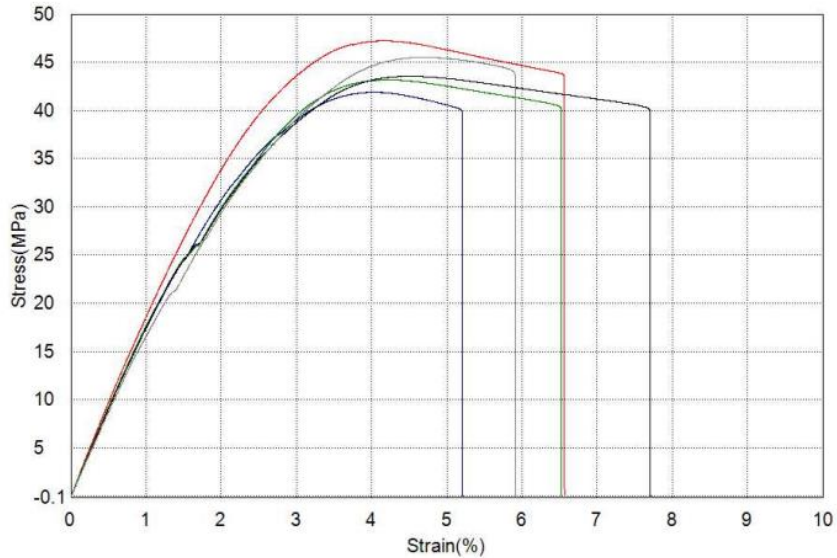
Figure 5.2 Tensile Load vs. Strain

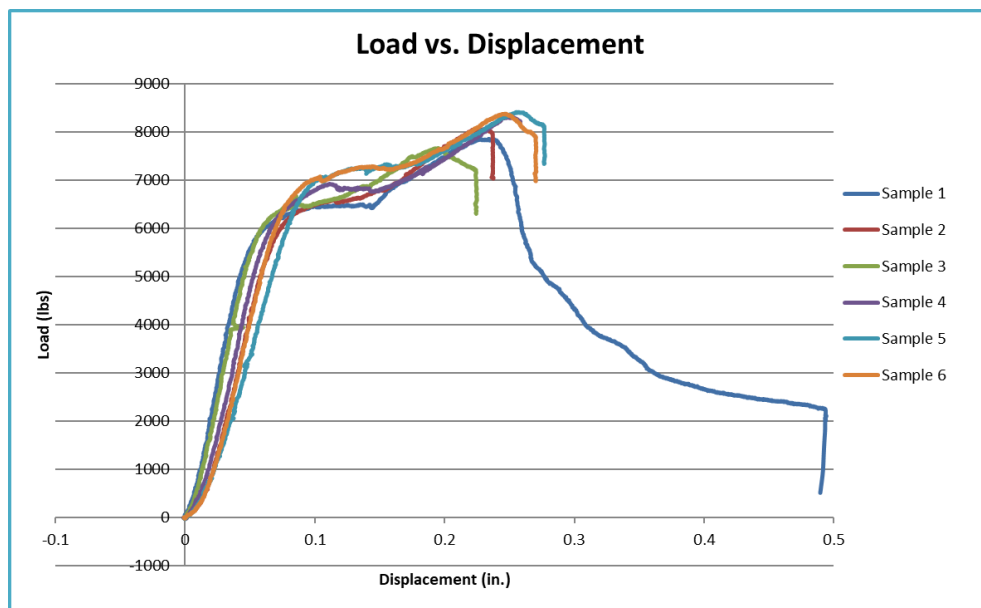
Figure 5.4 Punch Shear Load vs. Displacement

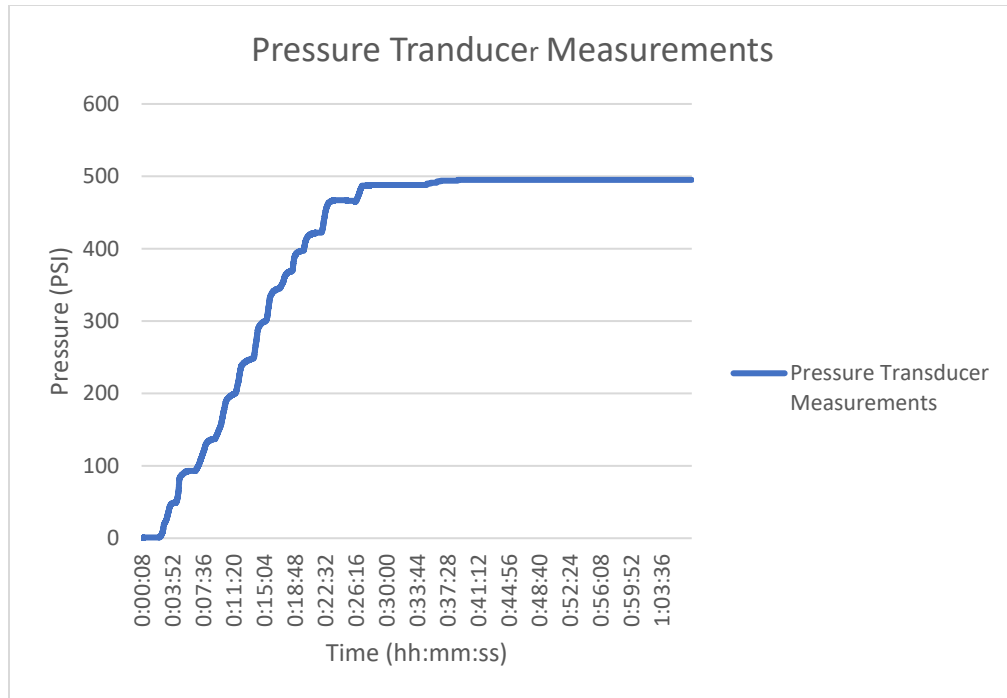
Figure 5.5 Pressure Transducer Measurements (1 in. Hole Spanning Pipe Sample)

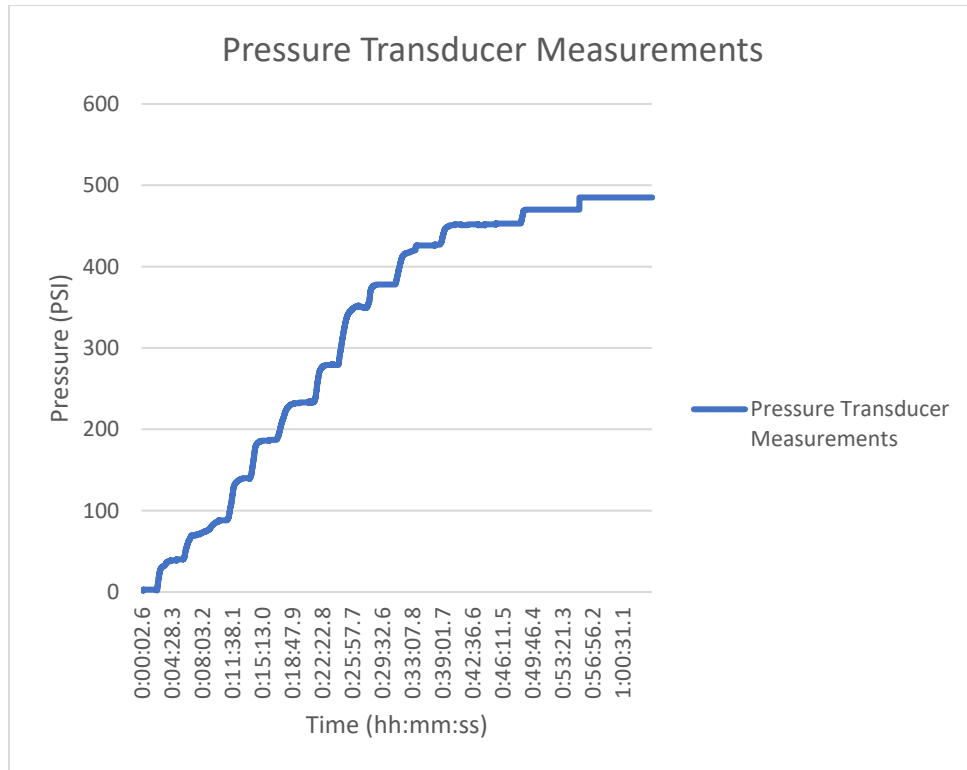
Figure 5.6 Pressure Transducer Measurements (2 in. Hole Spanning Pipe Sample)

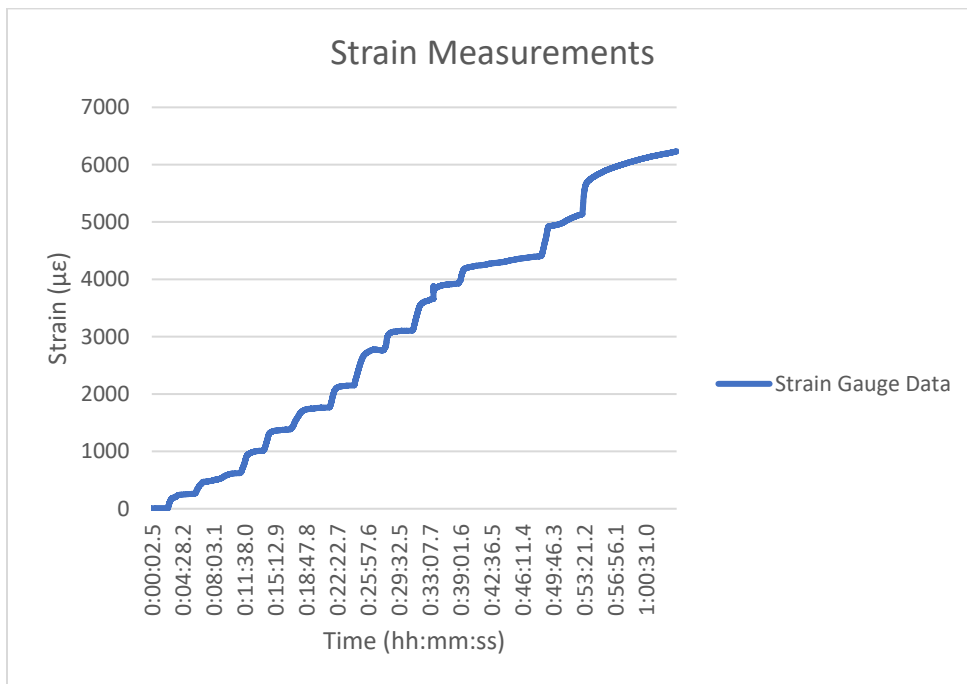
Figure 5.7 Strain Measurements at 2 in. Hole Spanning

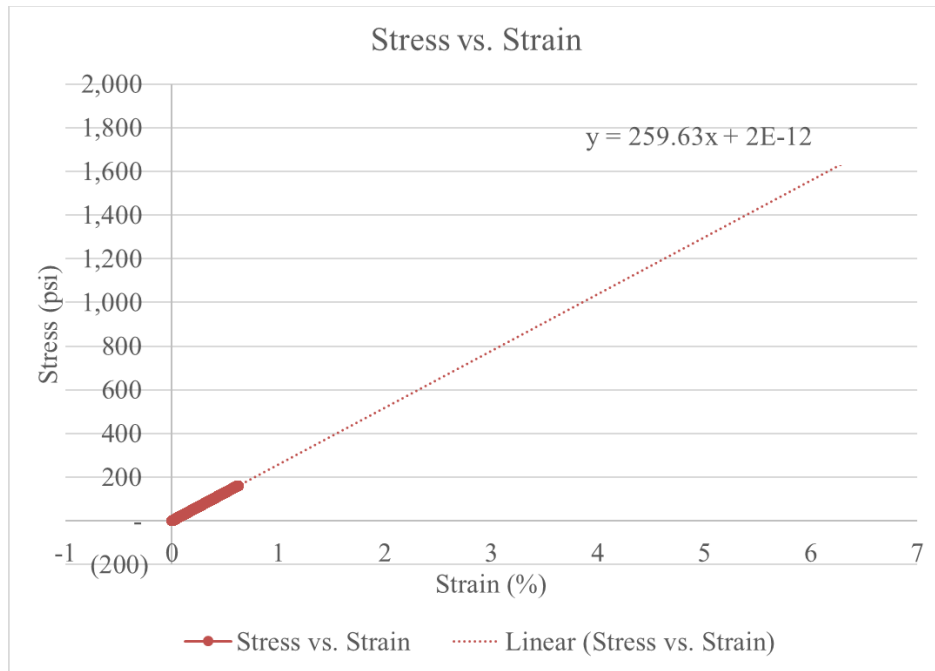
Figure 5.8. Stress vs. Strain (Obtained from Strain Gauge Data)

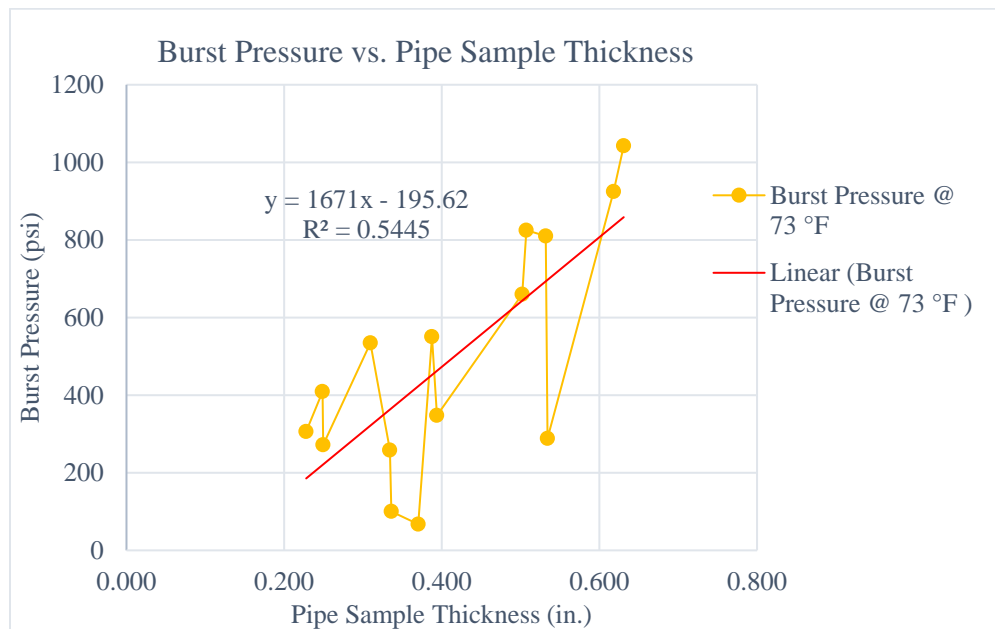
Figure 5.10 Burst Pressure vs. Pipe Thickness at 73 °F

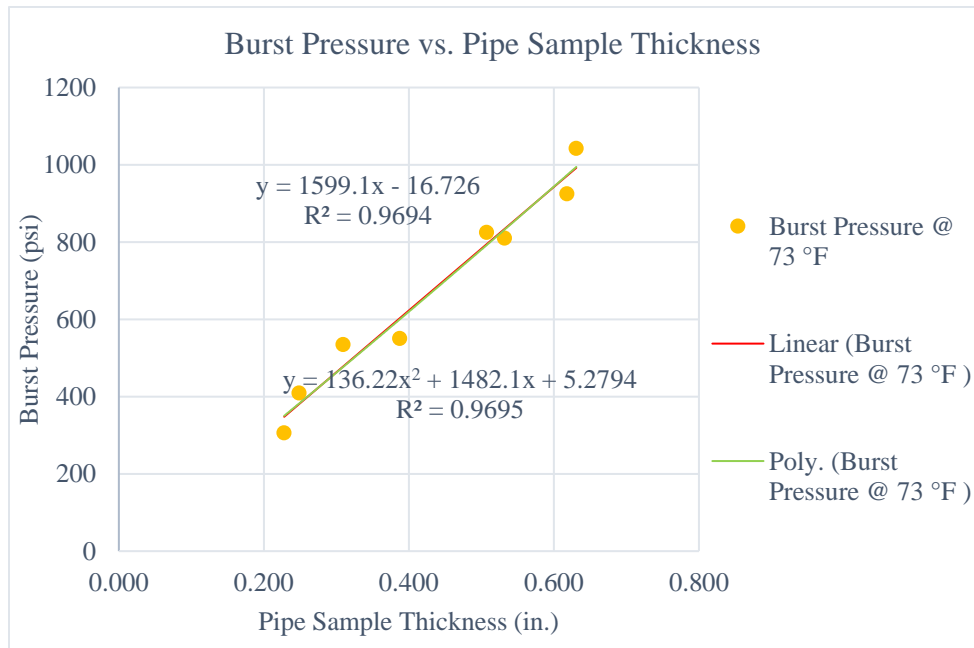
Figure 5.11 Burst Pressure vs. Pipe Thickness (after Data Curation)

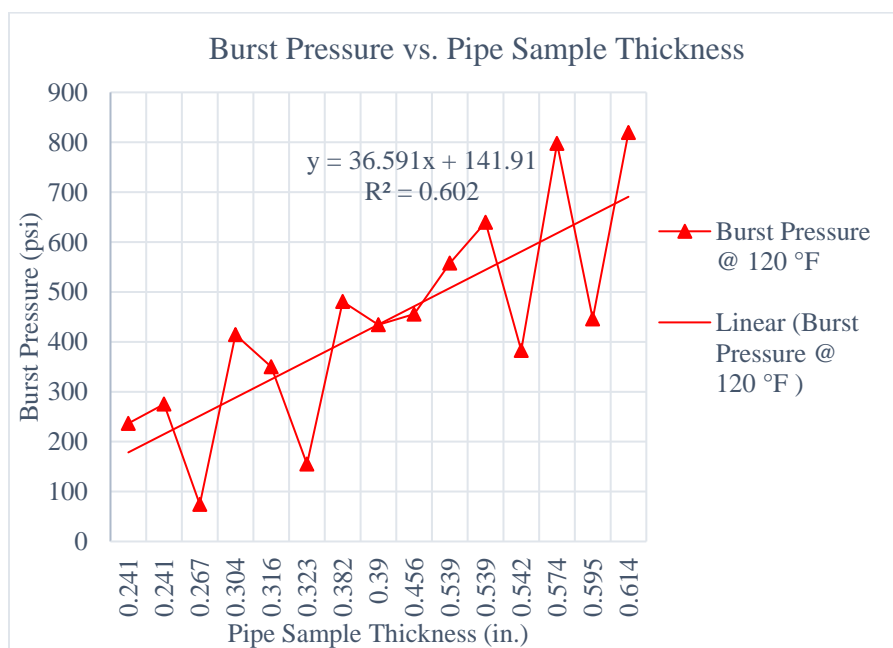
Figure 5.12 Burst Pressure vs. Pipe Thickness at 120° F

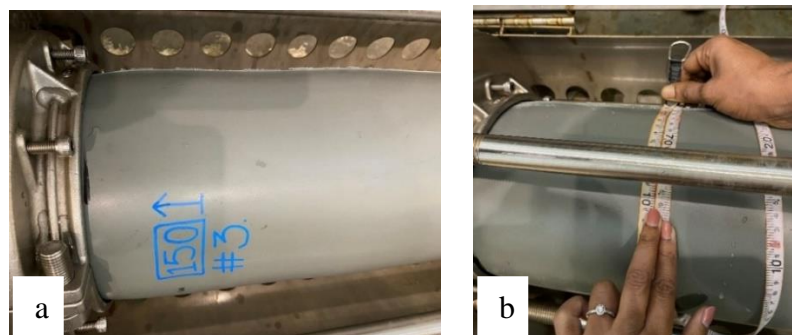
Figure 5.14 (a) Bulging of Pipe Samples (b) Measurement of Increase of OD

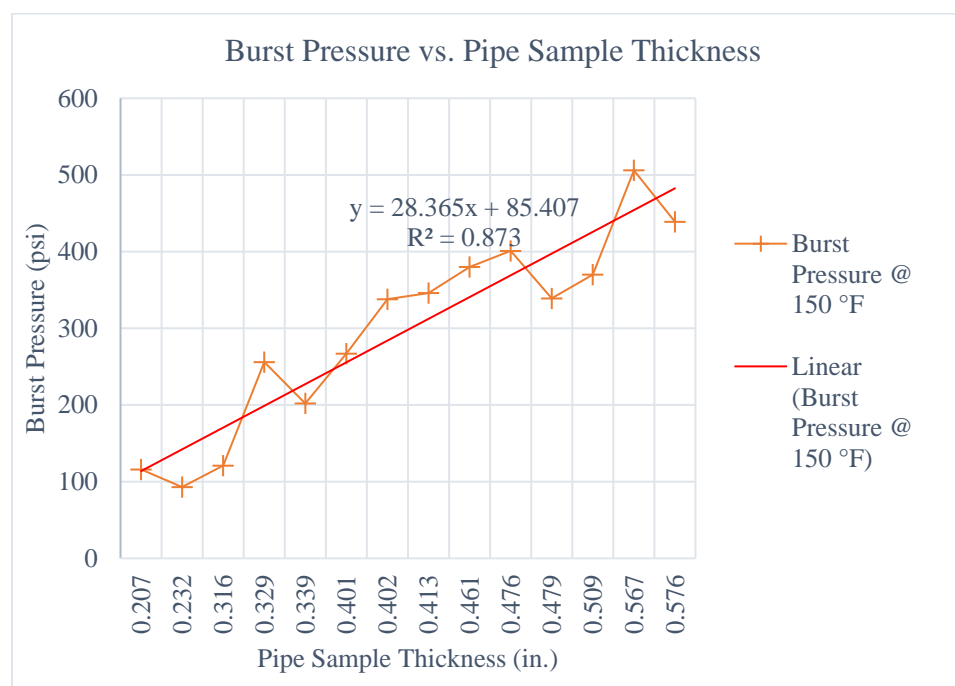
Figure 5.15 Burst Pressure vs. Pipe Thickness at 150° F

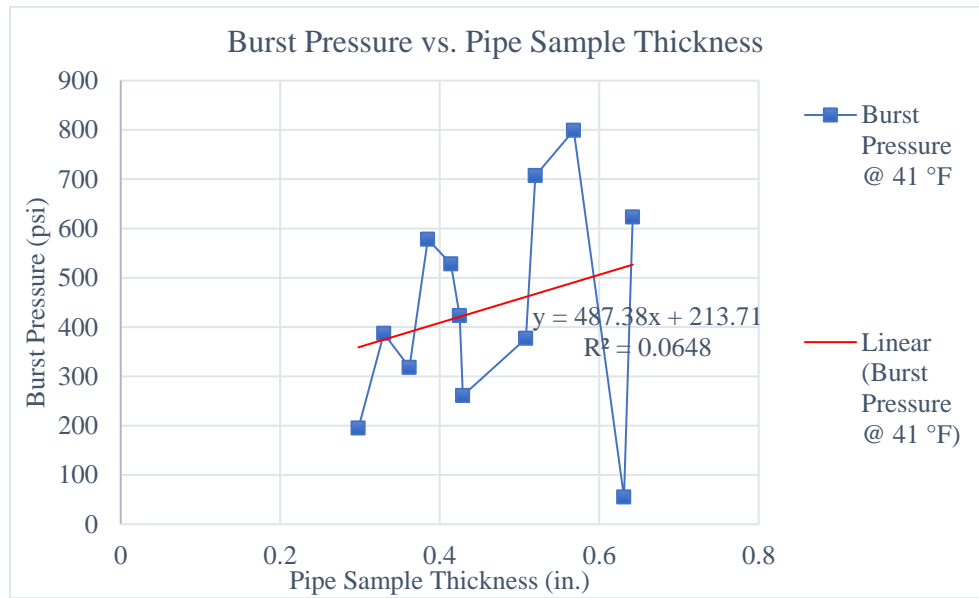
Figure 5.17 Burst Pressure vs. Pipe Thickness at 41° F

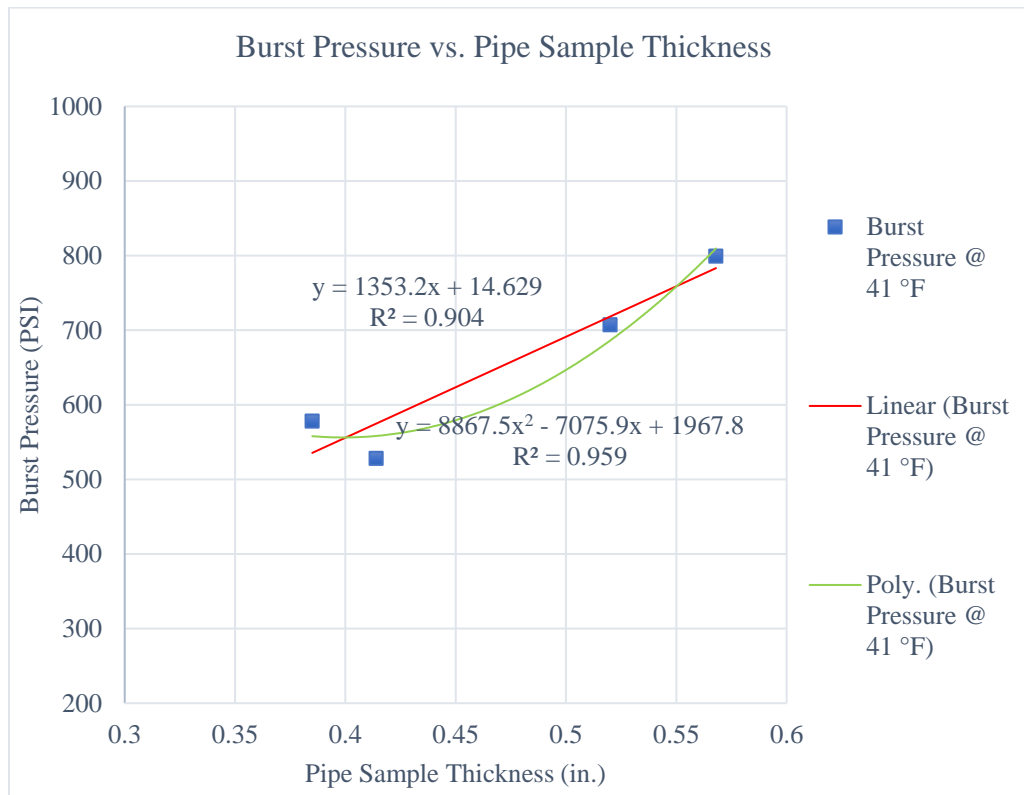
Figure 5.18 Burst Pressure vs. Pipe Thickness (After Data Curation)

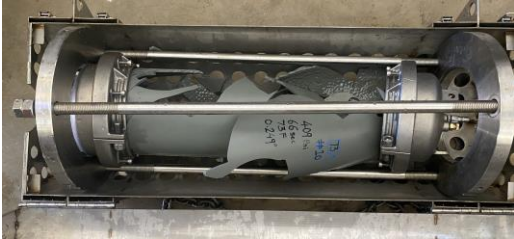
Failure Mode	Material Behavior	Failure Mode Picture
Catastrophic Failure	<ul style="list-style-type: none"> - Pipe was shattered into pieces, shows brittle fracture. - Material's brittle behavior to pressure resistance. - Pressure resistance was higher in such type of failures. - Observed at 73 °F and 41 °F temperature tests.

From Table 5.14, it is concluded that the pipe failure mode changed with the change in the test temperature. Pipe samples tested at low and ambient temperatures acted more stiffer and demonstrated maximum pressure resistance. Pipe samples failed with brittle fractures, illustrated an example of catastrophic failure. On the other hand, the stiffness of the polymer material decreases at elevated temperature. The material showed more deformation and cracks were generated during the pressure resistance at a high temperature. Thus, the sample showed a failure mechanism as ductile with deformation.

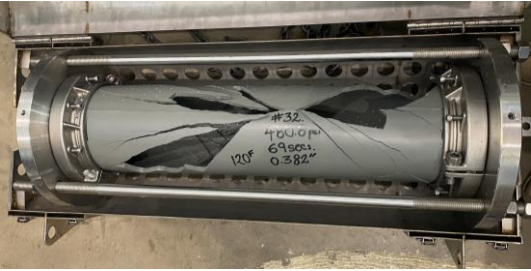
Failure Mode	Material Behavior	Failure Mode Picture
Elastic and Catastrophic Failure	<ul style="list-style-type: none"> - Pipes failed with cracks and few shattered pieces. - Material showed elasticity but also showed a slight brittle behavior to pressure resistance. - Pressure resistance was less in such type of failures. - Observed at 120 °F temperature test.
