TESTING AND EVALUATION OF POLYMERIC SPRAY APPLIED PIPE LINING IN PRESSURE PIPE APPLICATIONS

DISSERTATION

The University of Texas at Arlington

August 2023

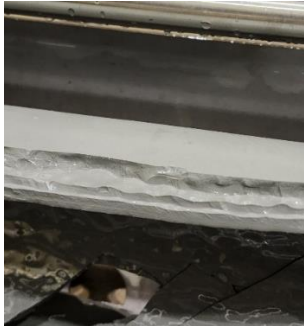
<p>Sample #33, Layers formation observed on broken pieces (Tested at 73° F)</p>

during testing at temperatures of 73° F and 41° F. The formation of layers may be attributed to the curing behavior of the sprayed layers. The setting time between the sprayed layers to achieve the required thickness is relatively short, which can result in the previous sprayed layer setting before the second layer is applied. Additionally, the installation procedure could also contribute to layer formation. Furthermore, the presence of micro-bubbles was observed in the broken sample pieces.

Layer formation was not observed in the broken samples at elevated temperatures. This could be due to the fact that at high temperatures, the different layers formed tend to merge together since the polymers are softer and more flexible. As a result, no distinct layer formation was visible in the broken samples. Figure 5.19 shows the layer formation and micro-bubbles on the broken pieces of samples.

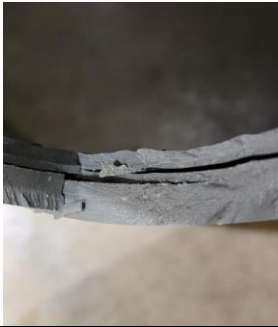
<p>Sample #4, Layers formation observed on broken pieces (Tested at 73° F)</p>	<p>Sample #58, Layers formation observed on broken pieces (Tested at 41° F)</p>

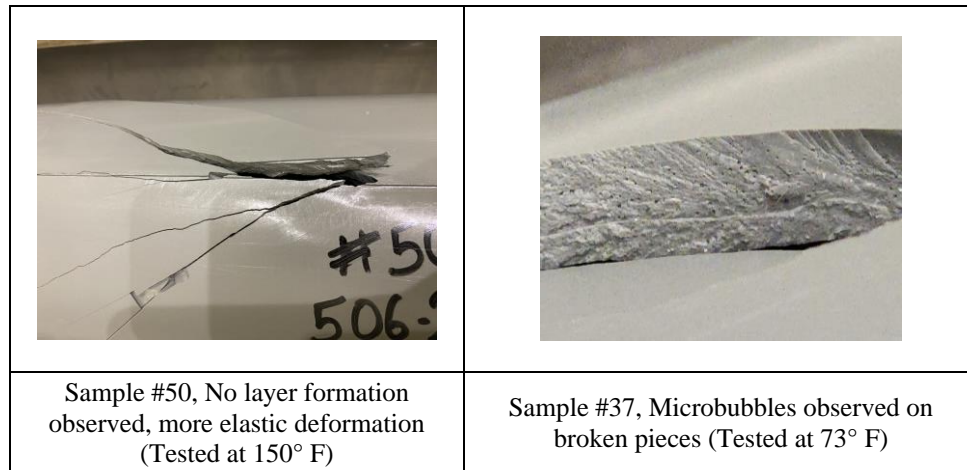
Figure 5.19 Pipe Failure Analysis

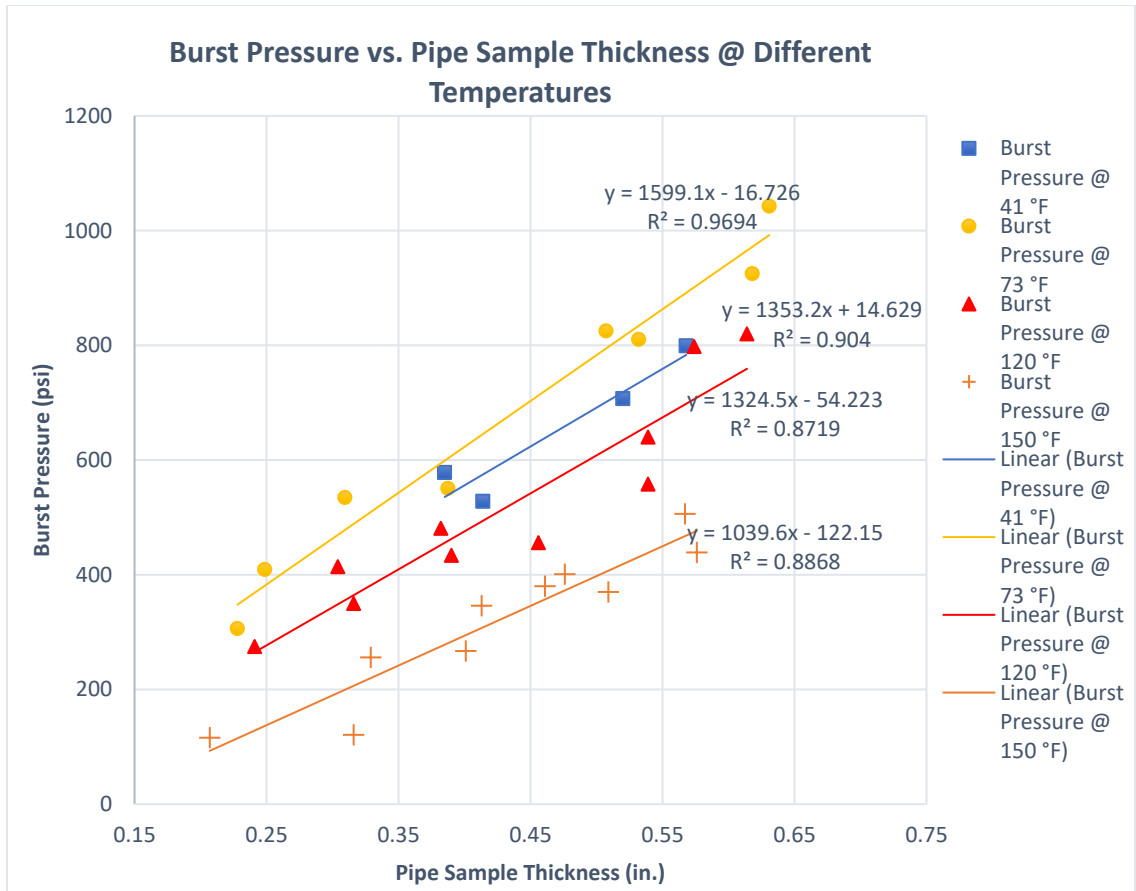
Figure 5.20 Burst Pressure vs. Pipe Sample Thickness Comparison at Different Temperatures

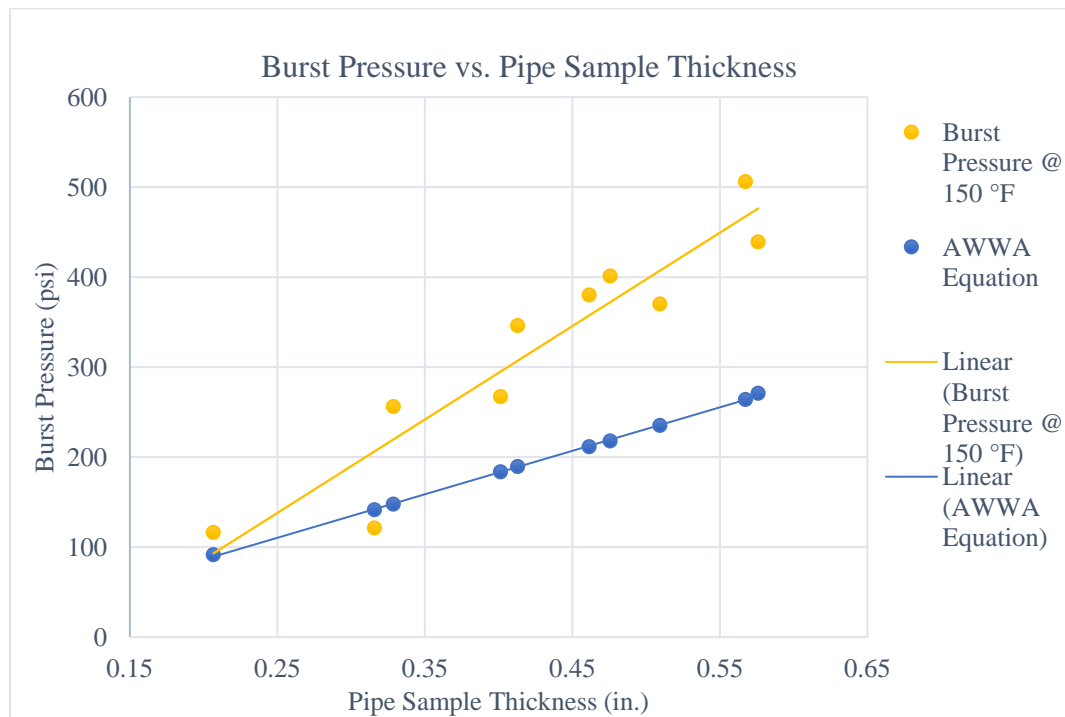
Figure 5.24 Experimental Test Results and AWWA Analytical Calculation at 150° F

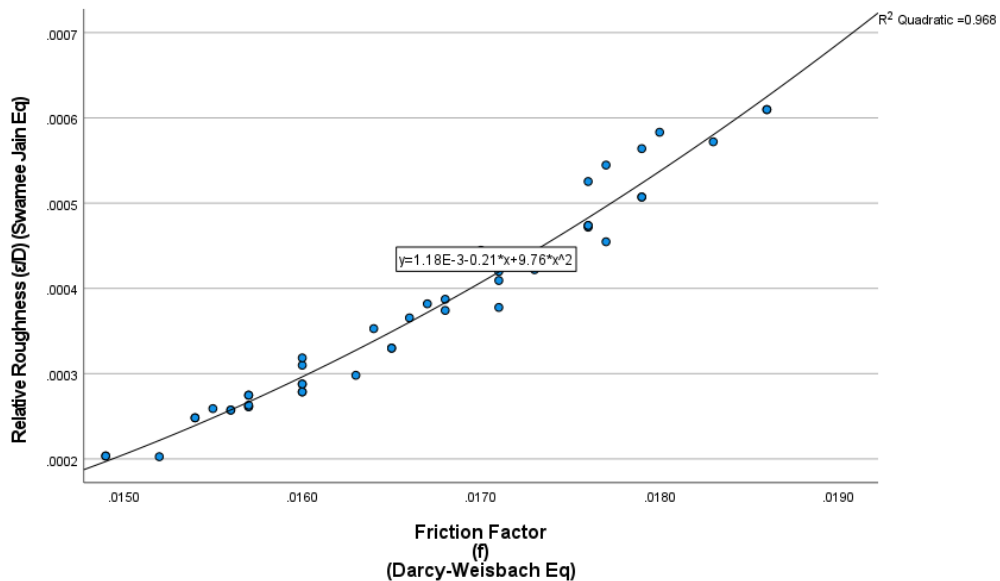
Figure 5.29 Bare Steel Pipe Friction Factor vs. Relative Roughness (Calculated with Swamee-Jain Equation)

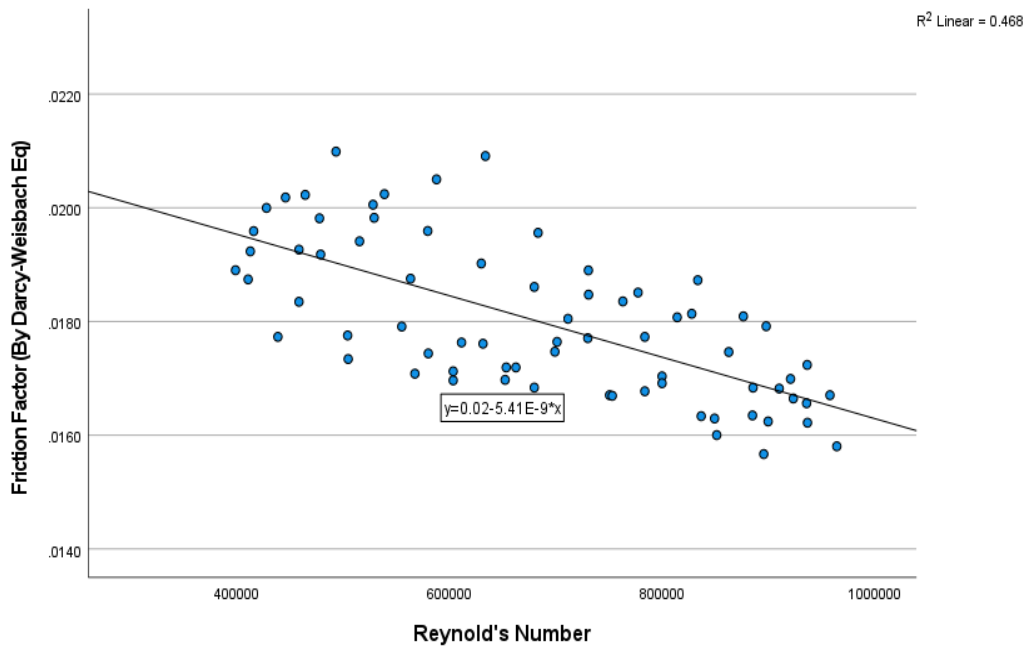
Figure 5.32 Lined Pipe Friction Factor vs. Reynolds number

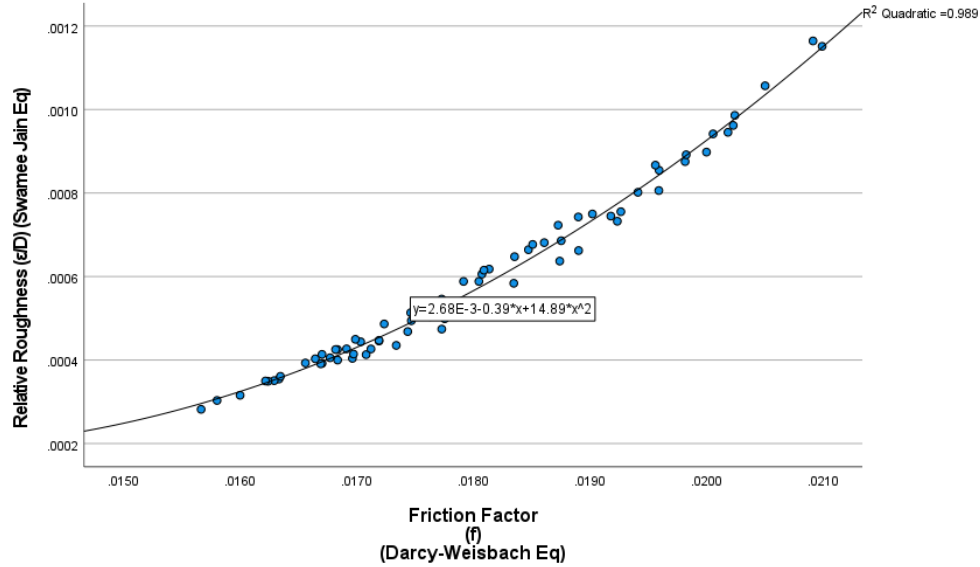
Figure 5.34 Friction Factor vs. Lined Pipe Relative Roughness (Calculated with Swamee-Jain Equation)

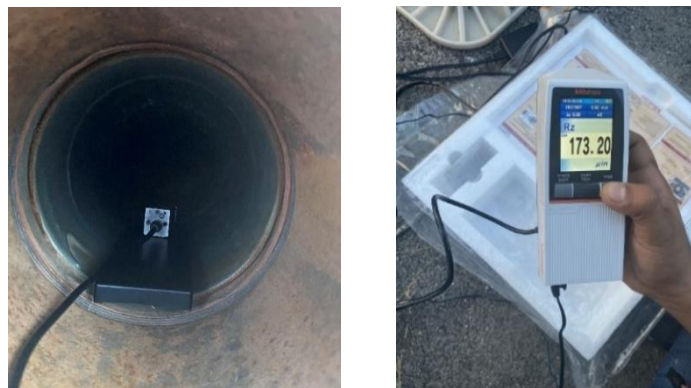
Figure 5.36 Roughness Measurement with Portable Surface Roughness Tester

The probe tip radius was $5\ \mu\text{m}$, and the sampling length used for measuring the roughness was 0.1 in. The roughness was measured at the bottom of the pipe is as shown in Figure 5.36.

Farshad and Pesacreta (2003) suggested that to measure the sand grain surface roughness, the measured peak-to-valley roughness, R_z gives a more realistic result as compared to arithmetic average roughness, R_a . In addition, R_z shows conservative roughness data, which could be considered for the liner measured roughness.

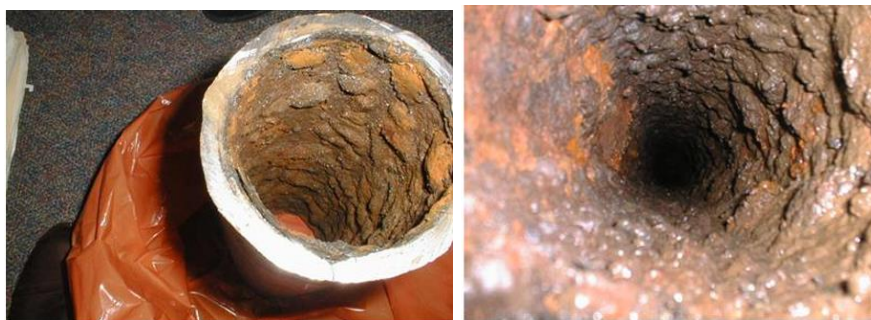
Figure 5.40 Nuclear Service Water System Piping Tubercles Increased Pipe Roughness and Reduce Pipe Internal Diameter (Adapted from Onat et al., (2016))

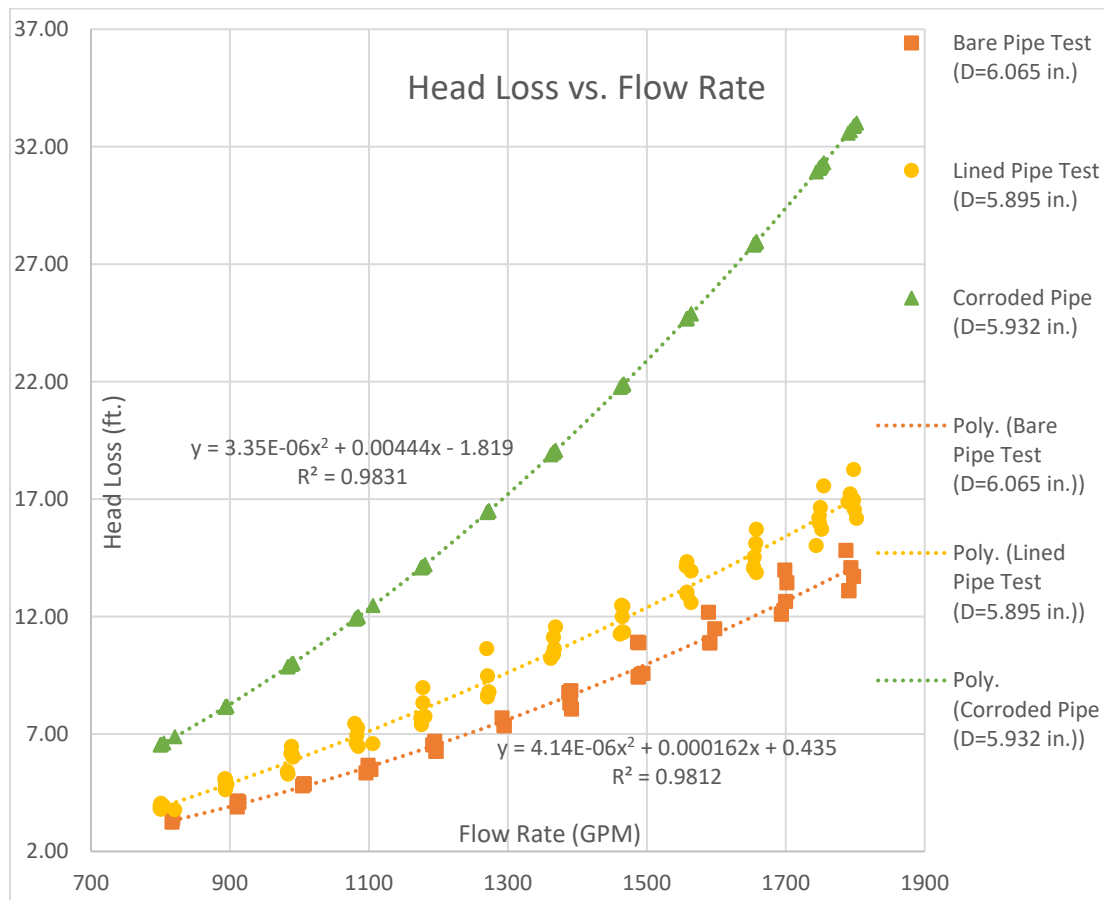
Figure 5.41 Head Loss Comparison for Bare, Lined and Corroded Pipes (at Different Flow Rate)

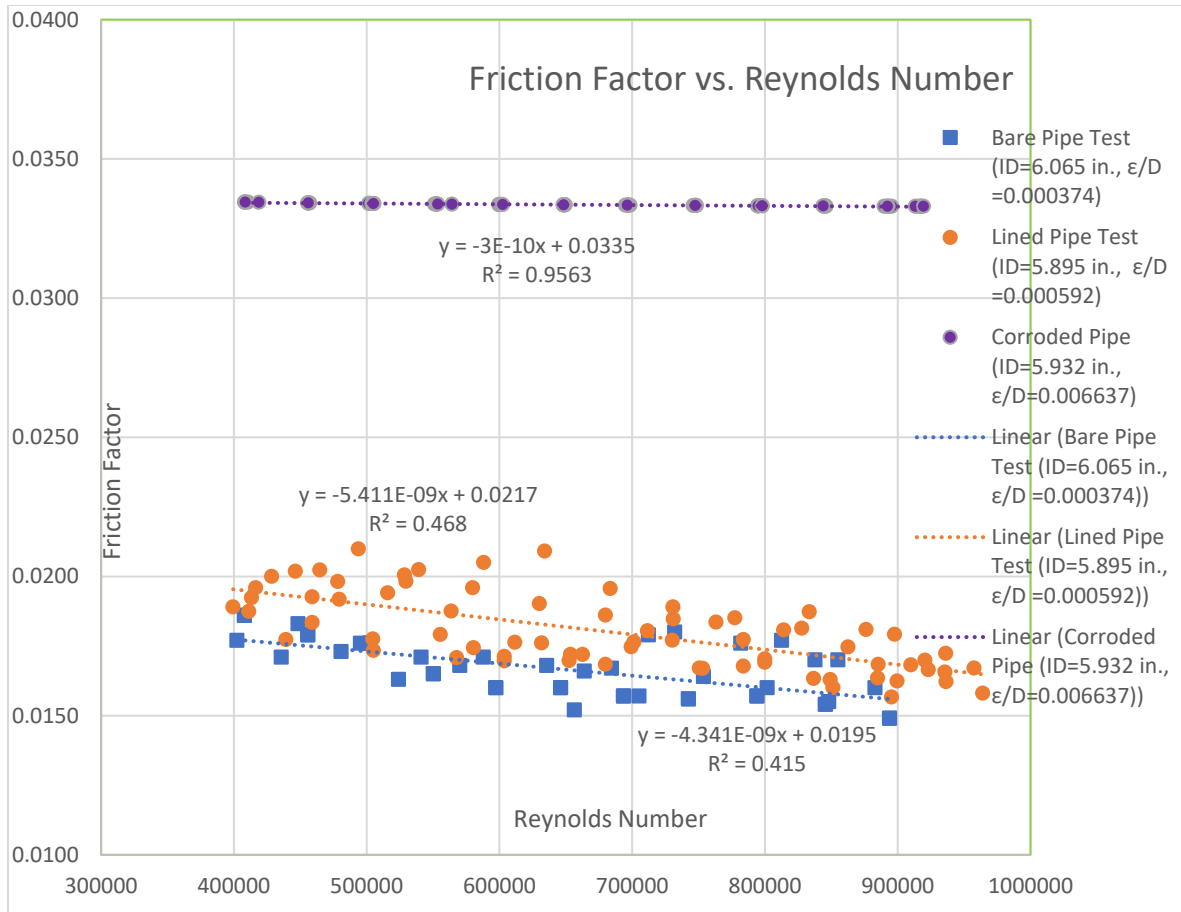
Figure 5.42 Friction Factor Comparison for Lined Pipe with Bare Pipe, and PVC Pipe
