PERFORMANCE EVALUATION AND RETROFITTING OPTIONS OF A PRECAST PRESTRESSED CONCRETE BRIDGE WITH DECK PANEL FAILURE

**PERFORMANCE EVALUATION AND RETROFITTING OPTIONS OF A
PRECAST PRESTRESSED CONCRETE BRIDGE WITH DECK PANEL
FAILURE**

Performance Evaluation and Retrofitting Options of Precast Prestressed Concrete Bridge with Deck Panel Failures

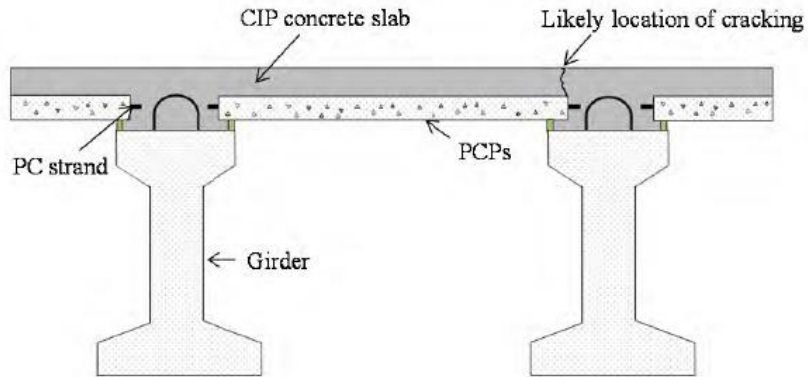
Figure 1-3: CIP-PCP bridge deck (section view) (Bayrak et al. 2013)

Among all of the construction of bridge deck systems, a CIP bridge deck on PCPs system (Figures 1-2 and 1-3) has been widely used around the world (Goldberg 1987) since it was first introduced in a bridge on the Illinois Tollway project in the 1950s (Barker 1975). The CIP bridge deck on PCPs system has many applications, one of which is for bridges located over water where access for construction is limited. Even though PCPs are beneficial in numerous applications, PCPs are susceptible to cracks and failure. Gualtero (2004) found that the cracks occurred at the interface of the CIP deck, and PCPs were caused by shrinkage in the CIP deck portion and creep induced in the PCPs due to prestress force (Figure 1-4). Furthermore, the longitudinal cracks produced transverse cracks that passed through the thickness of the CIP concrete. Additional longitudinal cracking was also associated with panels supported on the negative bedding strips, as shown in Figure 1-4. The cracking additionally caused the shear failure of the CIP concrete. Although using PCPs has some advantages as mentioned above, their propensity for deterioration and/or the possibility of construction errors during installation also have to be considered.

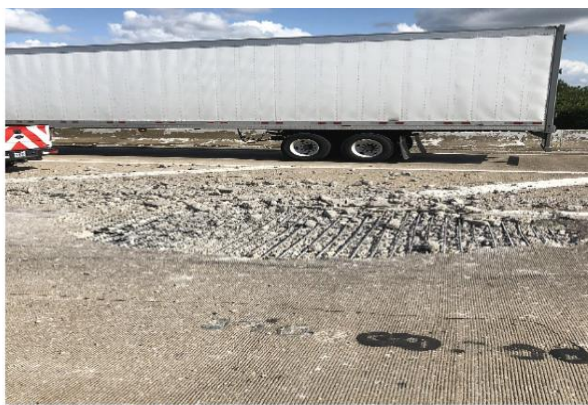
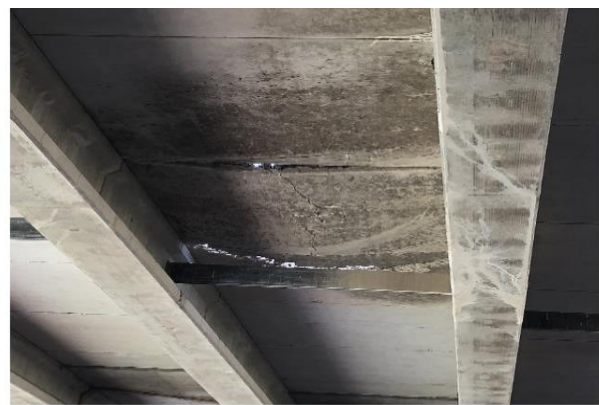
Figure 1-5 Failure patterns in span 2 of EB bridge (TxDOT): (a) CIP deck; (b) PCPs

The localized CIP deck failure in the EB bridge, measuring 7 x 15 ft, had exposed rebars [Figure 1-5(a)]. The deck failure resulted from the failure of four PCPs on June 18, 2018, near the mid-span diaphragm of span 2 EB [Figure 1-5(b)]. Consequently, the TxDOT Dallas District contacted the UTA team regarding the PCP failures and the patched holes on the sides of the bridges. A full-depth emergency repair was then performed on the two bridges [Figures 1-6(a-c)].

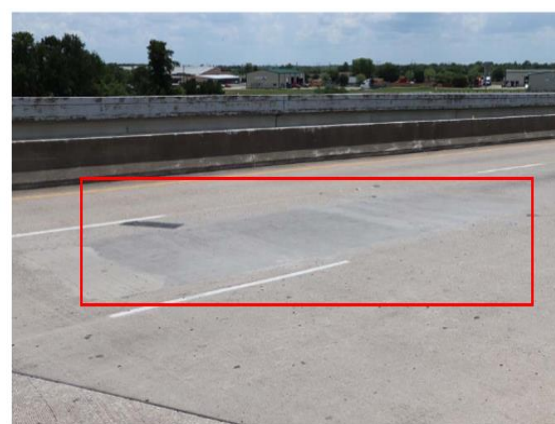
Figure 1-6 Full-depth repairs (TxDOT): (a) Span 2 EB;(b) Span 4 WB; (c) Bottom view of WB

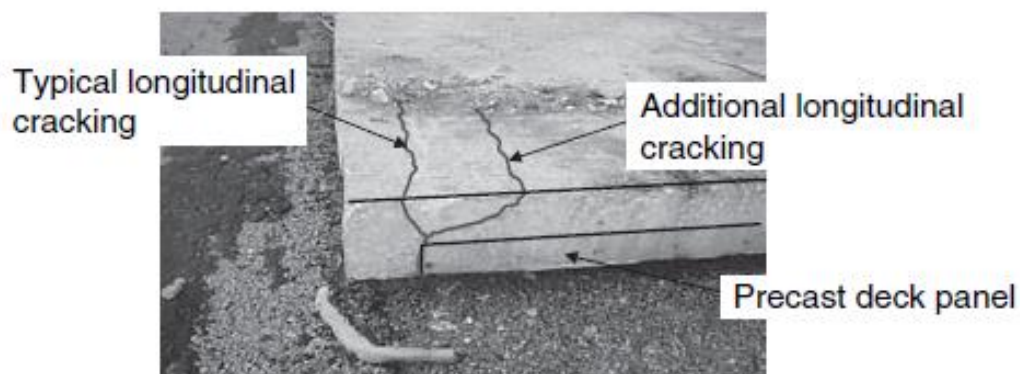
Figure 2-1: Longitudinal crack caused by shear (right crack) (Alvi et al. 2012)

Alvi et al. (2012) conducted research on 127 deck panel bridges with longitudinal, transverse, spalling, and shear cracking. The shear cracks were caused by the diagonal tension of the CIP concrete and extended to the top surface of the CIP, producing longitudinal cracks (Figure 2-1).

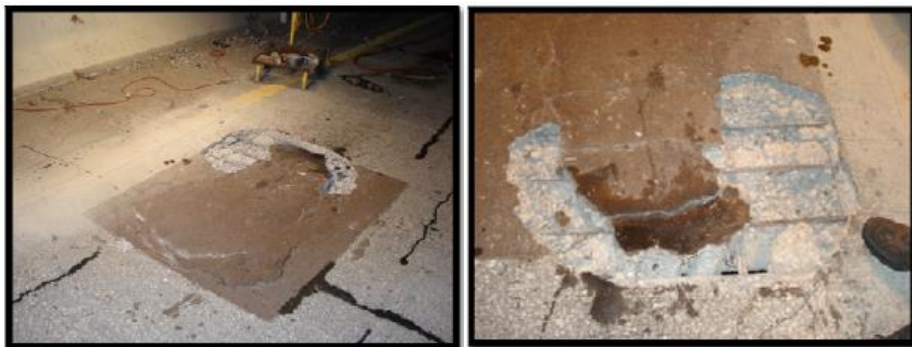
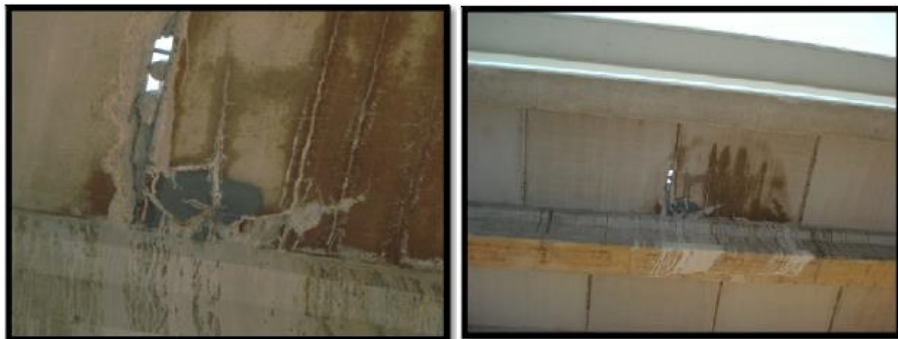
Figure 2-2 Bridge No. 100332, span 39 failure (Alvi, 2010): (a) Top view; (b) Bottom view

Alvi (2010) investigated the deck failures that occurred in Florida in 2007. Table 2-1 illustrates the localized deck failure, and Figures 2-2(a) and 2-2(b) represent the collapse of bridge #100332. The failure was located within the boundaries of the previous repair patch and on the edge of the PCP and girder.

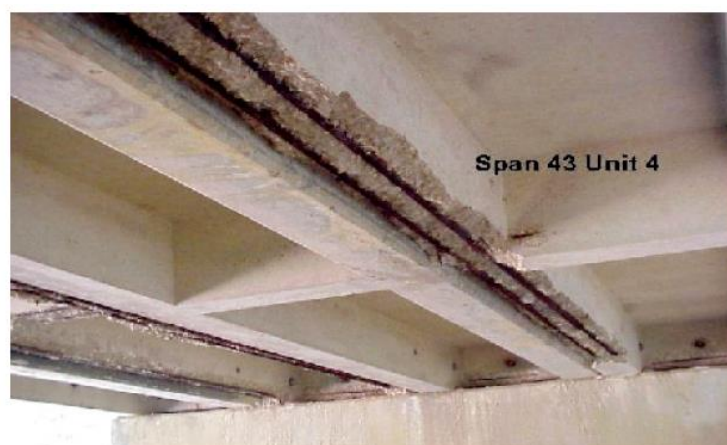
Figure 2-4: Deterioration of Jenkins' Ferry Bridge (Durham et al. 2004)

Durham et al. (2004) developed a field manual to classify 19 ft. precast non-prestressed channel beams without shear reinforcement and identified the beams that exhibited deficient structural behavior. The researchers observed corrosion and concrete spalling (Figure 2-4) in some of the precast channel beams.

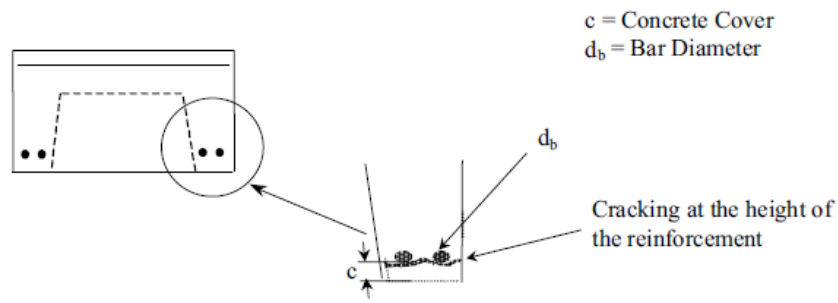
Figure 2-5: Corrosion-induced cracking (Durham et al. 2004)

Durham et al. (2004) concluded that the corrosion of the longitudinal reinforcing steel was caused by the presence of water and oxygen. The water and oxygen resulted in the expansion of the reinforcing steel, which initiated the cracks. The consequences of the corrosion were the loss of the concrete cover as well as the loss of the bond between the concrete and steel (Figure 2-5).

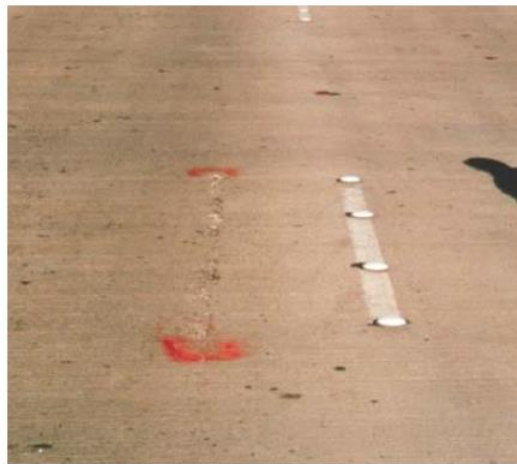
Figure 2-6 Cracks in PCPs: (a) Longitudinal crack; (b) Transverse crack (Merrill 2002)

Merrill (2002) posited that when using PCPs, most of the obstacles were related to longitudinal and transverse cracking. In his (2002) study, Merrill observed significant longitudinal cracking along the panel edge over the concrete girders [Figure 2-6(a)], which caused a reduction in deck stiffness over the girders. This cracking might have resulted from insufficient size, condition, or position of the bedding strips located under the PCPs that are meant to sustain the live load. Additionally, transverse cracking could have been caused by the shrinkage of the concrete as well as the gap between adjacent PCPs [Figure 2-6(b)].

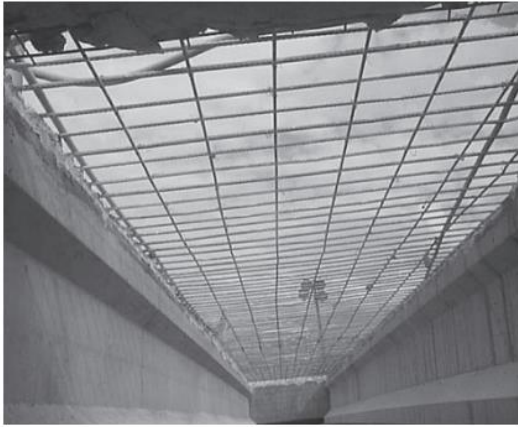
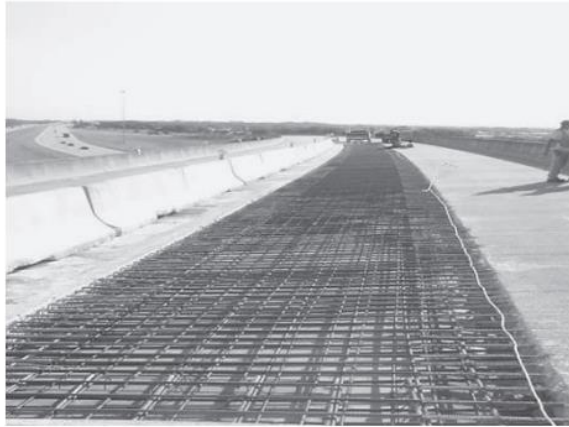
Figure 2-7 Repair methods (Alvi et al. 2012): (a) Maintenance spall patching; (b) Grout packing; (c) M1; (d) M2; (e) Existing full-depth bay replacement; (f) Full-depth Bay replacement with new steel

address PCP deficiencies and was used along the transverse joints of the PCP. The undesired material was eradicated approximately 6 in. on each side of the transverse joints to form an inverted T-beam with specific dimension requirements [Figure 2-7(d)]. Among all the repair method, full-depth bay replacement was the most common repair method that the District Structures Maintenance Office used. The repair involved the transverse distance between two girders and extends throughout the length of the span [Figure 2-7(e)].

Full-depth Bay replacement also involved demolishing the CIP deck and PCP of the affected area while keeping the original reinforcing steel grid for the purpose of continuity. A new bottom steel mat was designed and placed as an alternate to the PCP [Figure 2-7(f)]. According to Alvi et al. (2012), these repair methods had a common factor, which was the failure of applying the requirements of the composite actions between the PCPs and CIP. PCP with no overhang at its sides was observed and considered one of the failures detected by the researcher (Figure 2-8). Figure 2-8 also shows that an extended strand, from the PCP into the CIP concrete, should be installed as well.

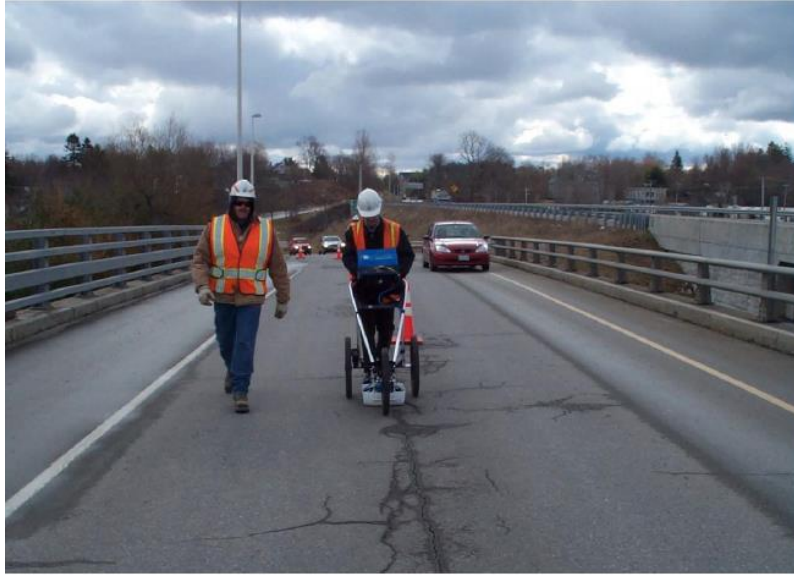
Figure 2-14 Bridge Deck (Parrillo and Roberts 2017): (a) GPR data collection; (b) Deterioration map

Figures 2-14(a) and 2-14(b) show the top view of the bridge deck and the associated bridge deck deterioration contour map, respectively. The reflection amplitude data of each rebar location was used as an indication of the deterioration condition. In Figure 2-14(b) the color legend becomes a dark redness as the deterioration condition increases

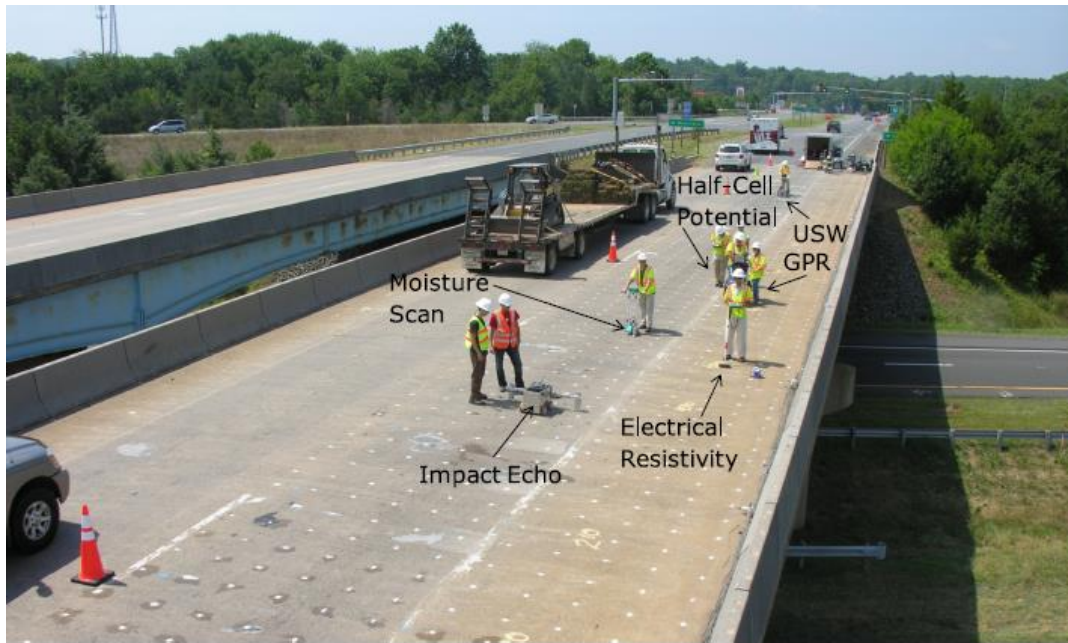
Figure 2-15: NDE technologies during data collection (Gucunski et al. 2016)

Gucunski et al. (2016) investigated a bridge concrete deck located in Haymarket, Virginia using five NDE techniques, including IE. The IE was performed to determine the deck delamination. The deck was scanned at different time intervals in September 2009, August 2011, October 2014, and June 2015. The scanning grid had a spacing of 2 ft. x 2 ft. Figures 2-15 and 2-16 show the actual grid scanning at the bridge site and delamination map, respectively.

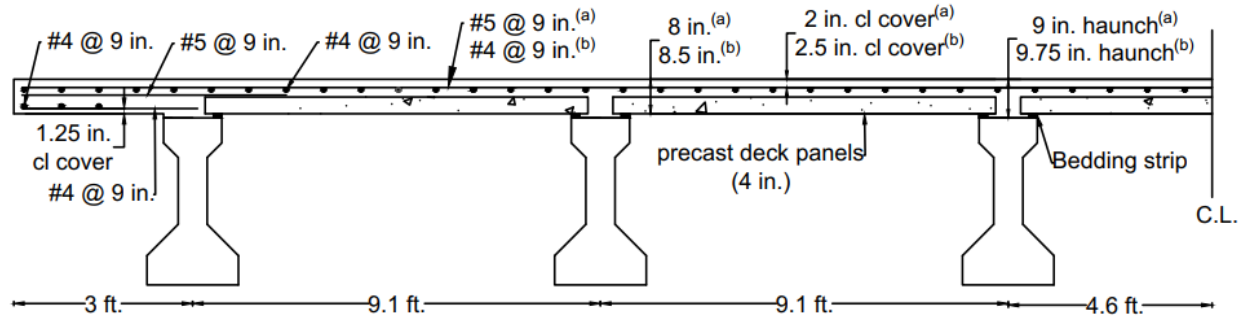
Figure 3-5: Typical transverse section for span 4 of the WB (Note: (a)&(b) represent the WB original and replaced bridge composite decks)

Span 4 is comprised of six Type C prestressed concrete girders, as illustrated in Figure 3-5. The typical transverse section of the WB bridge deck for span 4 has the same reinforcement details as the original EB deck as mentioned in Figure 3-2(a) but with a different number of girders, total deck thickness, haunch height, and girder spacing. Figure 3-5 illustrates the typical section of span 4.

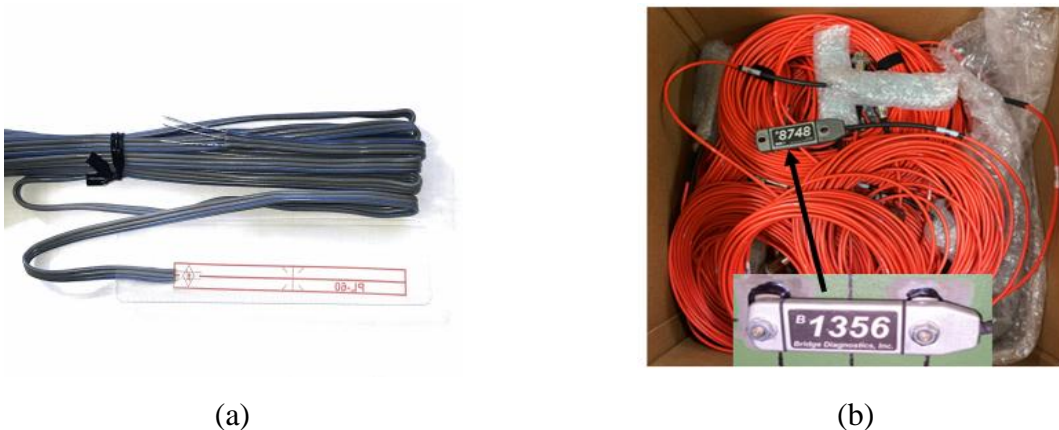
Figure 4-1 Concrete strain gage: (a) Non reusable; (b) Reusable/wireless gage

The strain gage was used to measure the structural member elongation. The strain gages used in the bridge testing consist of non-reusable and reusable/wireless strain gages. The non-reusable gages are a resistance-based foil strain equipped with different gage-length factors. Since the bridge involved a Type C girder made of concrete, a longer gage length of 2.4 in. (60 mm) or longer is optimal due to the non-homogenous nature and crack susceptibility. The non-reusable gages are manufactured by Tokoyo-Sokki, and their types are PL-60-11-3LJCT-F [Figure 4-1(a)]. The gage factor can vary among gages with a range between 2.08 to 2.12, while the gage resistance usually depends on the tested material types. For concrete, the resistance gage is 120 Ω . The reusable gage, ST350, is used for most material types, including steel, concrete, timber, and fiber-reinforced polymer (FRP), which has a gage length of 3 in. (76.2 mm) [Figure 4-1(b)]. ST350 also can measure strain up to 4000 $\mu\epsilon$, which is suitable for bridge testing.

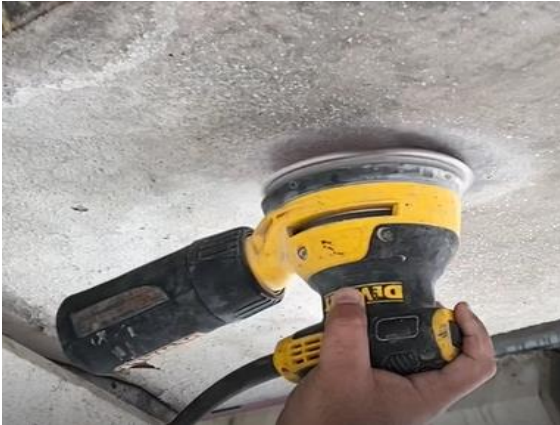
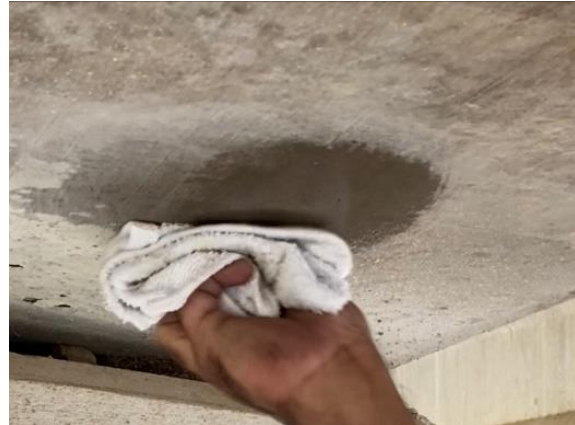
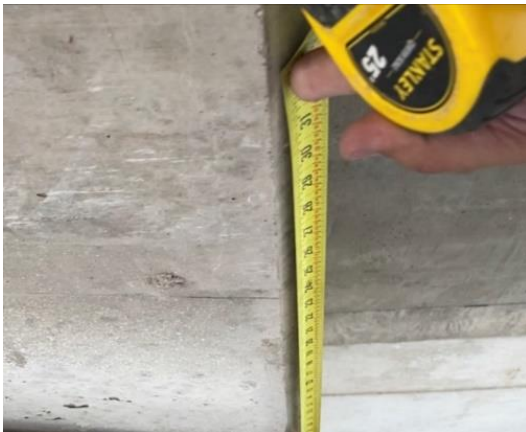
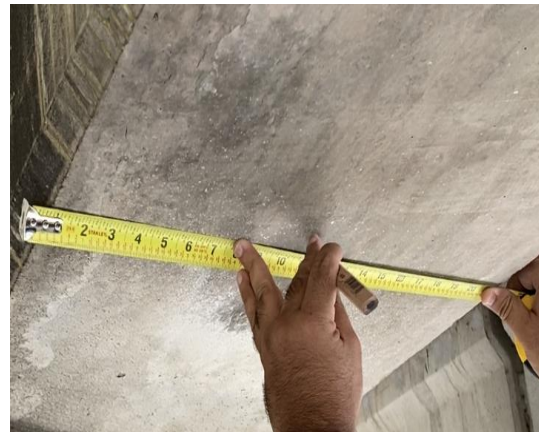
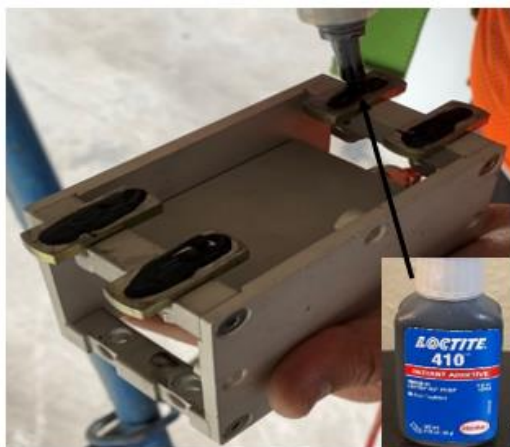
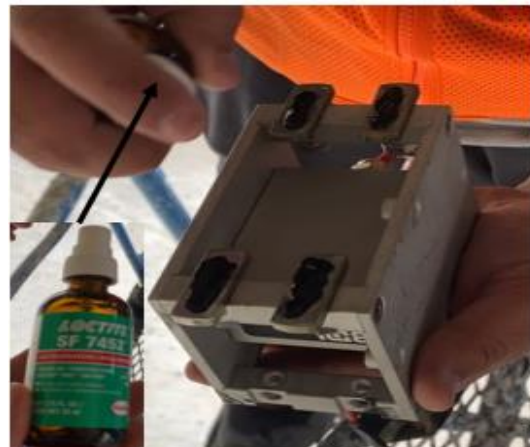
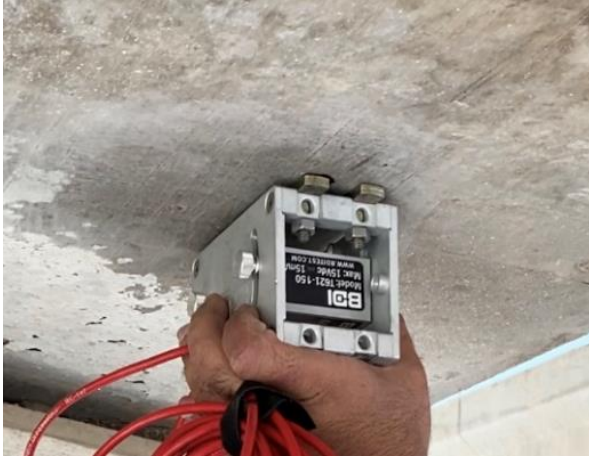
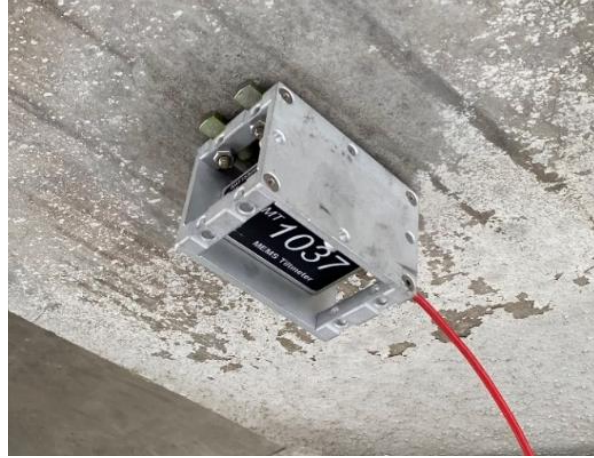
(a) Sanding the surface

(b) Cleaning surface with acetone

(c) Measuring 2 ft. from CL of bent 2

(d) Measuring mid-point of girder

(e) Applying Loctite 410 on steel plate

(f) Applying Loctite accelerator

(g) Holding tiltmeter for 10-15 seconds

(h) Attached rotational tiltmeter

Figure 4-3: Installation sequence of rotational tiltmeters and reusable strain gages

The installation process of the rotational tiltmeter on the concrete surface is the same as reusable strain gages. The sequence of installing rotational tiltmeters and the reusable/wireless strain gages is shown in Figures 4-3(a-h).

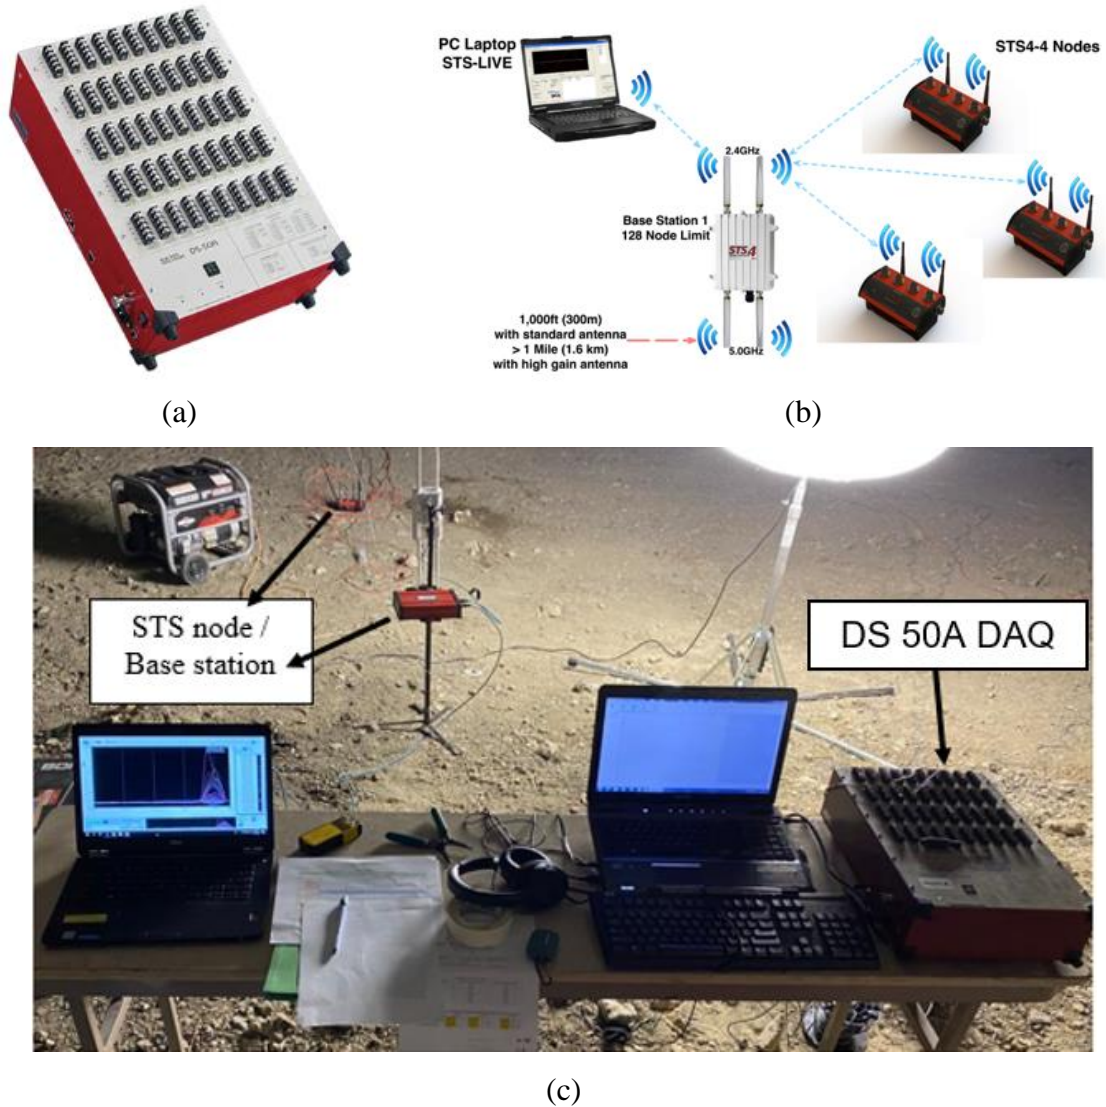
Figure 4-4 Equipment set-up: (a) DS 50A DAQ; (b) STS base station function [BDI]; (c) Full set-up

Both DAQs are functioned in a unique way. Tokyo Sokki DS 50A requires a cable used to transmit data from DS 50A to the laptop using a software called Strain Smart. DS 50A consists of 4 units in which every unit has 10 channels [Figure 4-4(a)]. Each non-reusable strain gage was connected to a specific channel number. The software allows users to change the gage calibration coefficient based on the recommendation from the manufacturer. STS4 Base Station, on the other hand, communicates wirelessly with STS nodes connected to reusable gages and tiltmeters through a router and transmits the collected data to a connected laptop [Figure 4-4(b)]. The sampling rate used was 10 data/ second. Figure 4-4(c) represents the full field equipment set-up ready for data collection.

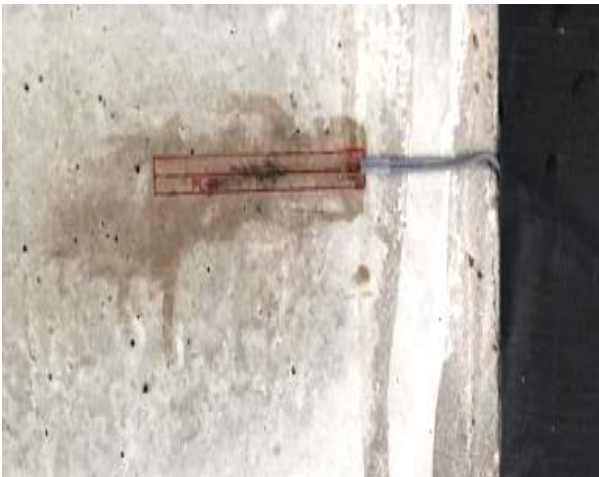
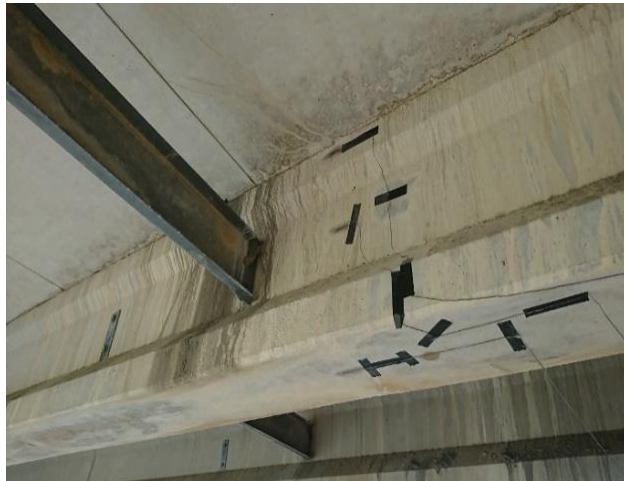
Figure 4-6 Attached non-reusable strain gages: (a) EB bridge; (b) WB bridge

- The optimal gage locations were determined on the bottom flange, mid-web, and top flange of the concrete surfaces.
- The concrete surface was smoothed by the grinding machine which was connected to a generator as a source of power and was subsequently cleaned with acetone and water.
- Non-reusable gages were installed on the concrete surface using CNE adhesive, while the reusable/wireless gages used Loctite 410 epoxy and Loctite accelerator with the assistance of a man-lift [Figure 4-3 (e) and 4-3(f)].
- White rope was used to tie the gage wires to the bridge diaphragms near the instrumented girder.

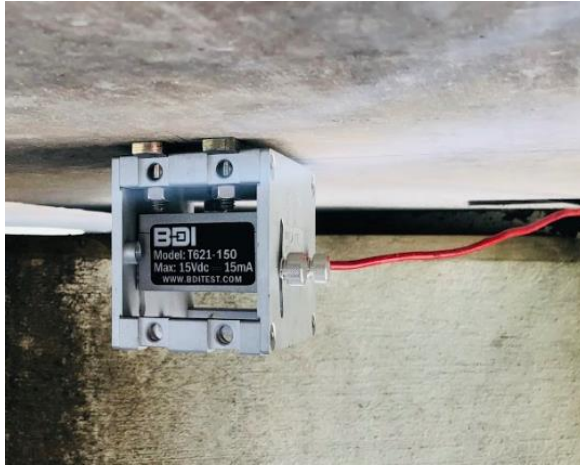
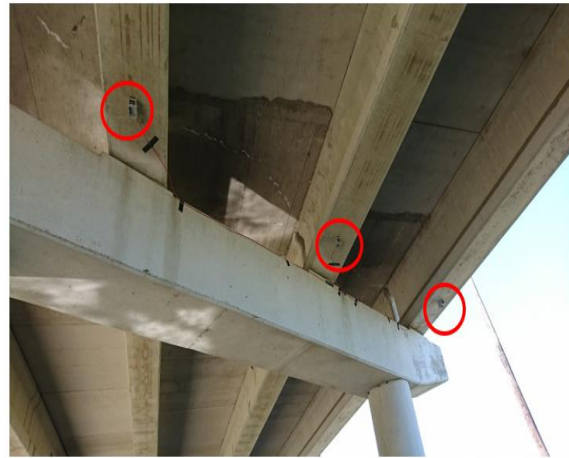
Figure 4-7 Attached tiltmeters: (a) EB bridge; (b) WB bridge

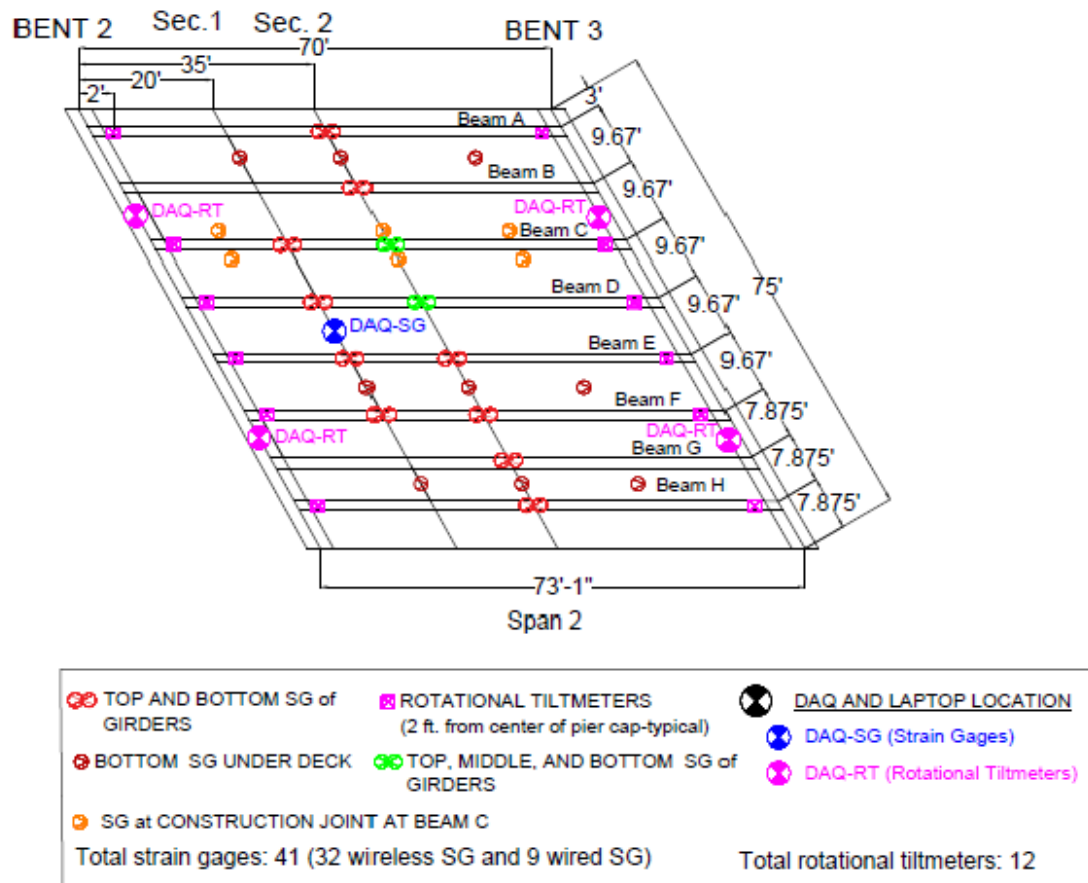
Figure 4-8: Follow up Instrumentation plan for load testing of EB replaced deck

wireless gages during Phase 1 instrumentation, non-reusable gages were only used on the previous deck. The replaced bridge decks used a total of 41 reusable strain gages. The tiltmeters attached to the girder are shown in Figures 4-10(c). Table 4-1 shows the location of the strain gages and rotational tiltmeters.

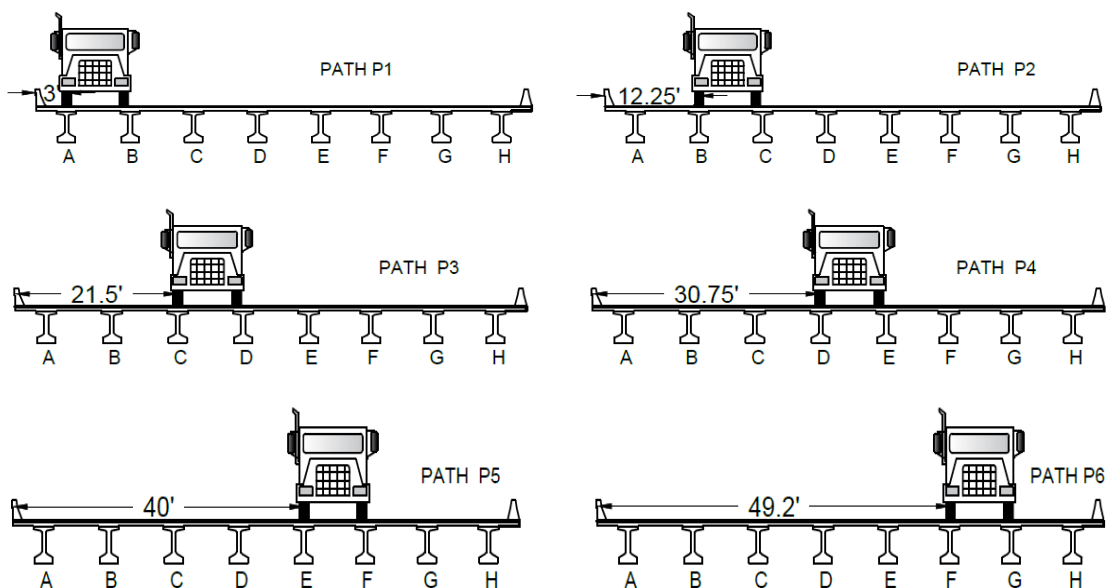
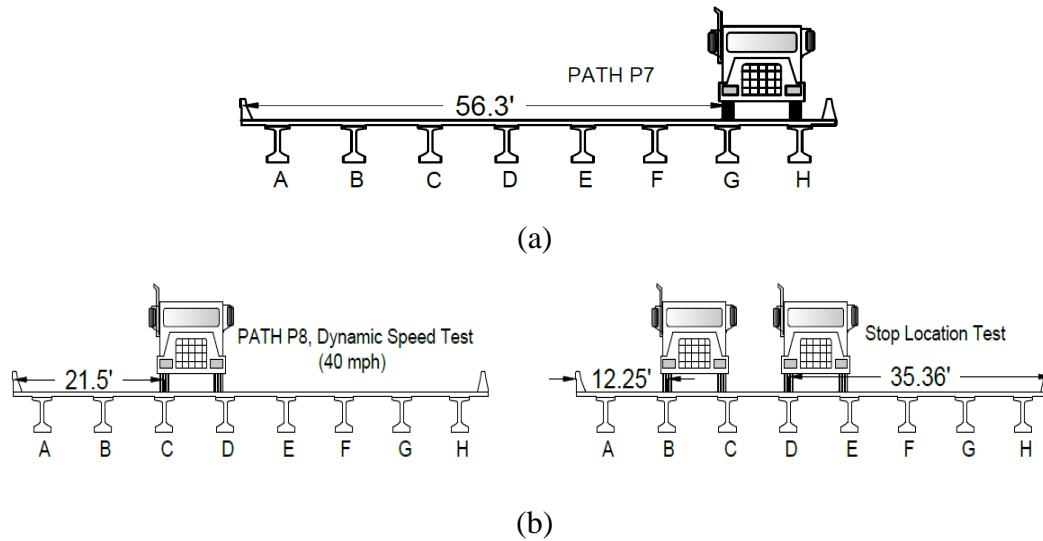
Figure 4-13 Follow-up test paths: (a) Crawl speed; (b) Dynamic and stop location

The follow-up load test involved a comprehensive bridge investigation to obtain insight into bridge performance in terms of composite action and load carrying capacity. A dynamic load test and additional static load test paths were included, when compared to phase 1 to reasonably evaluate the responses of all the girders. Stop location test was the same as in phase 1. As a result, the replaced deck test had six static paths and one dynamic path. The dynamic test was conducted using the same procedure as the crawl test utilizing the heavier truck A but at a speed of 40 mph. The proposed load paths in a follow-up test are depicted in Figures 4-13(a) and 4-13(b).

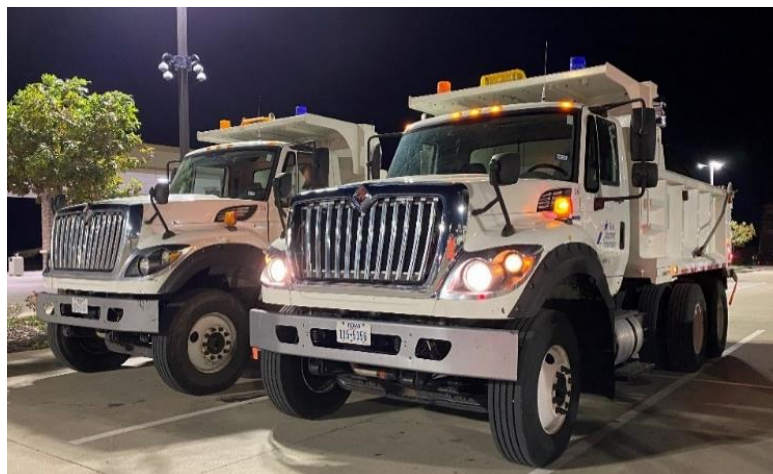
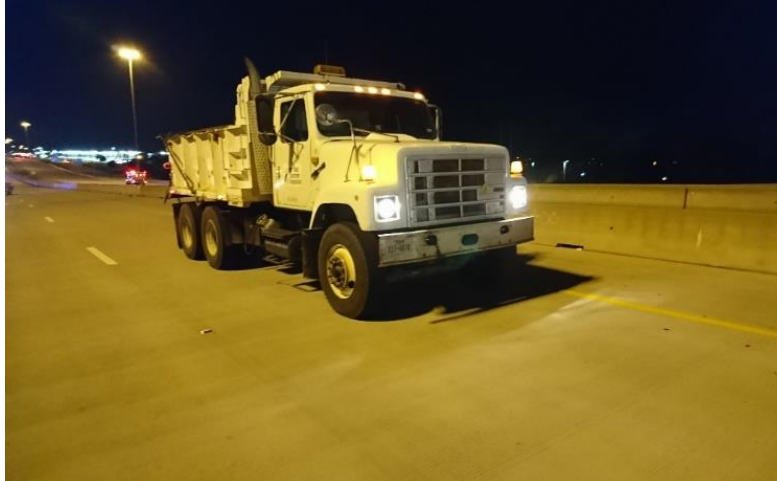
Figure 4-14: Typical dump trucks

Figures 4-14(a) and 4-14(b) show the typical two-truck and one-truck configuration during the load test, respectively. Each load test lasted for 2 to 2.5 hours after the necessary sensor connections were completed. Additionally, the load tests were held from 10:00 pm to 12:30 am due to high traffic on IH-20 during the daytime. The load testing also involved rolling traffic closure as the bridge lanes were closed for 15 minutes, and then the traffic was resumed for approximately 15-20 minutes. After the load test was complete, the reusable sensors were removed from the girder surfaces with the assistance of a man-lift.

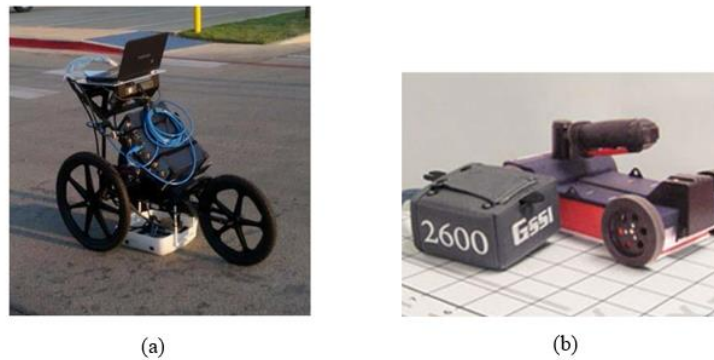
Figure 4-15 Ground penetrating radar (GPR): (a) Cart-mounted GPR; (b) 2.6 GHz antenna

Second, the depth of delamination and its location relative to adjacent steel bars might impact its detectability in GPR images. Antennae with higher frequency (e.g., 2.6 GHz) are used for low-depth analysis (0-12 in.), while lower frequency (e.g., 270 MHz) are used for higher depth evaluation (0-18 ft.). Figures 4-15(a) and 4-15(b) show a cart mounted GPR and 2.6 GHz antenna as a hand scanner, respectively.

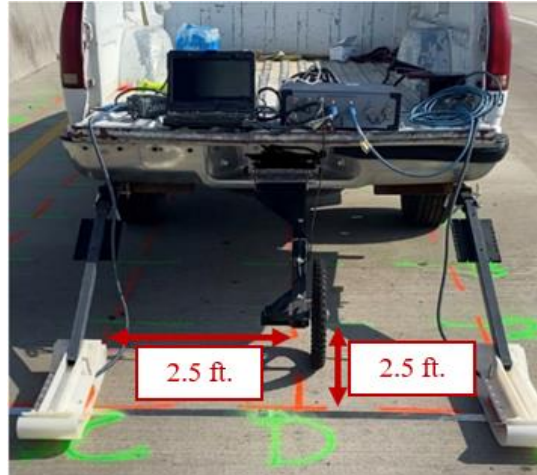
Figure 4-16: Truck-mounted GPR

GSSI SIR-30 GPR was utilized to scan the bridge deck. A truck-mounted GPR used multiple-frequency antennae: two 2.6 GHz [Figure 4-16] and one 400 MHz. These antennae cover a range of depths. The scans using truck-mounted GPR were performed at a speed of less than 5 mph, which saved a significant amount of time compared to a tri-wheel push-cart GPR with a single antenna. As the original EB and WB bridge deck experienced a localized CIP deck failure, the affected deck area was patched. As a result, to increase the accuracy of the scan, the tri-wheel [Figure 4-15(a)] was only used on the patched areas in both bridge decks. A square scanning grid was additionally used for GPR, and the grid was spaced at 2.5 ft. for the full bridge deck (Figure 4-16), with the exception of the patched area which was spaced at 1.0 ft.

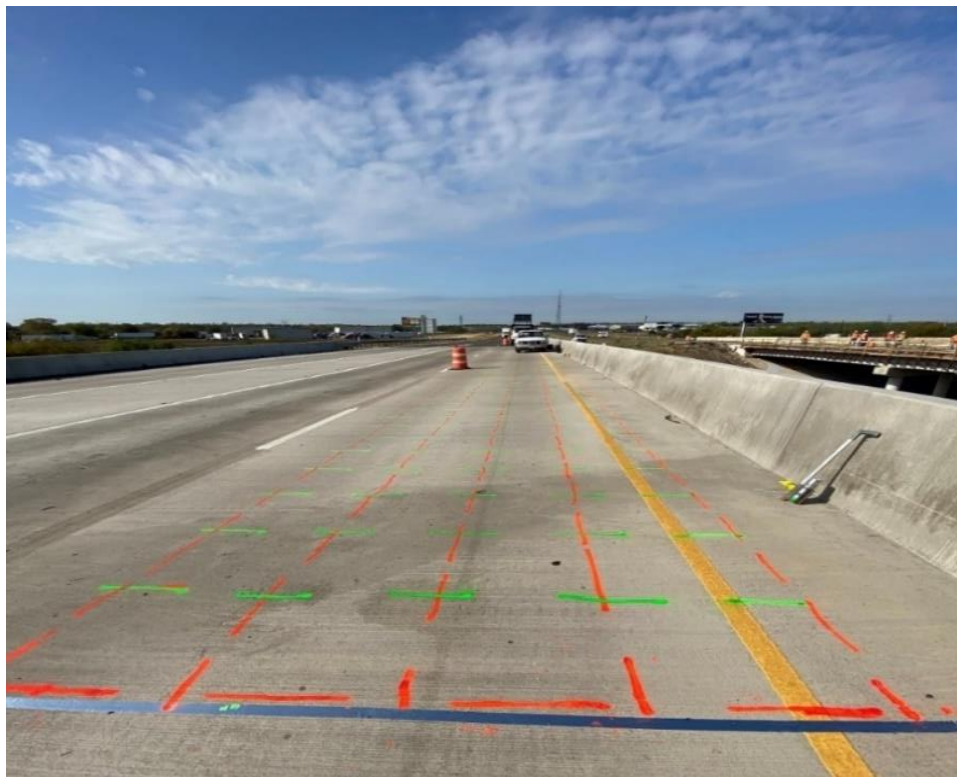
Figure 4-19: GPR and IE scanning grids

Only truck-mounted GPR with two antennae with high frequency (2.6 GHz) was used as the bridge deck was recently constructed in 2019. Figure 4-18 shows the follow-up scanning grid of the EB bridge. The GPR scan was performed on multiple paths and involved all bridge lanes, such as path A-C, path B-D, and path C-E (Figures 4-16 and 4-18). Figure 4-19 shows the actual field scanning grid used for GPR. These grids were used during the GPR scans. Gridlines parallel to the direction of traffic and denoted in orange color were utilized for the GPR scanning (Figures 4-19).

The IE scanning was performed in both bridges. Figures 4-21(a) and 4-21(b) show the scanning grids of the original bridge decks. The replaced deck used the same scanning approach as the original bridge (Figure 4-19).

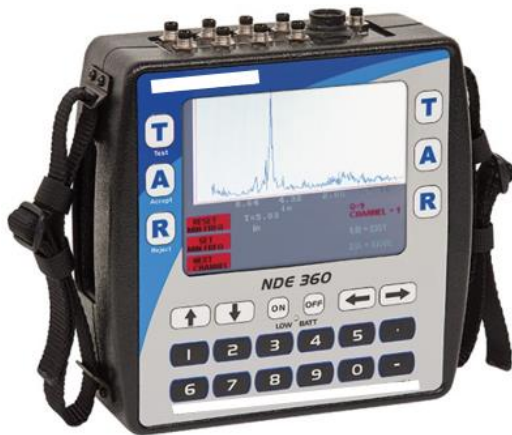
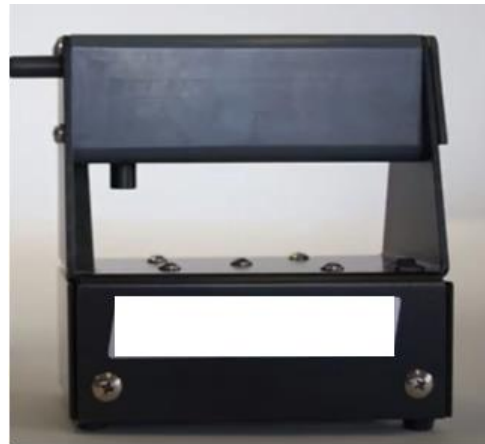
Figure 4-20 IE device: (a) NDE 360 platform; (b) Hand-held

thickness based on Impact Echo (IE) principle. The IE creates an impact at a certain point on the deck surface. At each specific point, the device captures two impact/data and then the average between these two-impact data appears on the IE monitor, and the user has the option to either accept or reject the data if it is within the tested deck thickness or far away from the anticipated deck thickness, respectively. The created impact reflects if delamination presents within the concrete deck thickness. The IE device is only scanned one point at a time and is not a continuous scan as is the case with the GPR device. The IE scanned points are identified as the intersection of the longitudinal and transverse grids, which are denoted in orange and green colors, respectively (Figure 4-19). The IE scanning followed ASTM Standard C1383, and scanning was performed at multiple points on the bridge deck. Figures 4-20(a) and 4-20(b) show the IE configuration.

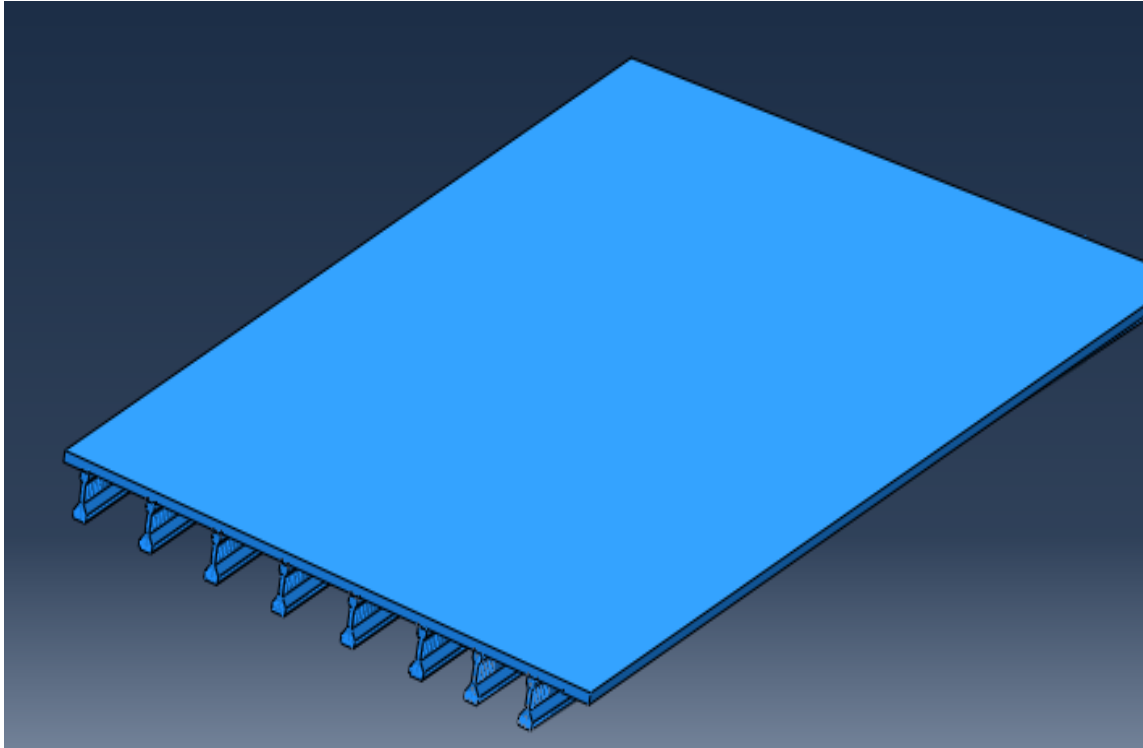
Figure 5-1 FEM views of span 2 EB bridge

The initial FEM was modeled using ABAQUS (2018) and involved creating a 3D geometric model of span 2, defining material properties, interactions, and boundary conditions. Figure 5-1 shows the model view of the targeted span. The model employed 8-node linear brick elements (C3D8) for the concrete and 2-node linear truss elements (B21) for the reinforcements and prestressing strands, as these can carry only tensile forces. Moreover, simple support boundary condition was assumed for all of the girders. The reinforcements and prestressing strands were then embedded in the concrete, using the embedded region constraint option. The reinforcements were the embedded elements, and the girders, PCPs, and CIP deck concrete were the host elements. The interactions between the PCPs, CIP deck, bedding strips, and girders were initially simulated using a tie constraint option. The bedding strips, modeled in FE, have dimensions of 1 in. height and 2 in. width, so the total deck thickness above the girder flange is 9.25 in above the girder flange.

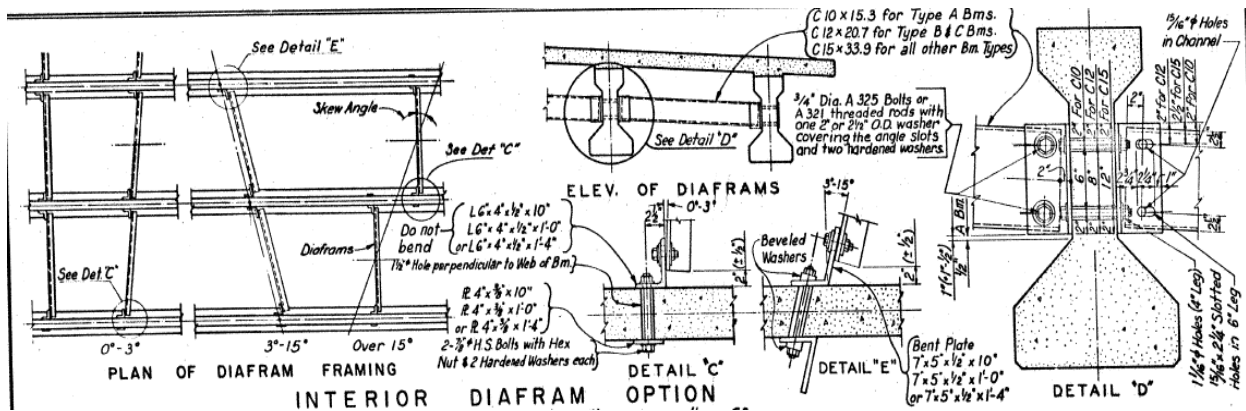
Figure 5-9: Steel channel and angle specifications

EB bridge diaphragms in span 2 were modeled according to the as-built drawing. The diaphragms also include a steel channel and steel angle. The steel angle is used to connect the steel channel with girders. Figure 5-9 shows the drawing of the steel channel and angle. Steel channel and angle, measured at C12 x 20.7 and L6 in. x 4 in. x ½ in. x 12 in., were used as specified for the Type C girder. Figures 5-10(a) and 5-10(b) show the modeled diaphragm parts in FE. Two of the diaphragm's nuts located between girders B and C were missing [Figure 5-10(c)]. Figure 5-10(d) shows the bottom view of the span 2 model, including the missing diaphragm in ABAQUS. Table 5-2 shows the physical properties of the steel channel and angle.

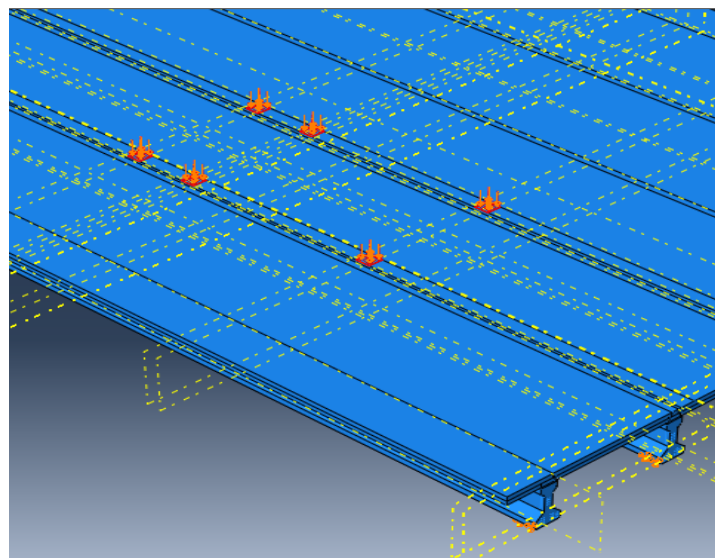
Figure 5-14: Wheel loads applied as patch loads

The modeling involved applying the truck wheel loads of the original EB bridge shown in Table 4-2 as patch loads over a 200 in² area. The tire contact area of a wheel consisting of one or two tires was assumed to be a single rectangle measuring 20 inches wide and 10 inches long (Grubb et al. 2015). The tire pressure was also assumed to act uniformly within the tire contact area. Figure 5-14 shows the loads on the top of girders B and C at mid-span in FEM, simulating the Path 2 (P2) load test condition shown in Figure 4-12(a).

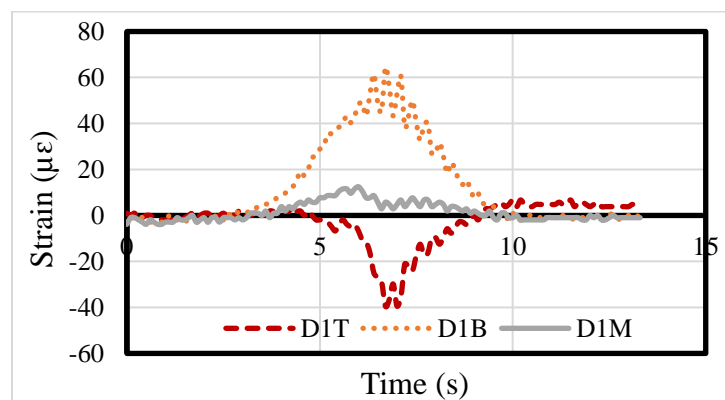
Figure 6-1: Raw strain data for Path 3 Run 1 of WB bridge

The strain gage and the rotational tiltmeter data were analyzed to evaluate the bridge response due to the induced truck load. The legend of strain gage results (Figure 6-1) was designated as follows: the 1st letter denotes the girder (A-H), the 2nd number shows the section (1, 2), and the last letter shows the location (T-top, M-Middle, and B-bottom). The bottom strain gages were subjected to tensile stress, whereas the top gages were subjected to compressive stress, resulting in a negative reading. The middle gages should have no or little strain readings depending on their location from the girder neutral axis (N.A.). The non-reusable strain and rotational tiltmeter responses exhibited noise and vibration during the load test. The data was then refined using the moving average between 10 points. Figure 6-1 shows the raw strain response for Path 3 Run 1.

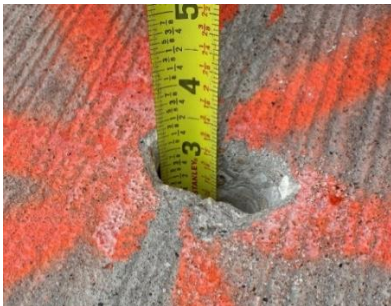
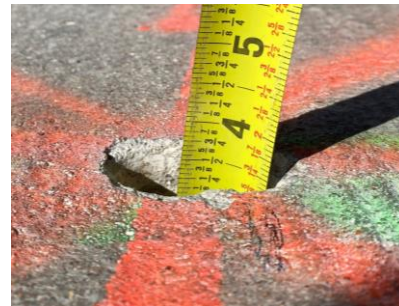
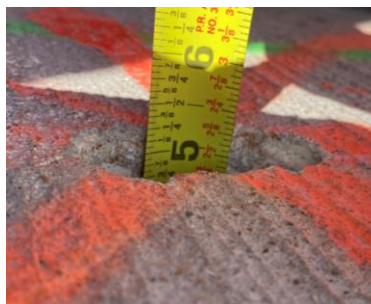
Figure 6-20 Core drill calibrations: (a) Lane 1E, 3.0 in.; (b) Lane 2E, 3.63 in.; (c) Lane 3E, 5 in.

2-D GPR scan contours from span 2 of the EB bridge deck, showing the top reinforcement cover depths, are presented in Figures 6-19(a) and 6-19(b). The reinforcement profile was clearly visible, and the color legends, shown in the 2-D contour plan, indicate the areas of different cover depth ranges in inches. The percentages of the cover depth ranges of each area are also shown. The color legends moreover indicate that 57% of the bridge deck in lanes 1,2, and 3 has a rebar cover depth between 3 in. to 4 in. Therefore, an average of 3.5 in. was used in the load rating (as detailed in section 6.3.2). According to the as-built plans, the concrete cover for the deck top layer rebars was 2.5 in. To verify the top rebar cover, three of the drilled cores are shown in Figures 6-20(a-c) to verify the accuracy of the GPR readings [Figures 6-19(a) and 6-19(b)]. The locations of the cores are also shown with the black circles in the contour plots. A 5 in. core drill is located above the girder where only a full CIP concrete deck exists.
