PERFORMANCE EVALUATION AND RETROFITTING OPTIONS OF A PRECAST PRESTRESSED CONCRETE BRIDGE WITH DECK PANEL FAILURE

**PERFORMANCE EVALUATION AND RETROFITTING OPTIONS OF A
PRECAST PRESTRESSED CONCRETE BRIDGE WITH DECK PANEL
FAILURE**

Performance Evaluation and Retrofitting Options of Precast Prestressed Concrete Bridge with Deck Panel Failures

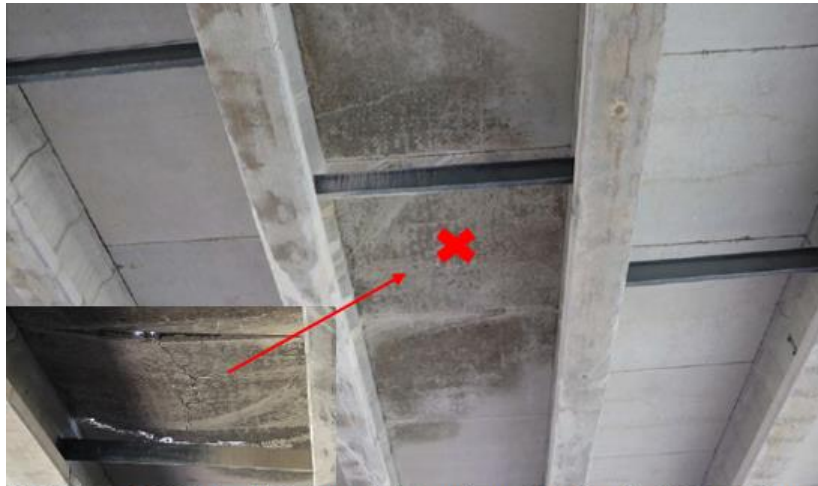
NOTE: 1. On 5/22/18, four P/S deck panels between beams 3 & 4 from North in Span 2 from West have evidence of water staining and hairline cracks with efflorescence. This deterioration is located below a small patch in top surface of deck.
 2. On 6/18/18, the P/S deck panel just West of the mid-span diaphragm fractured and failed causing a localized deck failure (~7' W x 15' L) that required a full-depth repair (see additional photos).

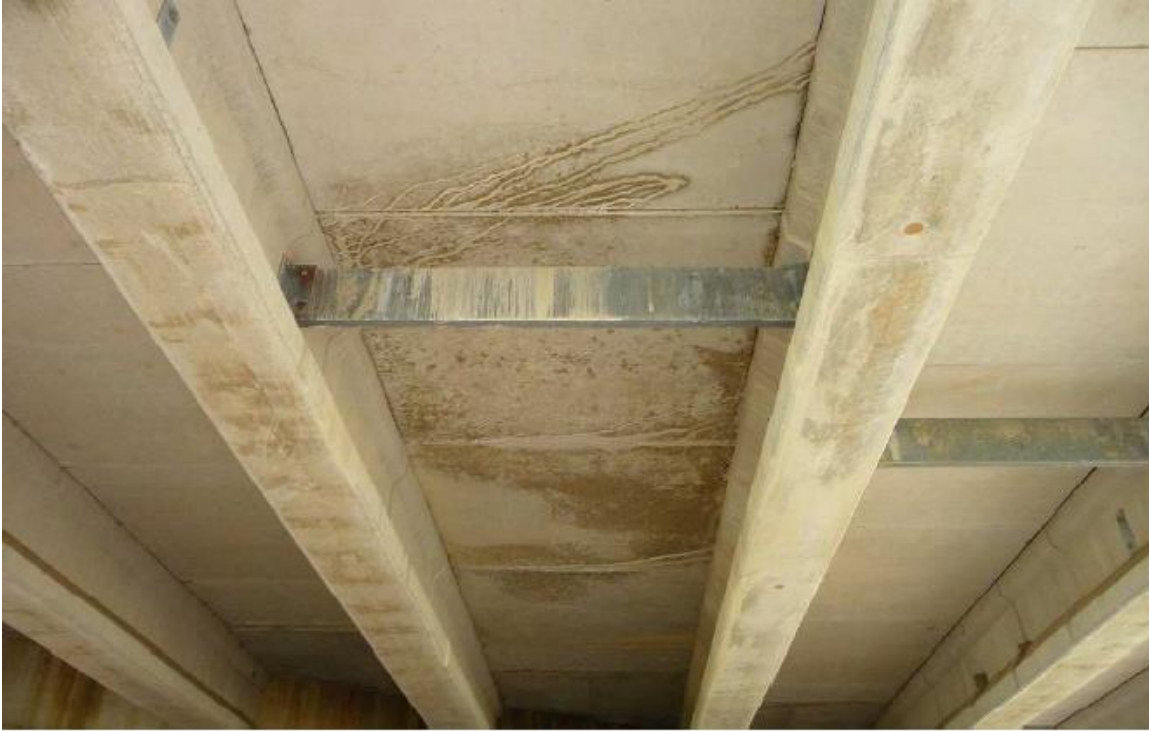
NOTE: Widespread hairline to minor alligator cracking (some with efflorescence) of Deck Panels between Girder Nos. 3 and 4 (from NW) in Span No 4. (This area is directly below patches in Deck surface.)

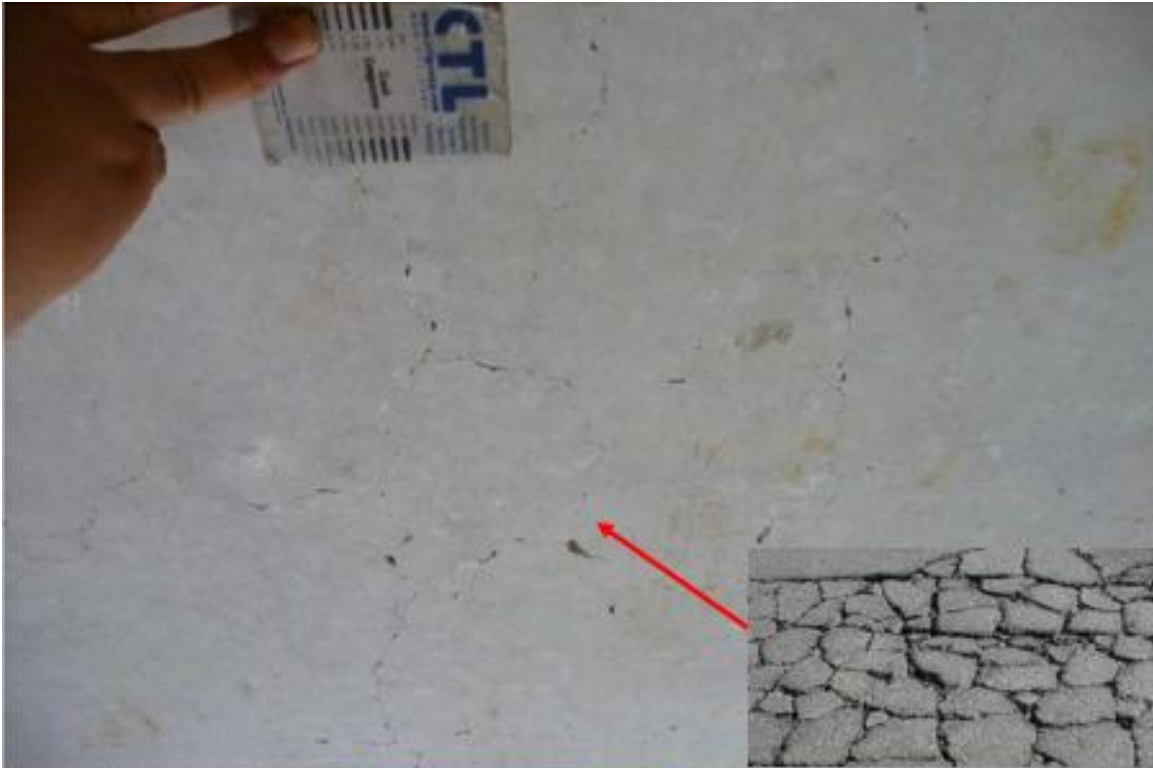
NOTE: Widespread hairline to minor alligator cracking (some with efflorescence) of Deck Panels between Girder Nos. 3 and 4 (from NW) in Span No 4. (This area is directly below patches in Deck surface.)
